ARCHITECT'S SUPPLEMENTAL INSTRUCTIONS

PROJECT:	Roosevelt Lofts Historic Rehabilitation San Angelo, TX	Report No.	Seven (7)
OWNER:	Overland Property Group 234 N. Santa Fe Ave, Suite A Salina, KS 67401	Date	Nov. 20, 2024
CONTRACTOR:	MCP Group 3501 SW Fairlawn Rd. Topeka, KS 66614	Architect's Proj No.	22-3281
		Contract For:	General Construction Mechanical, Electrical

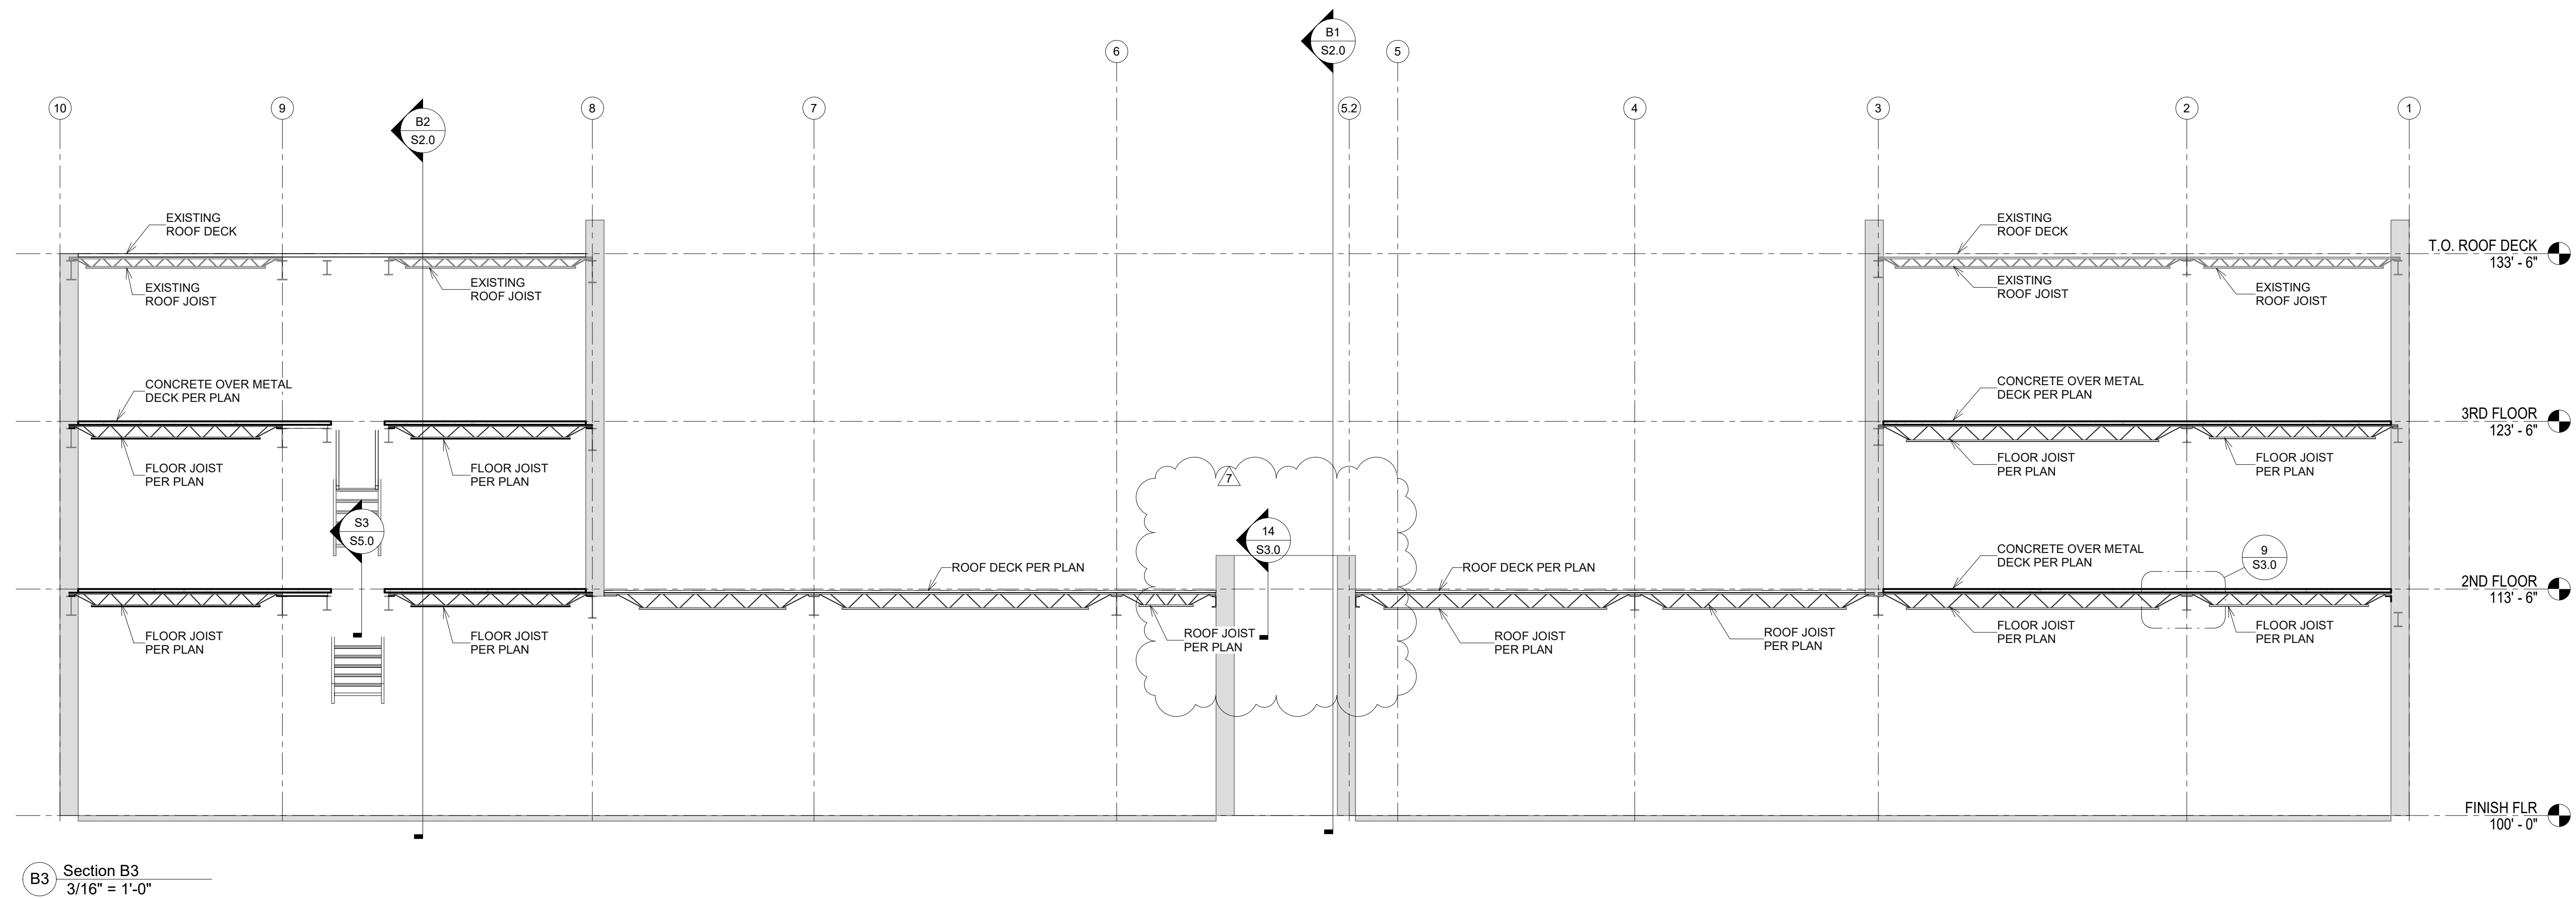
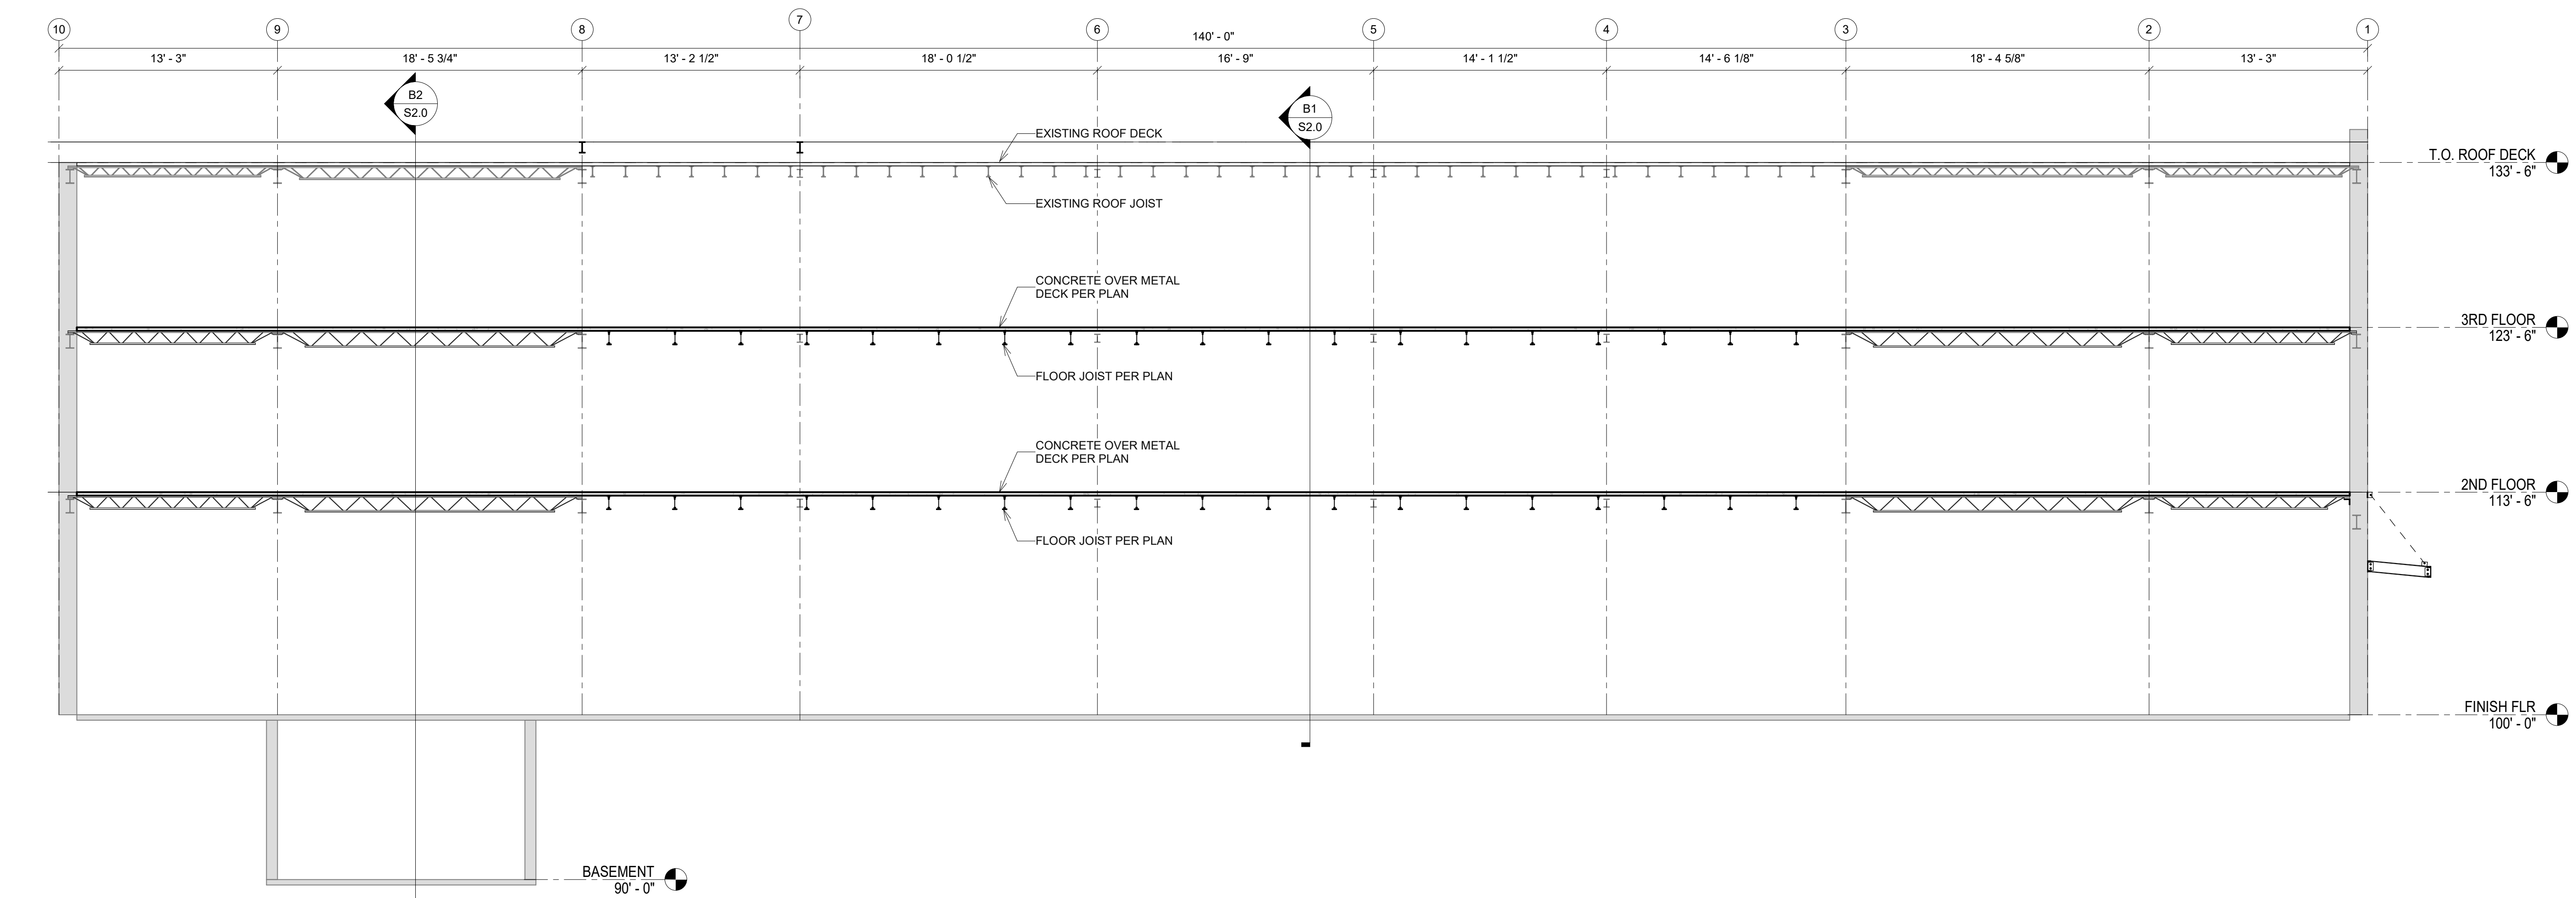
1. Sheet S1.1 – Replace with new sheet with modified joist bearing around bump-in between gridlines 5 & 6 wall.
 - a. Added MC channel beams around bump-in for joist bearing
 - b. Added notes 8, 9, 10 for repair of masonry bearing of steel beams.
 - c. Added sections 14/S3.0 and 15/S3.0
2. Sheet S2.1 – Replace with new sheet with modified joist bearing
 - a. Modified B3/S2.1 to show joist bearing on MC channel at bump-in on north wall
3. Sheet S3.0 – Replace with new sheet with modified and added details
 - a. Modified sections 3/S3.0 and 5/S3.0 to show masonry wall without embedded steel beam and to show new MC channel for joist bearing.
 - b. Added sections 14/S3.0 and 15/S3.0 to show steel beam connections and joist bearing around north wall bump.

6. DELAMINATION ON BEAM
 - A. CLEAN AND REMOVE RUST AND SCALE.
 - B. CHECK REMAINING THICKNESS.
 - C. WHERE MORE THAN 25% OF ORIGINAL THICKNESS IS MISSING, WELD 5/16" COVER PLATE 1/4" MIN. 6" ON EACH SIDE OF DAMAGE.

- D. PRIME AND PAINT REPAIRED AREA AFTER REPAIR IS COMPLETE
7. CONTRACTOR TO FIELD VERIFY CONDITION OF ALL EXISTING BEAMS. ADDITIONAL REPAIRS MAY BE REQUIRED BEYOND THOSE NOTED.

8. GROUT FULL ALL CLAY TILE VOIDS AND POINT ALL OPEN JOINTS IN CLAY TILE BELOW EXISTING BEAM BEARING FOR WIDTH OF 4' (2" ON EACH SIDE OF BEARING).
9. REMOVE ONE (1) COURSE BY 2" WIDTH OF CLAY TILE AND REPLACE WITH SOLID GROUTED "BLOCK" FOR CHANNEL BEAM BEARING. GROUT SOLID AROUND BEAM. REPAIR CLAY TILE BELOW BEAM BEARING PER NOTE 8 FOR WIDTH OF 2" FROM CORNER.

10. FILL GAP BETWEEN CLAY TILE AND MASONRY @ EXISTING STEEL BEAM BEARING WITH NONSHRINK GROUT. CLEAN AND REPAIR EXISTING MASONRY PER GROUT MANUFACTURER PRIOR TO APPLYING GROUT TO ACHIEVE MAXIMUM BOND.
