Lead Based Paint Inspection

Vacant Seven-Story Former WTU Office Building

Proposed Repurpose to a Residential Use

301 Cypress Street, Abilene, Taylor County, TX 79601

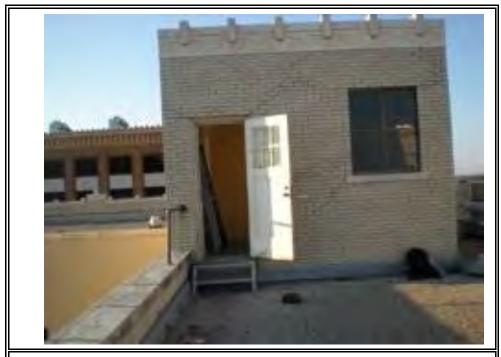
1) View Elevator Penthouse & Main Fire Stairs; valve on right.

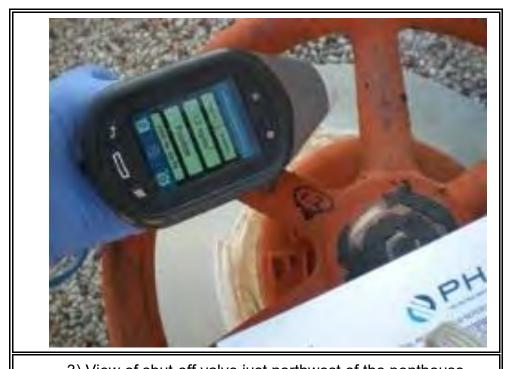
3) View of shut-off valve just northwest of the penthouse.

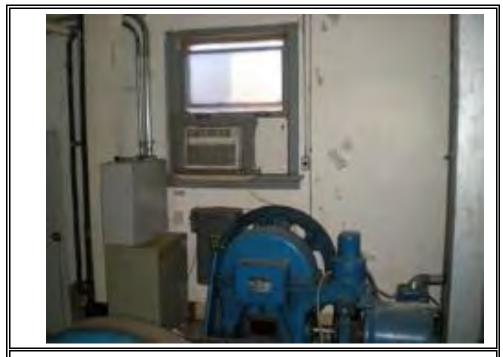
7) View of the elevator penthouse; note the south window.

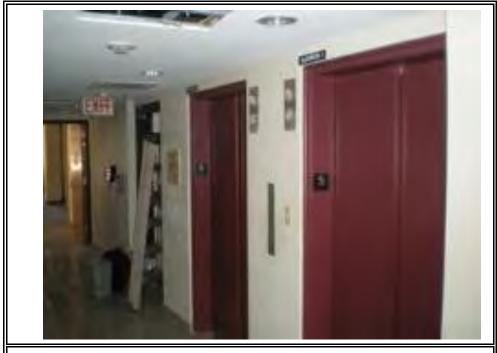
9) View of the 5th Floor Elevator car #1, left door.

It is presumed that the elevator cars, doors and control circuitry will be removed and replaced with modern equipment.

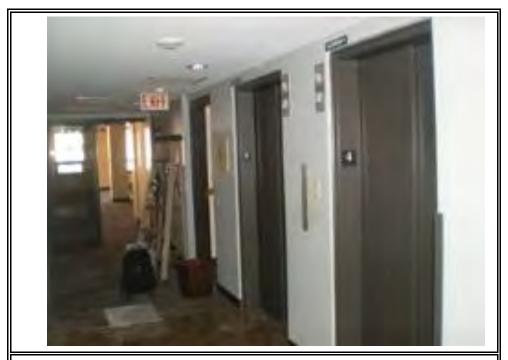
10) View of the 4th Floor doorway to the main fire escape stairs.

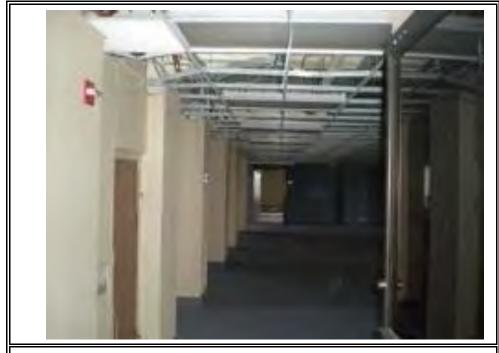
11) View 3rd Floor Large Suite on South side

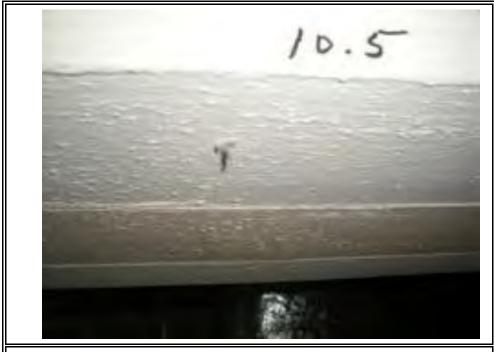
12) View of the painted Concrete ceiling beam (307/301).

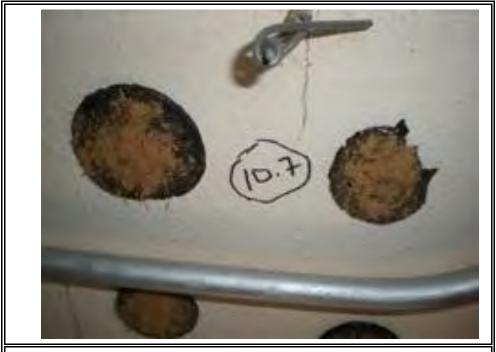
16) View of painted plaster ceiling in Suite 310

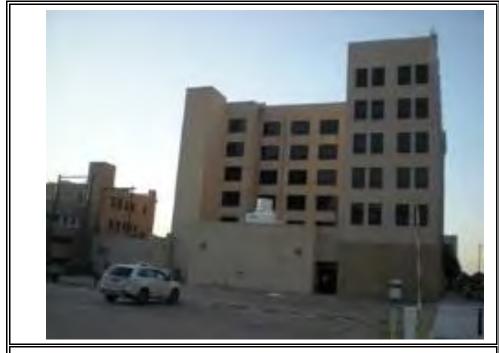
17) View South across the subject parking lot.

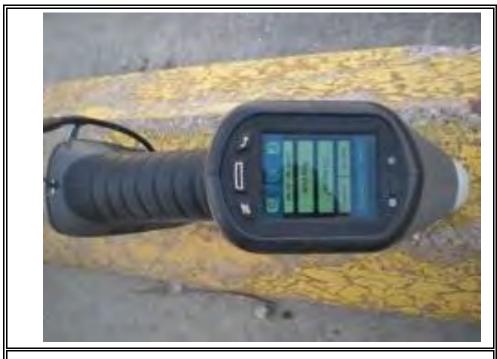
18) View of a painted concrete wheel stop.

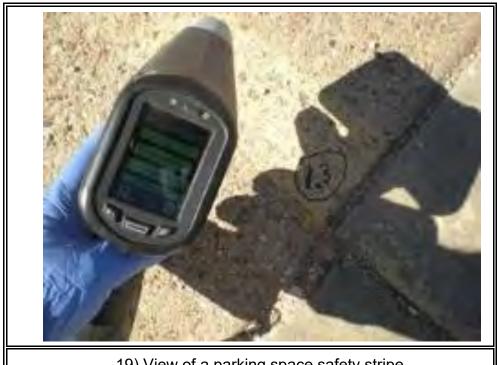
19) View of a parking space safety stripe.

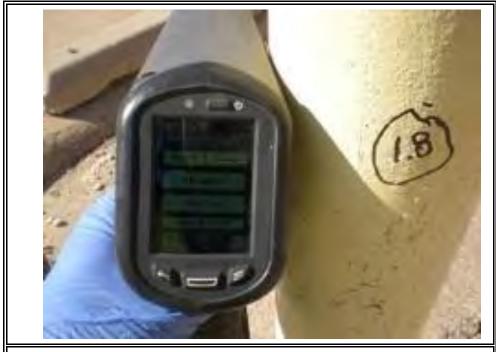
20) View of a bollard on the east side of the parking lot.

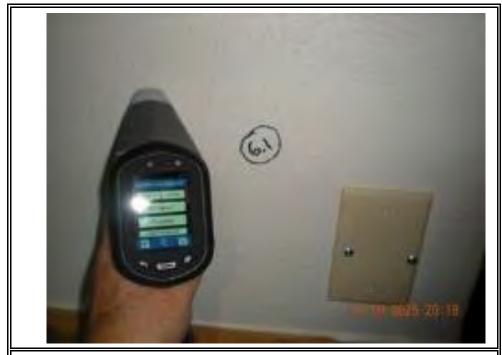
21) View painted plaster wall (B-North) 2nd Floor Landing.

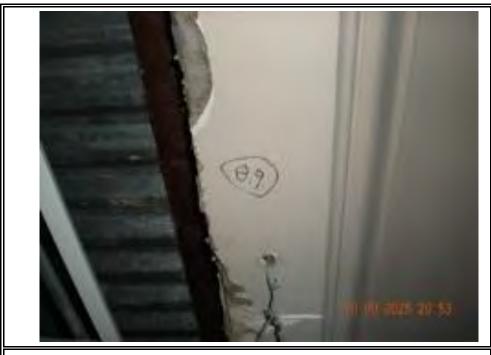
22) View of plaster ceiling beam 2nd Floor (original 1st Floor)

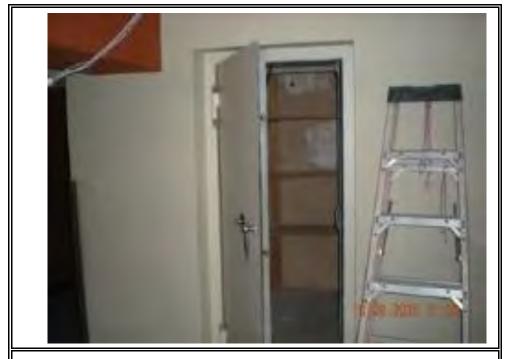
23) View of the Mosler records Vault in the East side suite.

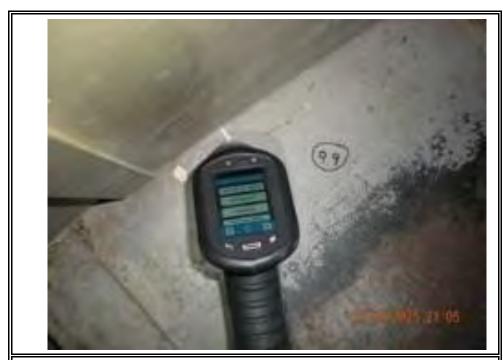
24) View of a positive reading on the vault door threshold.

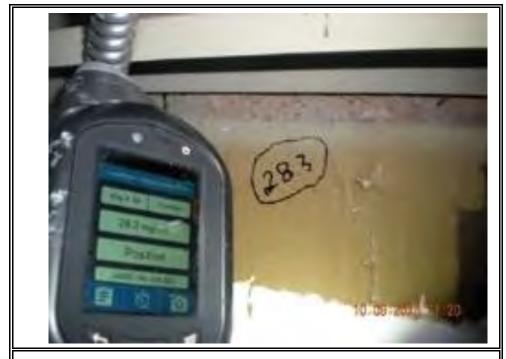
25) View of original east wall in the Lunch room.

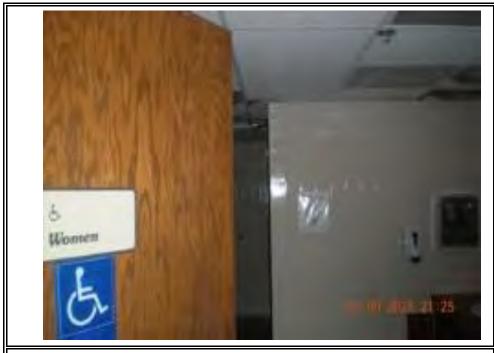
26) View of updated Women's Restroom; positive on ceiling.

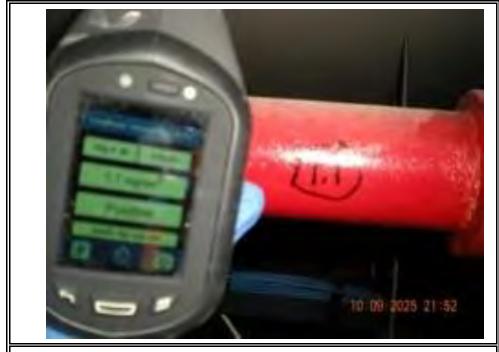
27) View of fire suppression piping in 2^{nd} Floor Phone Room.

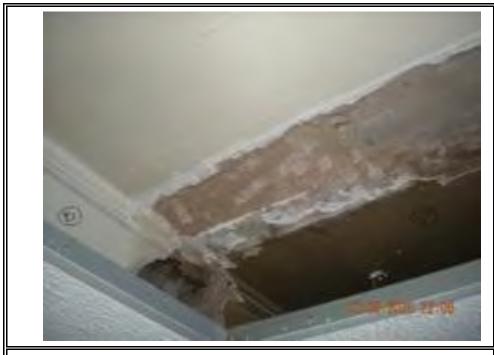
28) View of positive readings on 2nd FL (original SWC) ceiling.

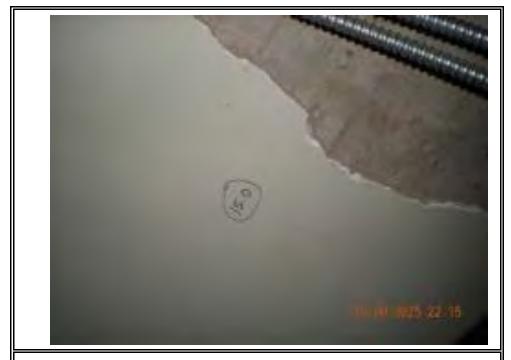
29) View of positive reading on 2nd FL (original) Balcony ceiling

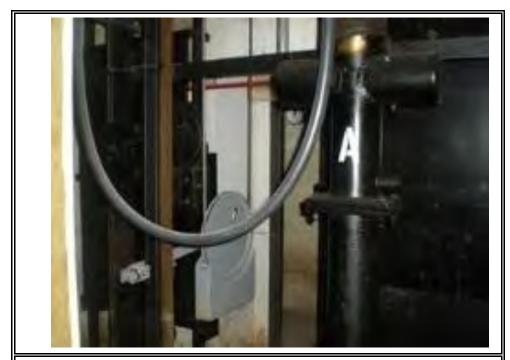
30) View of bottom of elevator shaft; entry door has LBP.

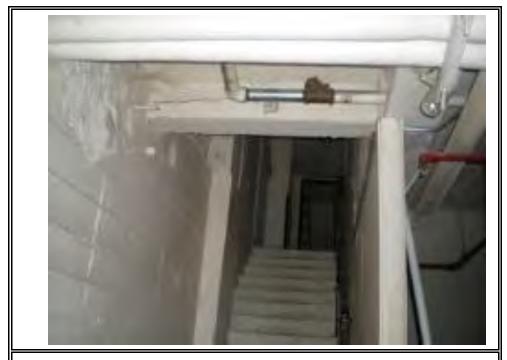
31) View of Basement stairs; the sump pedestal is on the right.

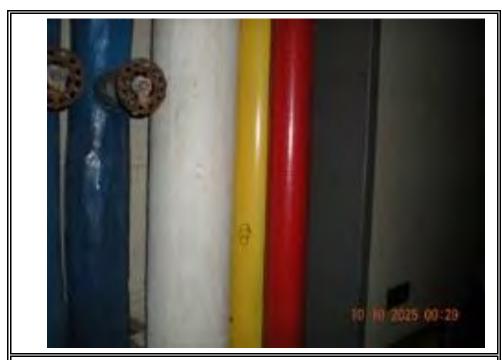
32) View of Mechanical Room discharge piping on west wall.
