## Limited Asbestos Inspection Report

Landmark on Cypress

301 Cypress Street

**PE Project No.: 202506075**

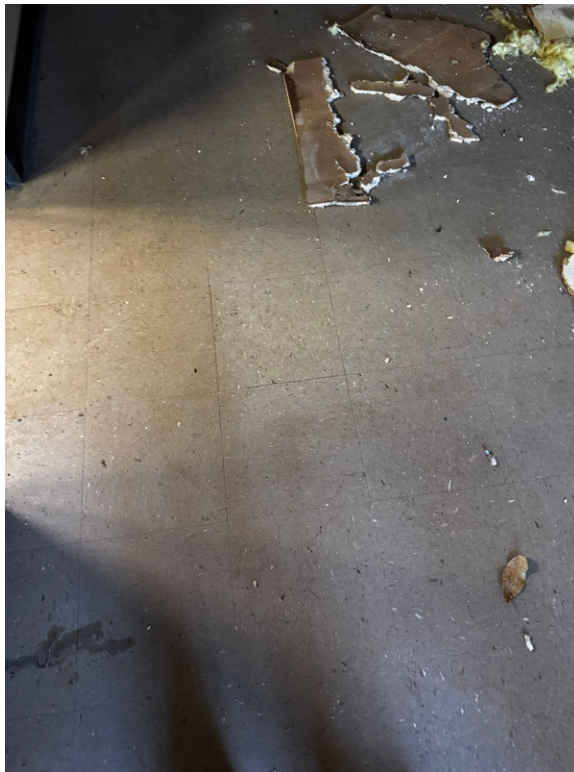
1. 12"x12" floor tile with black mastic current samples 1-3

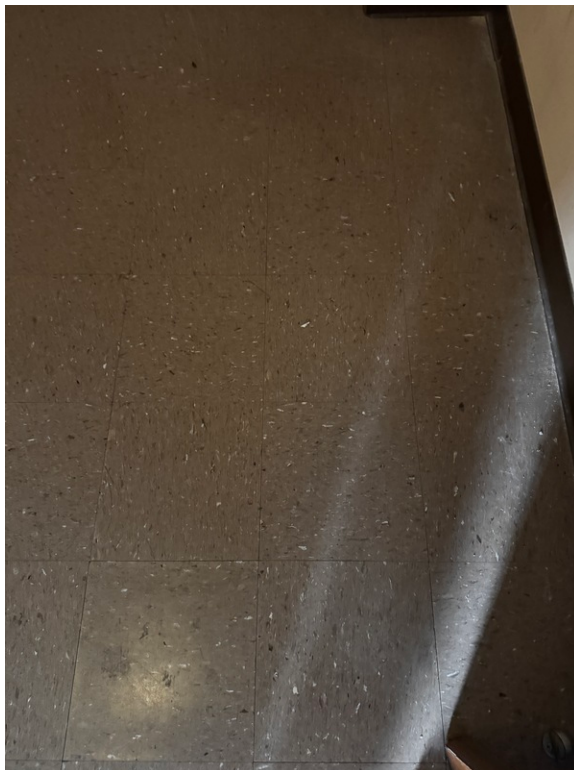
2. Former identified floor tile ACM samples (068-070)

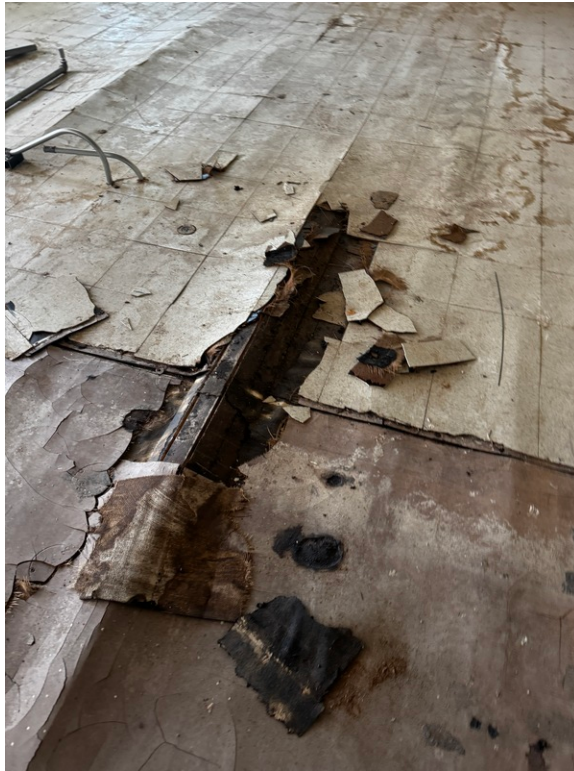
3. Former identified FT and floor covering ACMs 015-017 and 059

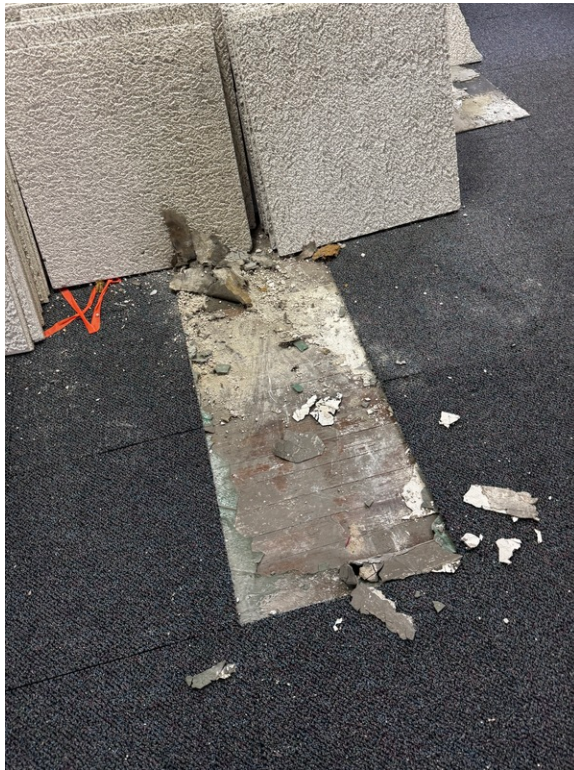
4. Former sampled area on 3rd floor samples 025-027

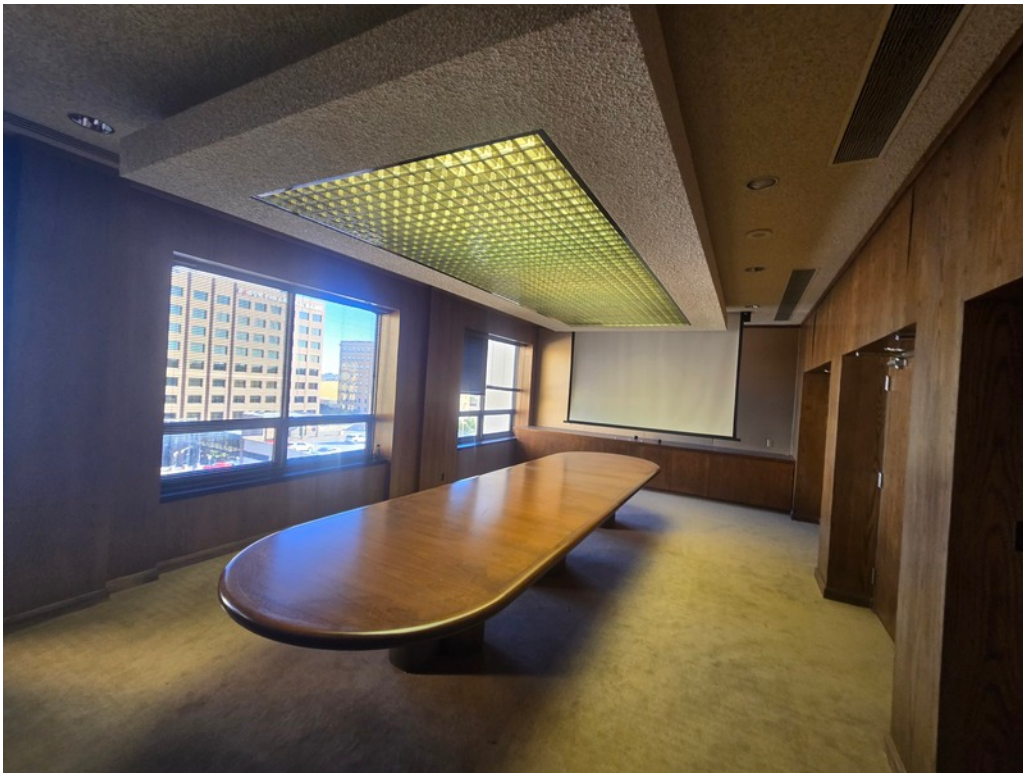
5. HA-2 ceiling material in 7th floor board room samples 4-6

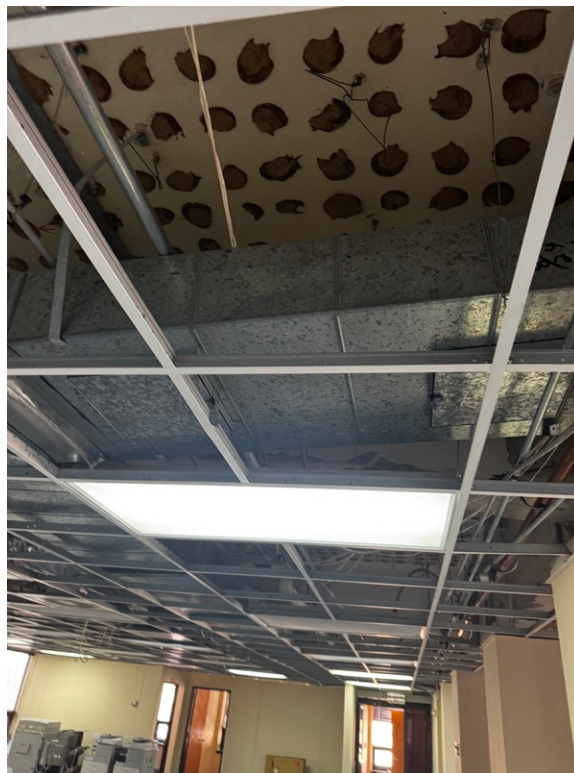
6. Mastic remaining from acoustical tiles

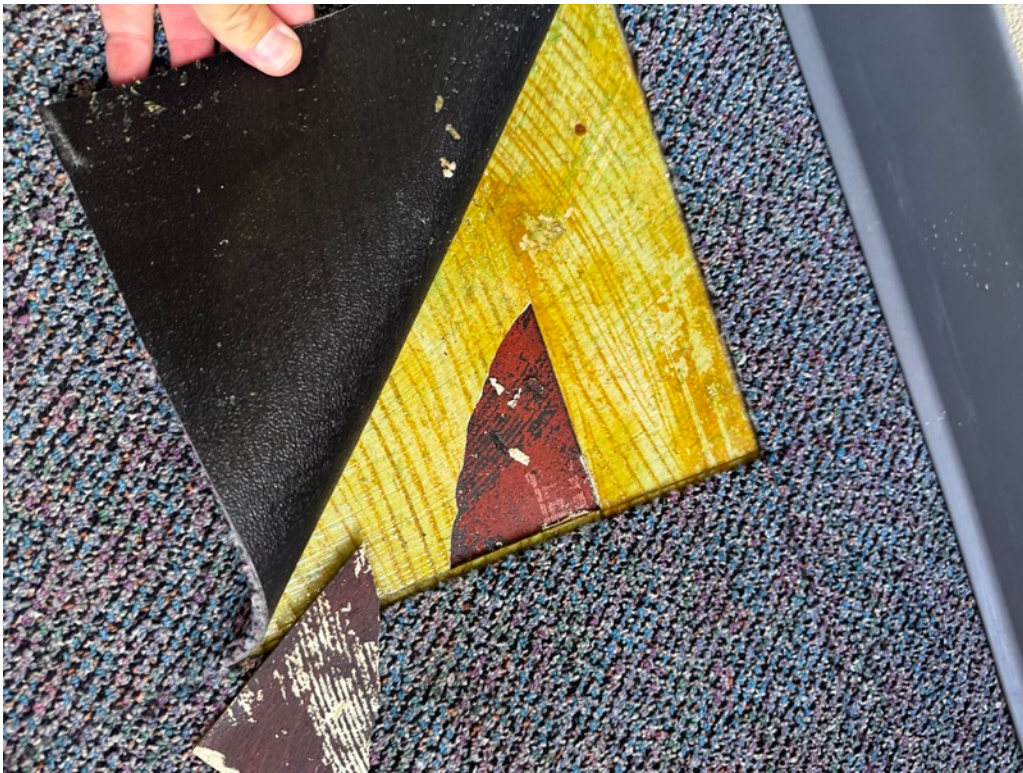
7. Prior identified ACM samples 047-049

- 032, 033, 034, 035, 036, 051, 052, 053, 054, 055 – White Mastic on TPI and TPFI, located on air conditioning / heating pipes throughout the facility;
- 047, 048, 049 – 12" x 12" White with Brown Streaks RFT and Black Mastic, located on the 3<sup>rd</sup> and 4<sup>th</sup> Floors of the facility;
- 056, 057 – Red and Grey Concrete, located on 2, 3, 4, 5, 6 and 7<sup>th</sup> Floors in the west side stairwells and elevator corridors;
- 059 – Black Mastic, located on the surface of the Brown Composite Sheet Flooring on the 4<sup>th</sup> Floor;
- 068, 069, 070 – 12" x 12" Grey with White Streaks RFT, located on the 2, 3, and 4<sup>th</sup> Floors; and
- 080 – Black and Grey Concrete, located on 2, 3, 4, 5, 6, and 7<sup>th</sup> Floors in the west side stairwells and elevator corridors.

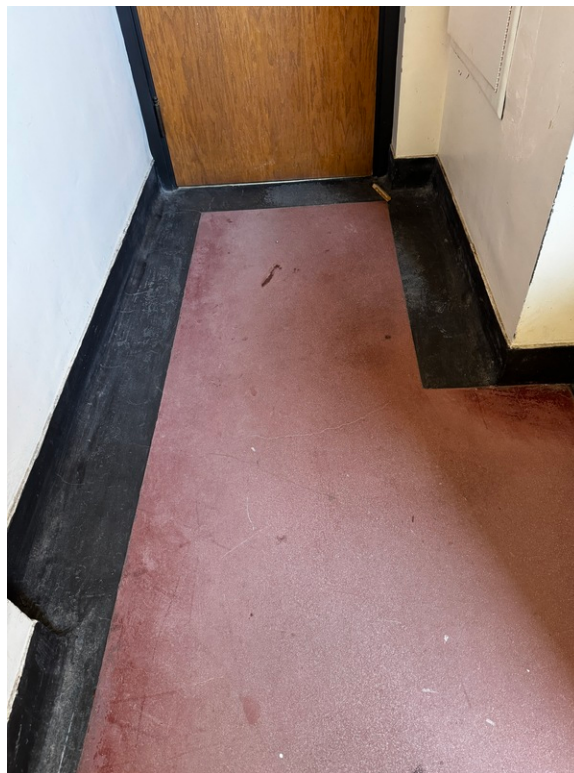
8. Red concrete (056-058)

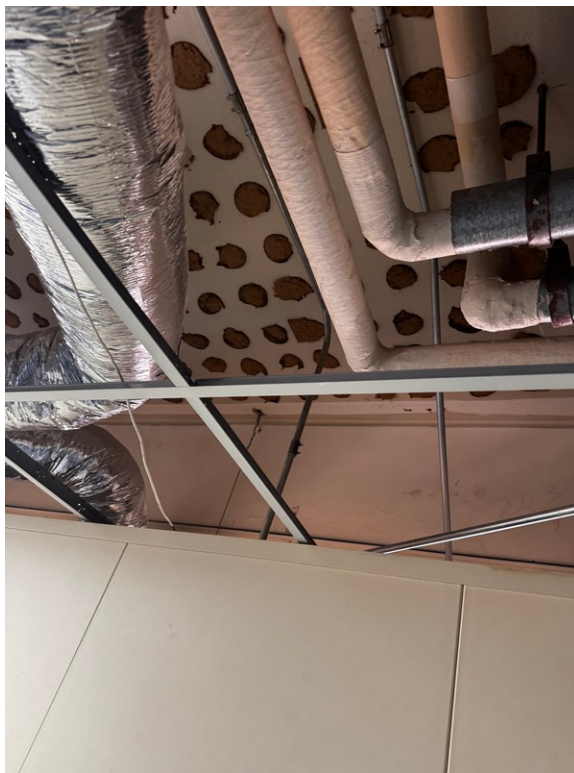
10. TSI and mastic from acoustical tiles

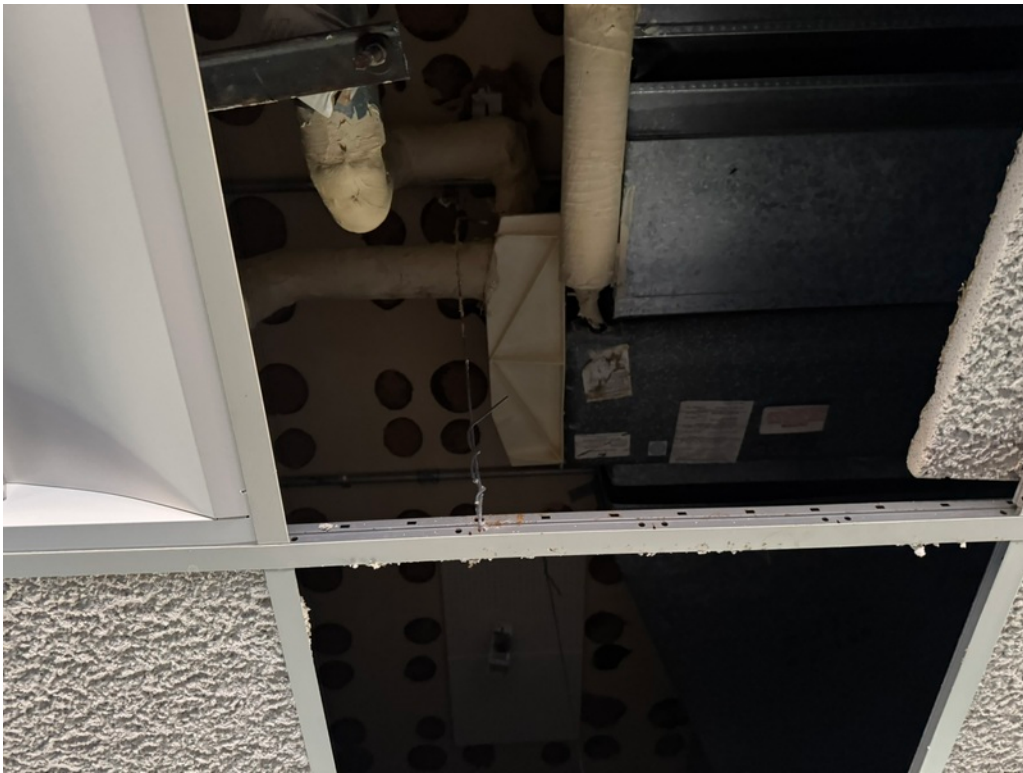
11. TSI and mastic from acoustical tiles

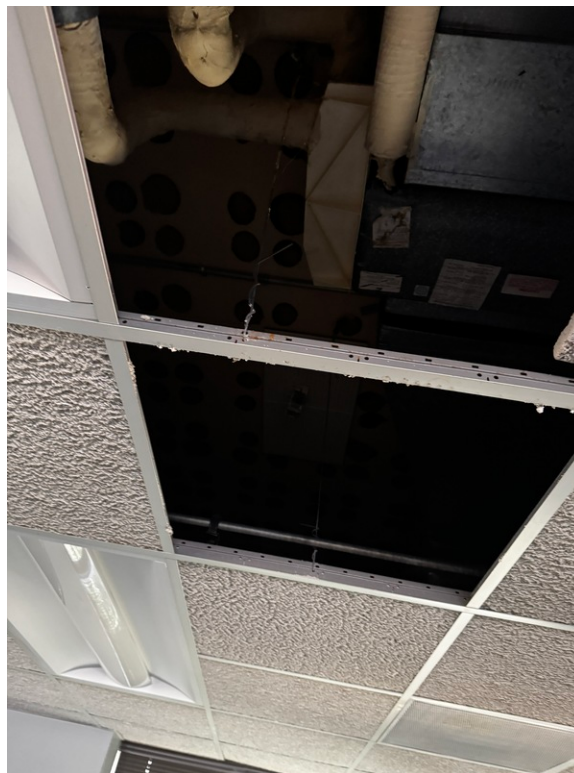
12. TSI formerly identified as ACM
