1 FIRST FLOOR FRAMING PLAN  
1/8" = 1'-0"

LANDMARK ON CYPRESS  
HISTORIC REHABILITATION - APARTMENTS  
ABILENE, TEXAS

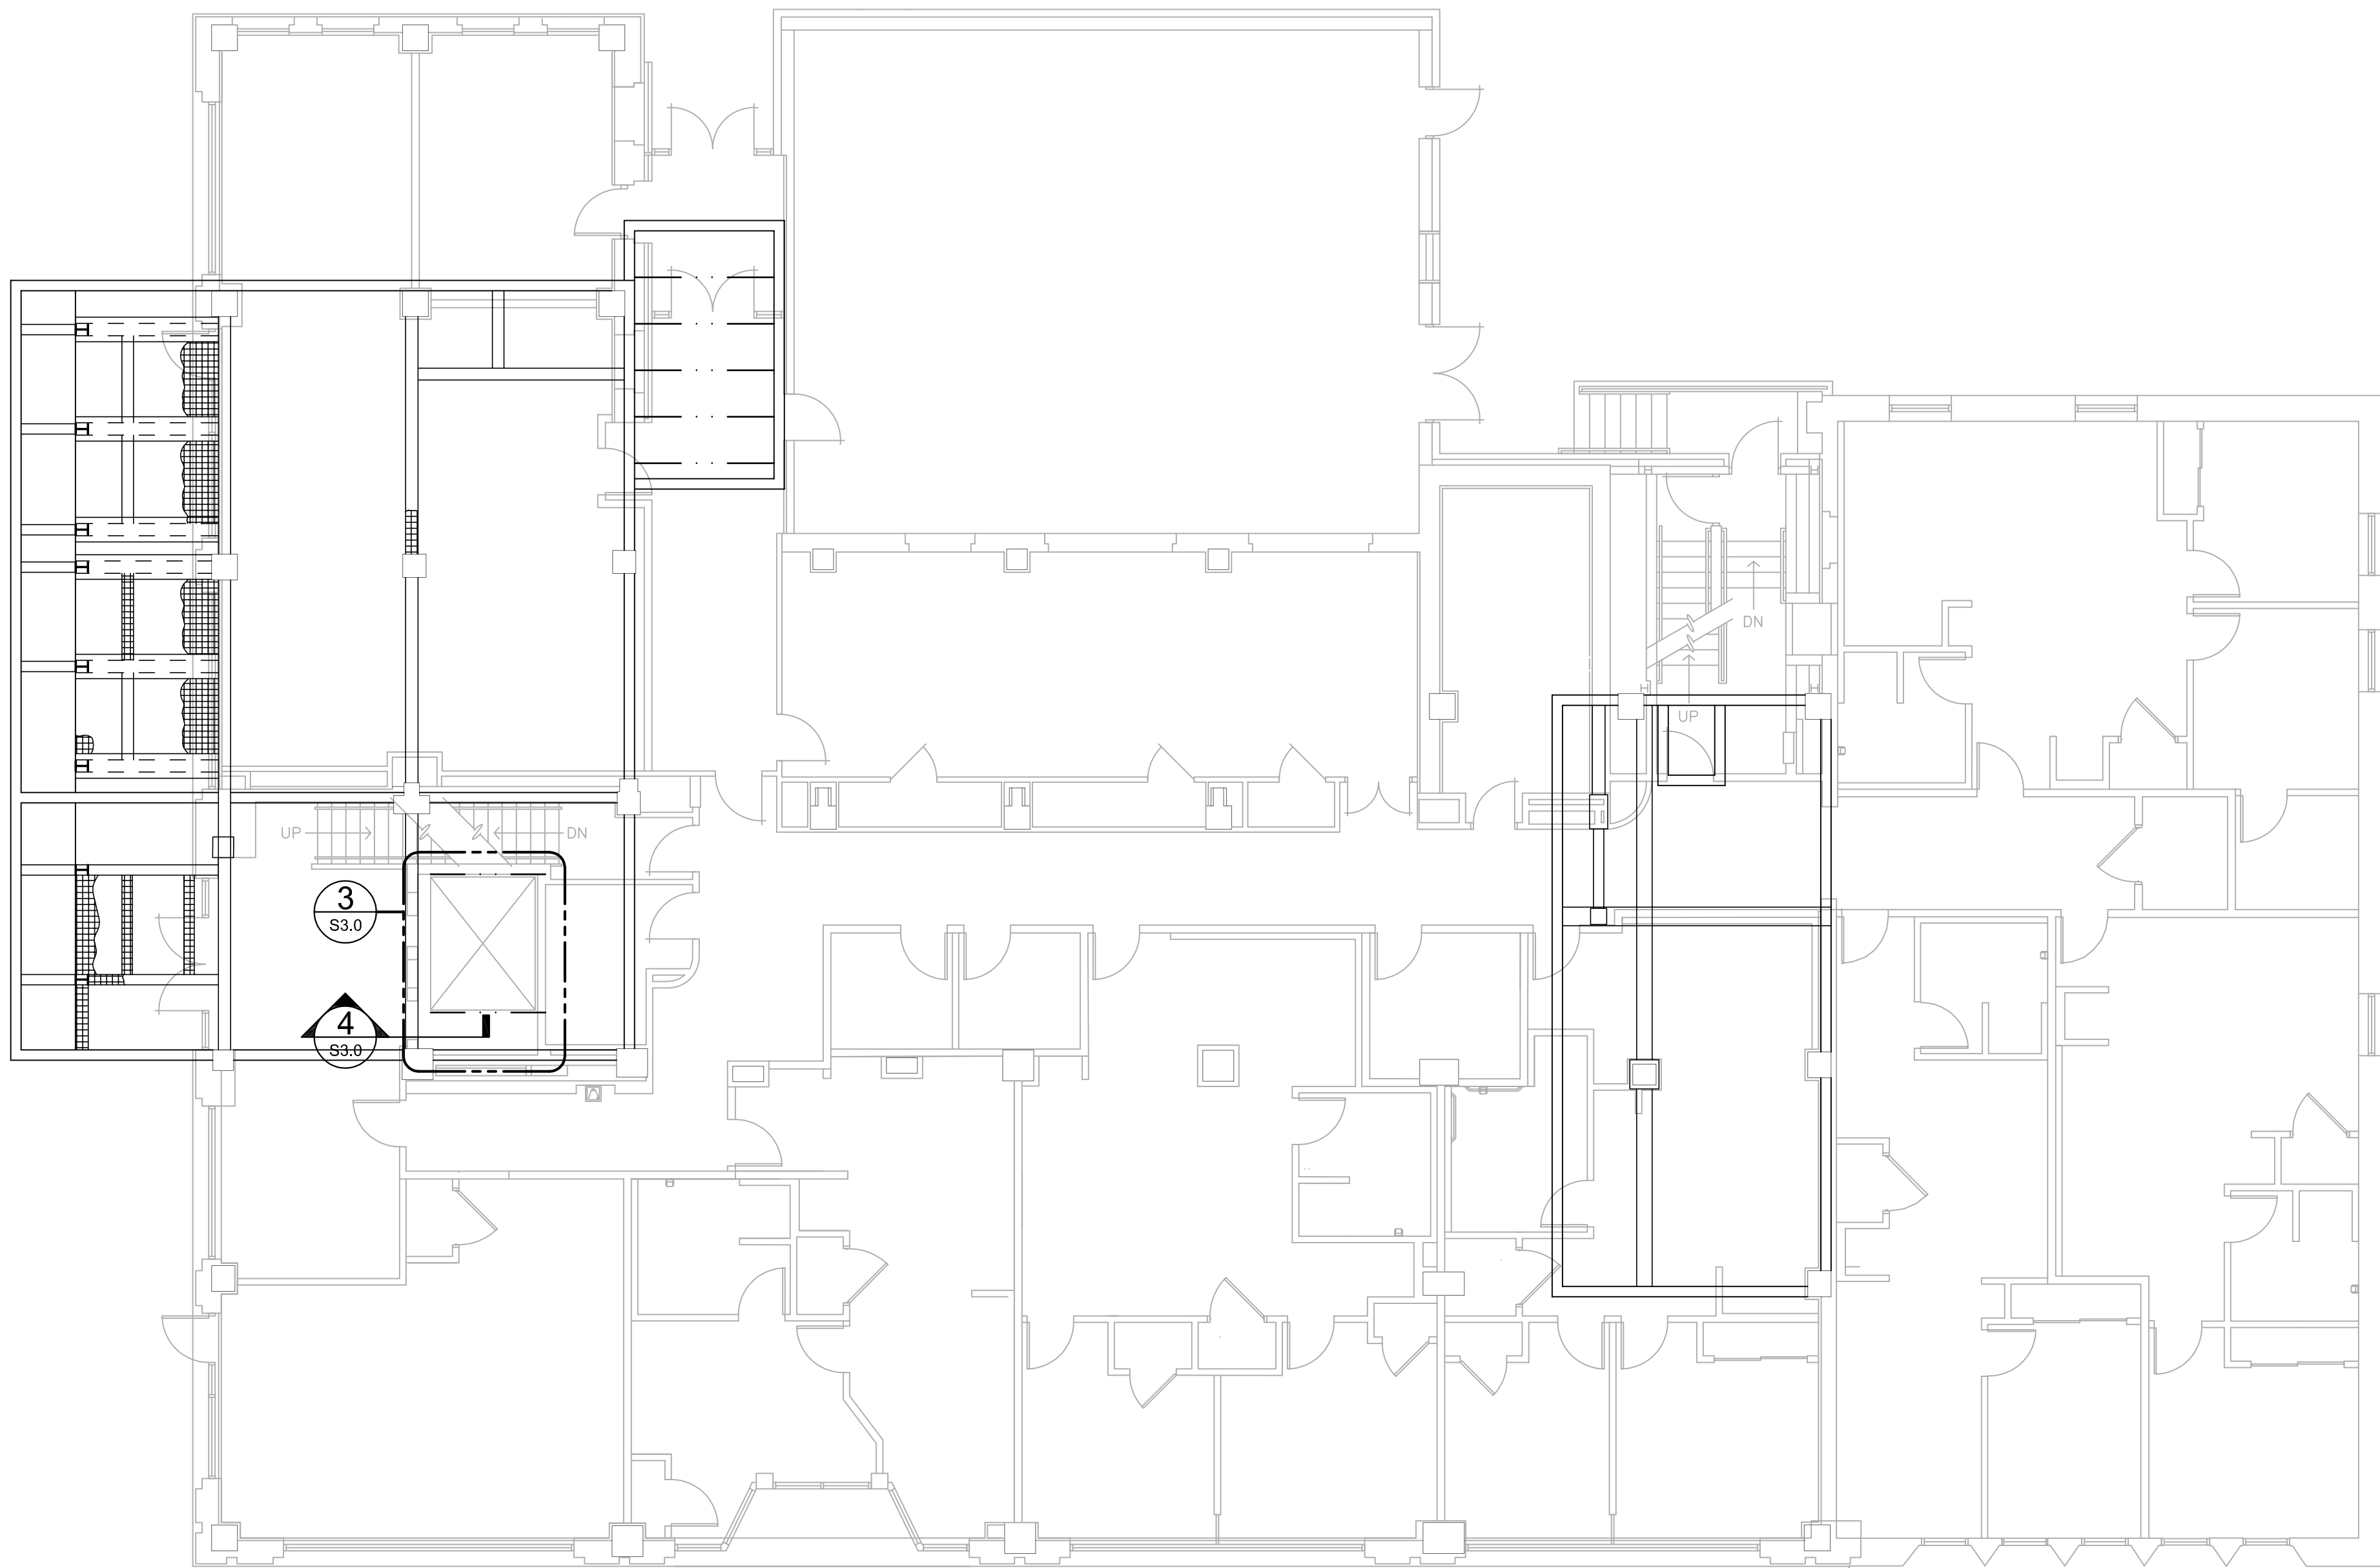
A. REFER TO SHEET S4.0 FOR REPAIR PROCEDURES FOR EACH REPAIR CATEGORY.  
HATCHED ##### LOCATIONS SHOWN ON PLAN MAY NOT SHOW ALL DAMAGED AREAS.  
CONTRACTOR TO IDENTIFY AND NOTIFY EOR OF LOCATIONS NEEDING TO BE ADDED TO THE SCOPE.

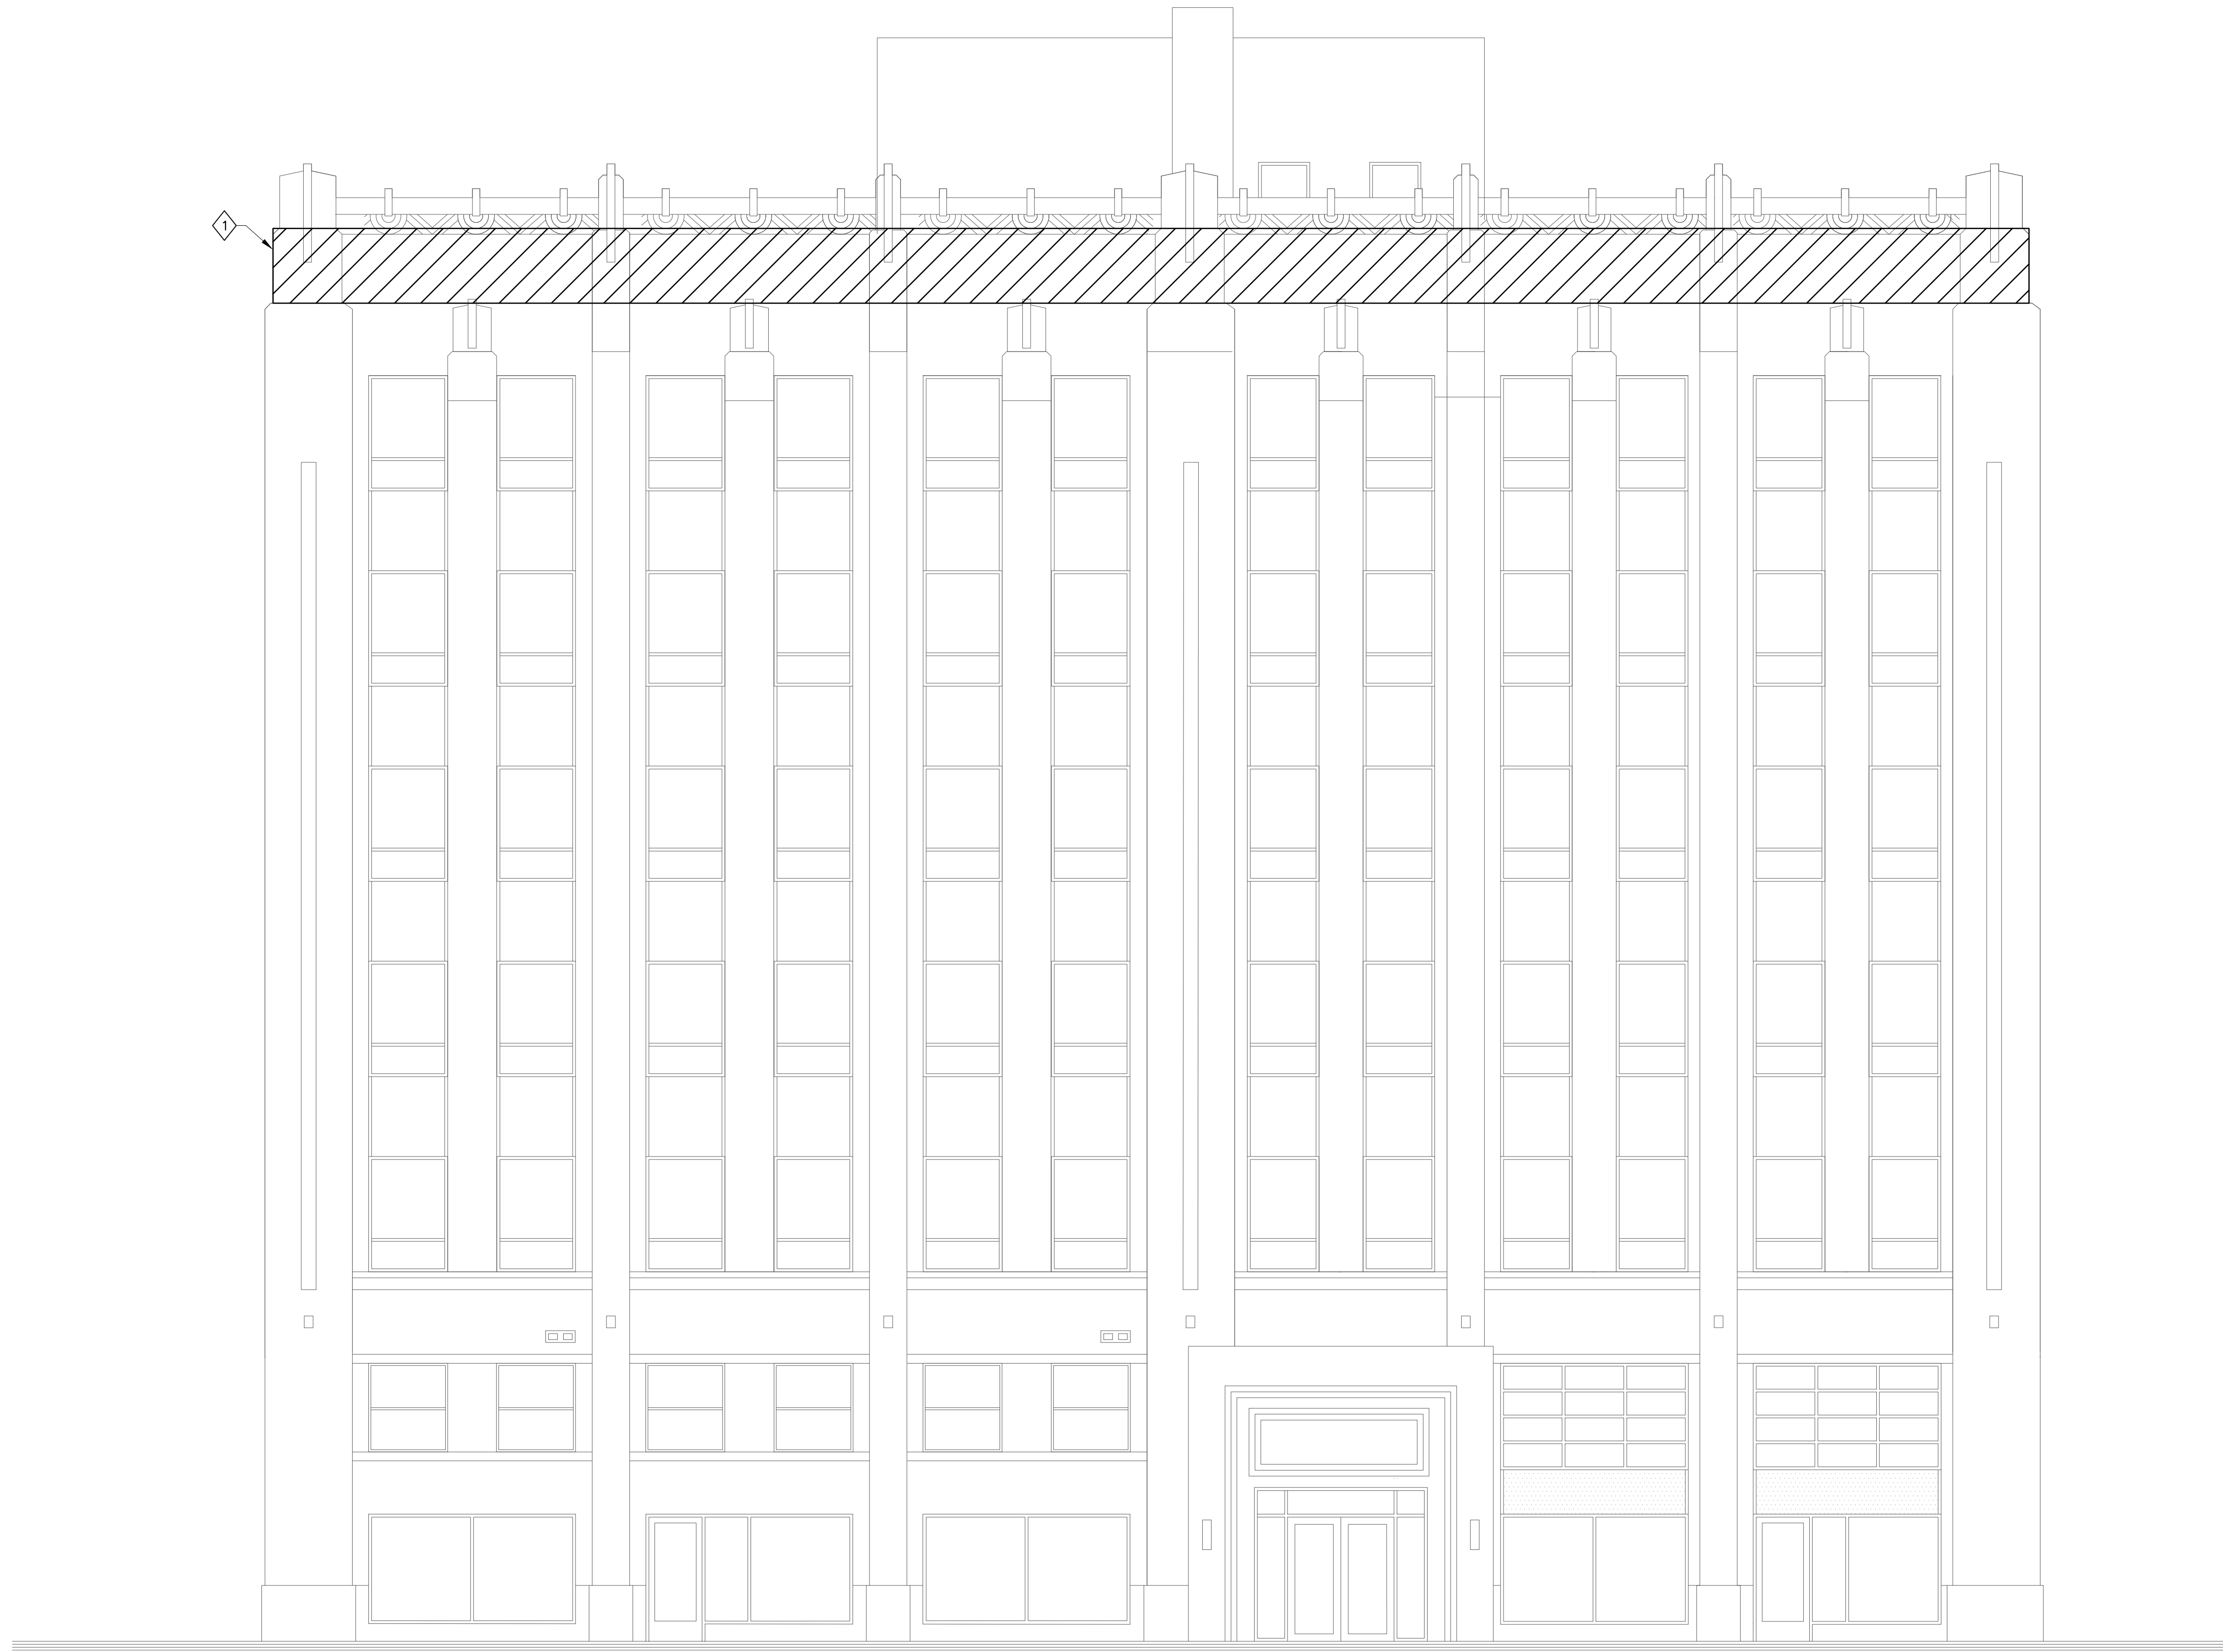
1 WEST ELEVATION  
3/16" = 1'-0"

1 CRACKED MASONRY JOINTS: TUCKPOINT MASONRY.

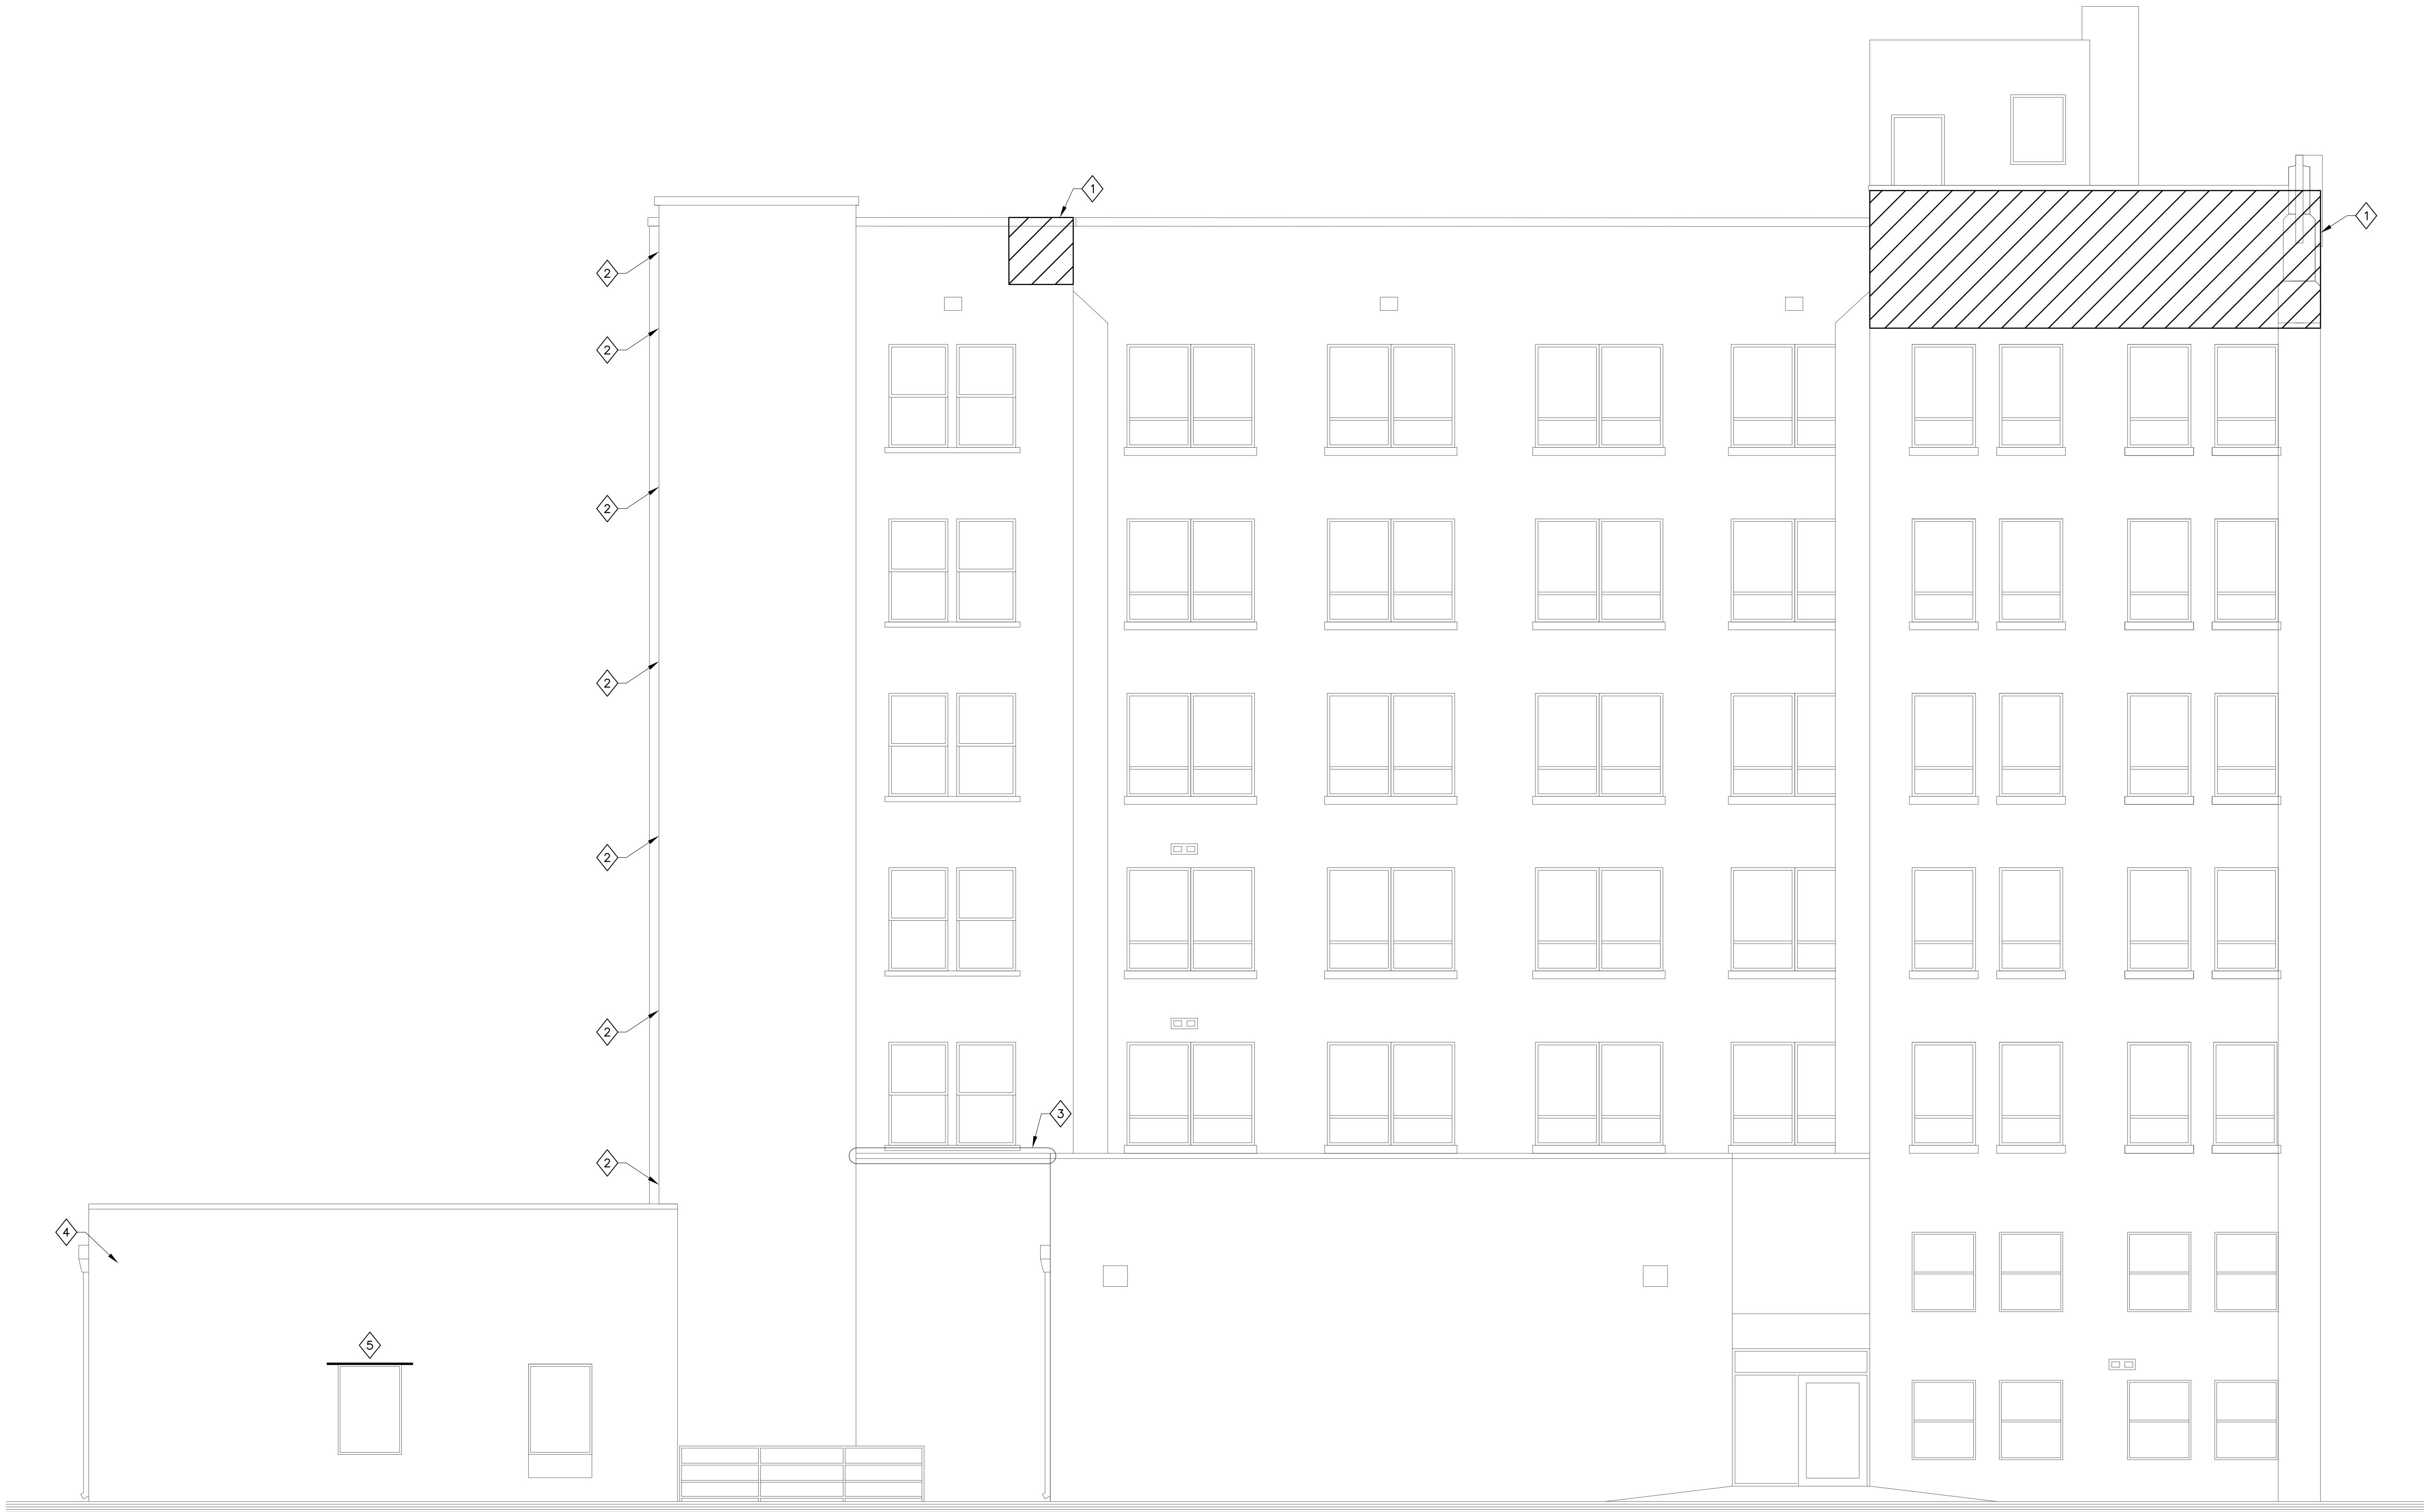
1 NORTH ELEVATION  
3/16" = 1'-0"

| MASONRY NOTES | |
| 1 | CRACKED MASONRY JOINTS: TUCKPOINT MASONRY. |
| 2 | CRACKED MASONRY AT STEEL FRAMING OF STAIR TOWER; INSPECT CONDITION OF STEEL FROM EXTERIOR. REPAIR STEEL AS NEEDED AND TUCKPOINT MASONRY. |
| 3 | LEAK AT STONE CAP JOINTS CAUSING MASONRY DEGRADATION BELOW; REPAIR CAP JOINTS AND TUCKPOINT MASONRY. |
| 4 | MASONRY COATING PEELING; REMOVE PEELING COATING AND INVESTIGATE CONDITION OF MASONRY. REPAIR AS NEEDED. |

| MASONRY NOTES | |
|---|---|
| 5 | NEW LINTEL. SEE LINTEL SCHEDULE SHEET S1.2. |

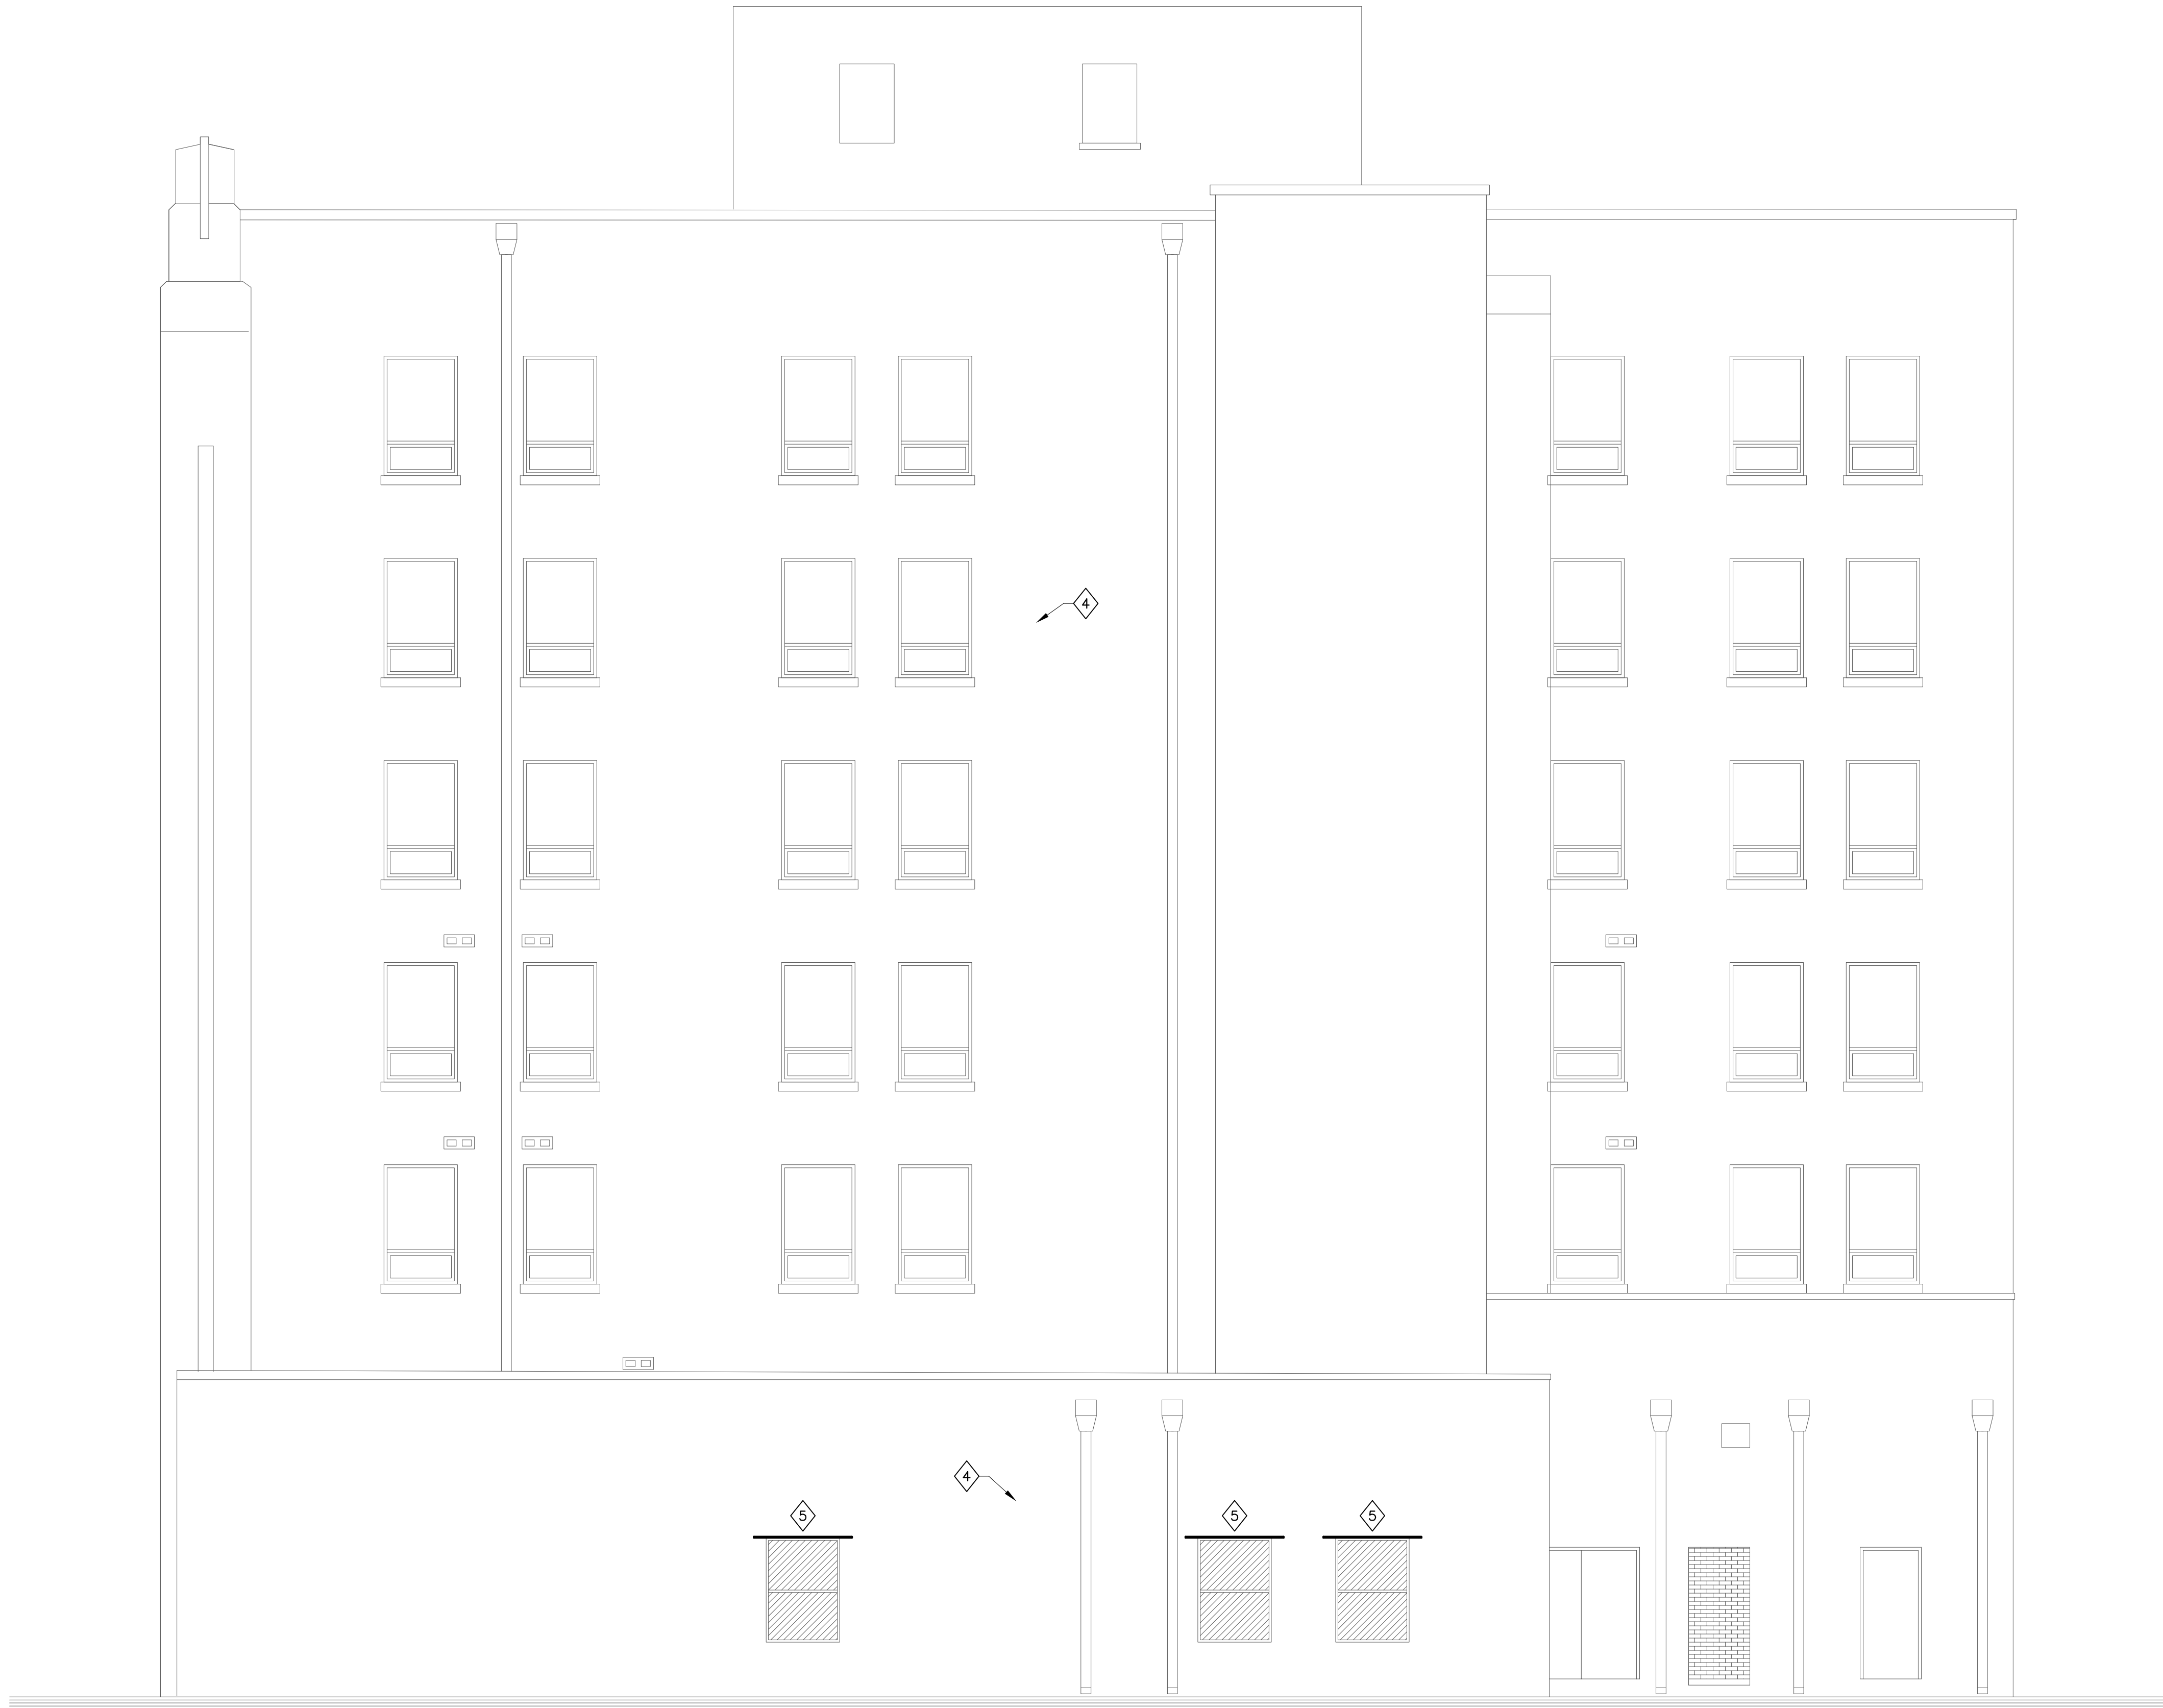
1 EAST ELEVATION  
3/16" = 1'-0"

- 4 MASONRY COATING PEELING; REMOVE PEELING COATING AND INVESTIGATE CONDITION OF MASONRY, REPAIR AS NEEDED.
- 5 NEW LINTEL. SEE LINTEL SCHEDULE SHEET S1.2.

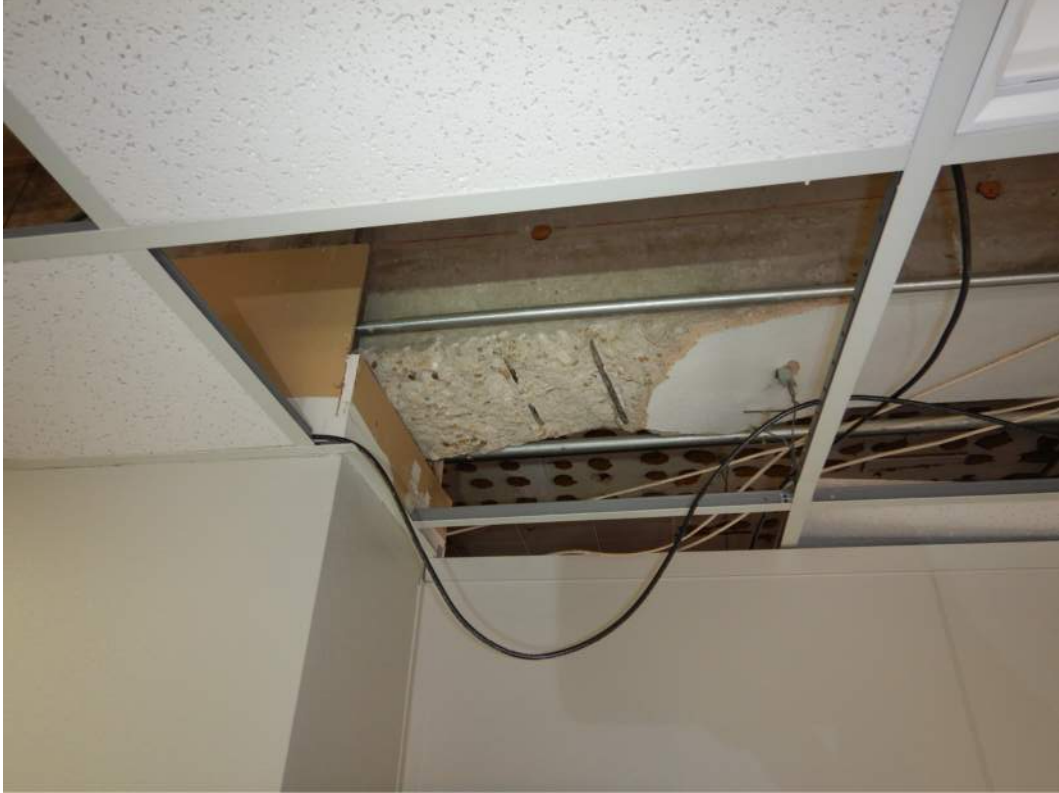
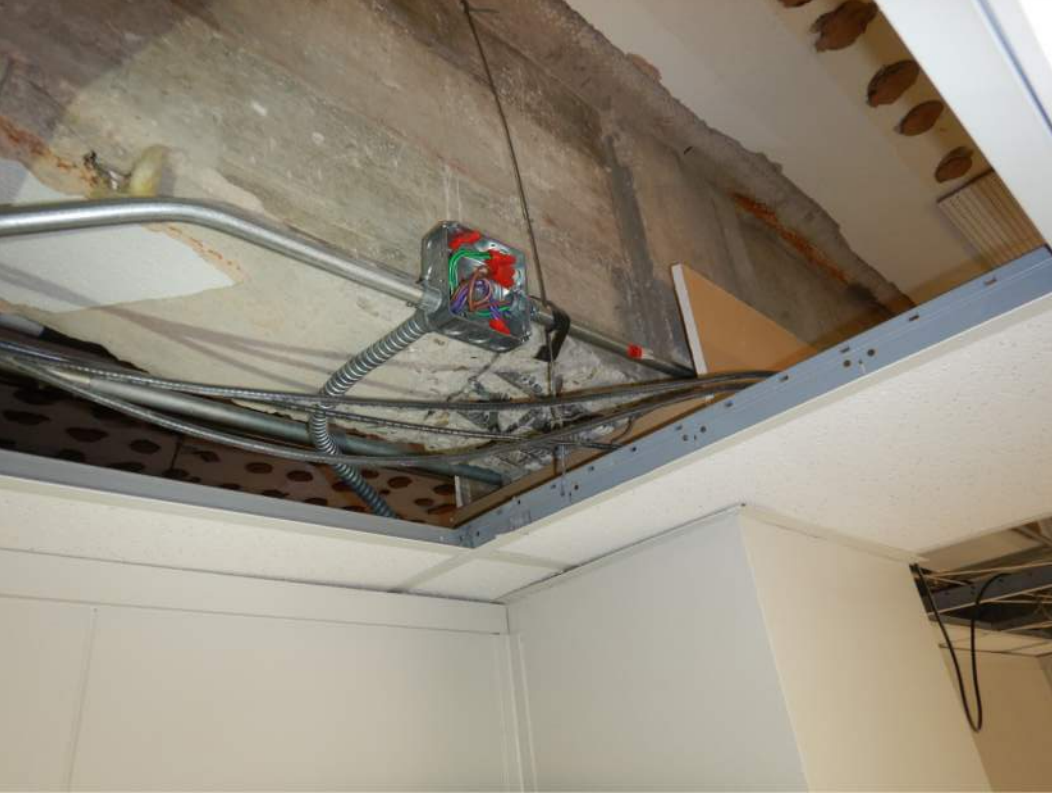
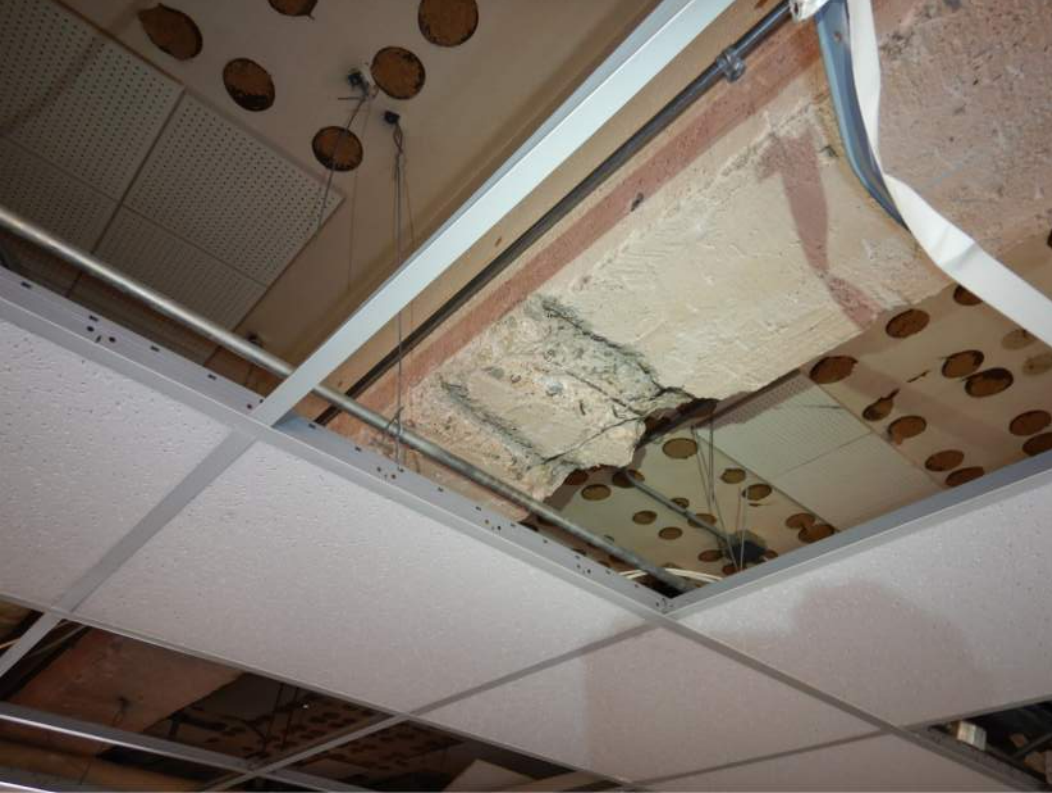
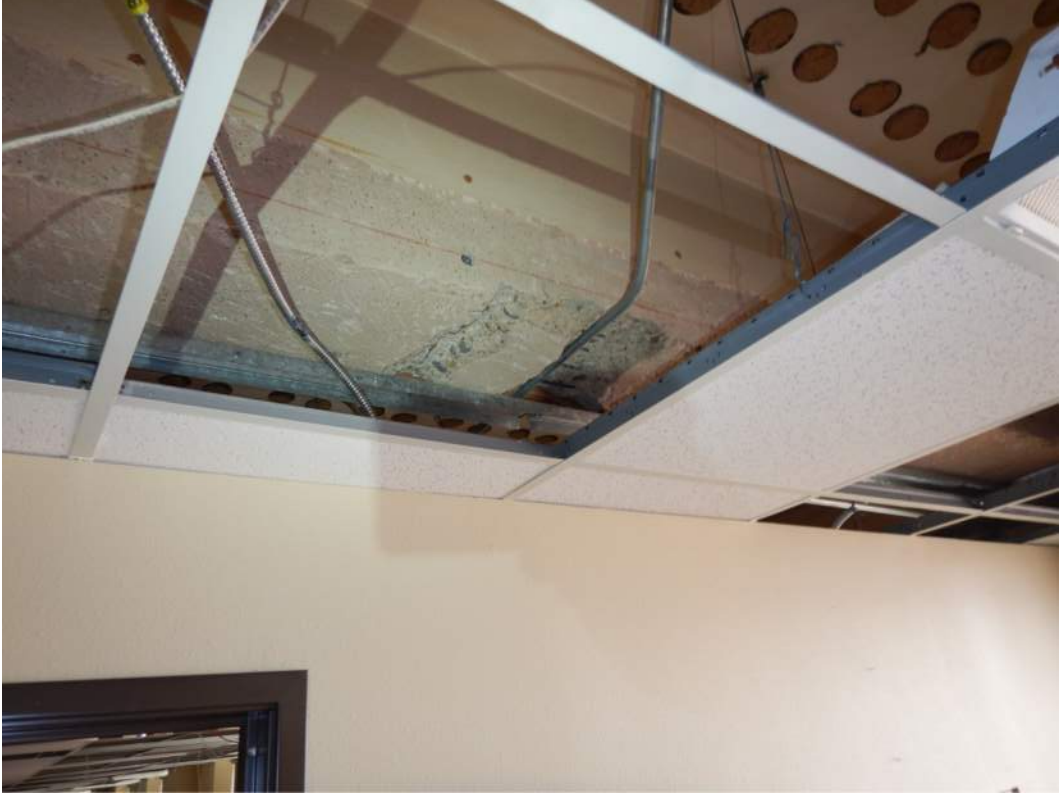
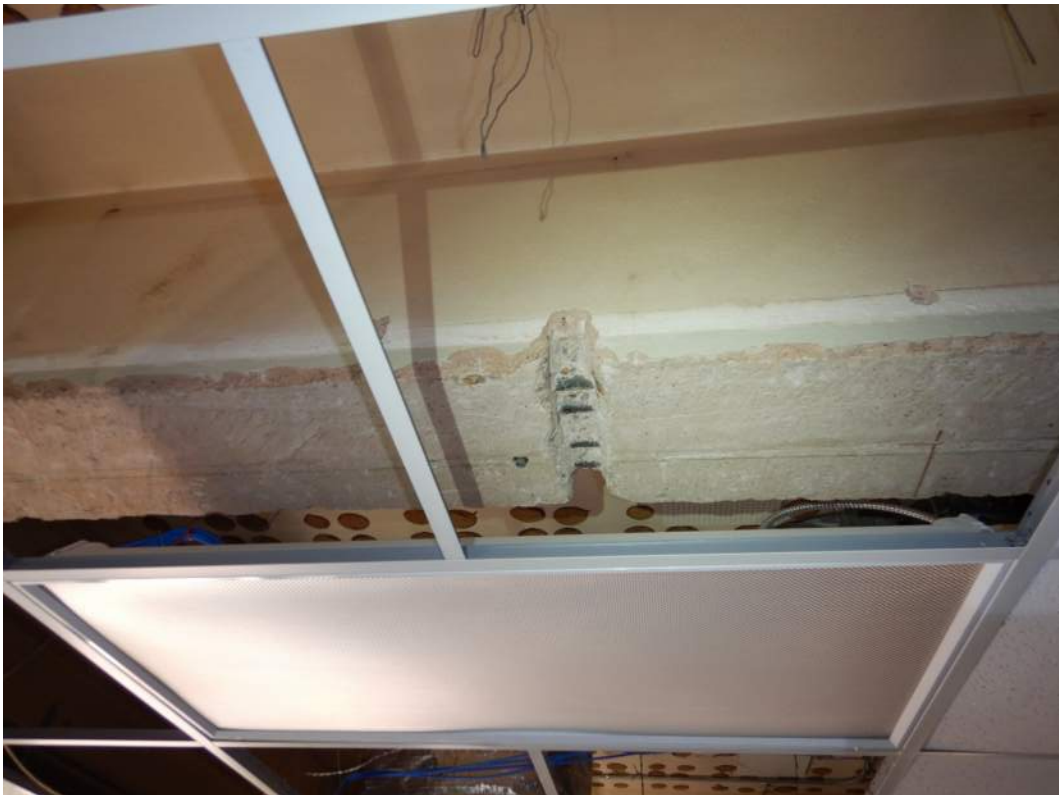
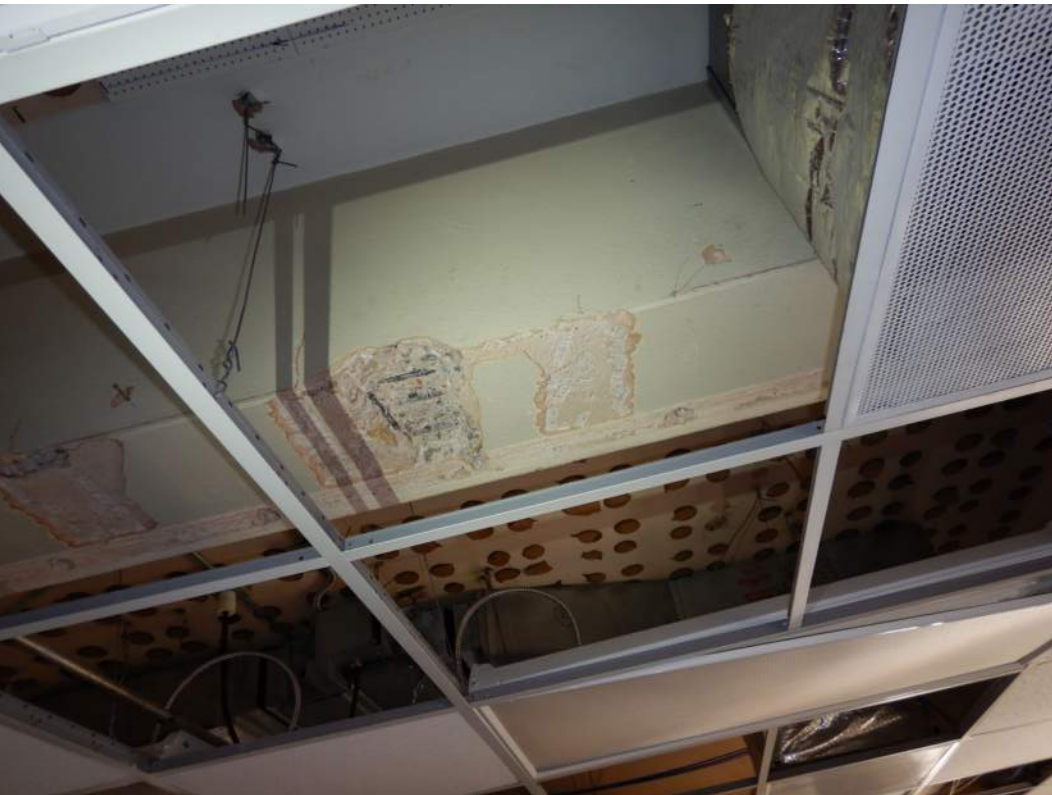
| CATEGORY 'A' | <div><p>DESCRIPTION:<br/>CONCRETE CHIPPED AWAY WITH REBAR EXPOSED.</p><p>REPAIR:<br/>CLEAN AREA AND PATCH WITH SIKAGUICK VOH REPAIR MORTAR OR SIKACRETE 100 C: CONCRETE MIX. REPAIRS TO BE VERIFIED USING SOUND HAMMERING METHOD.</p></div> <div></div> |
