1 FIRST FLOOR FRAMING PLAN  
1/8" = 1'-0"

LANDMARK ON CYPRESS  
HISTORIC REHABILITATION - APARTMENTS  
ABILENE, TEXAS

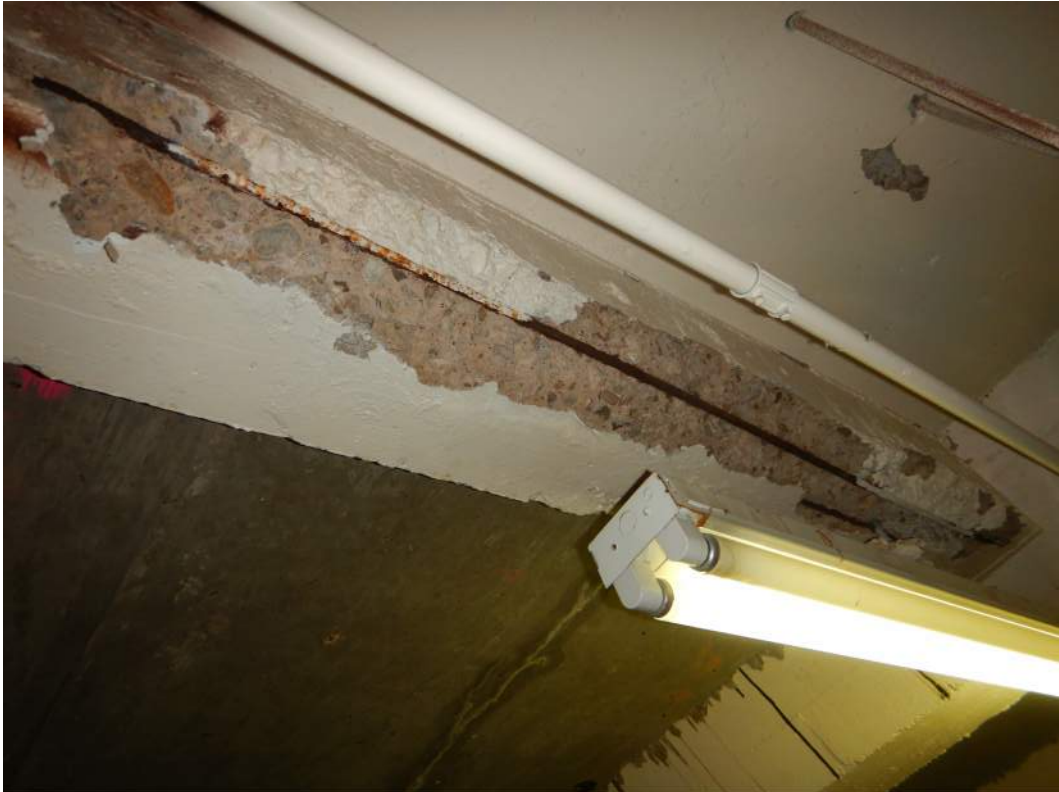
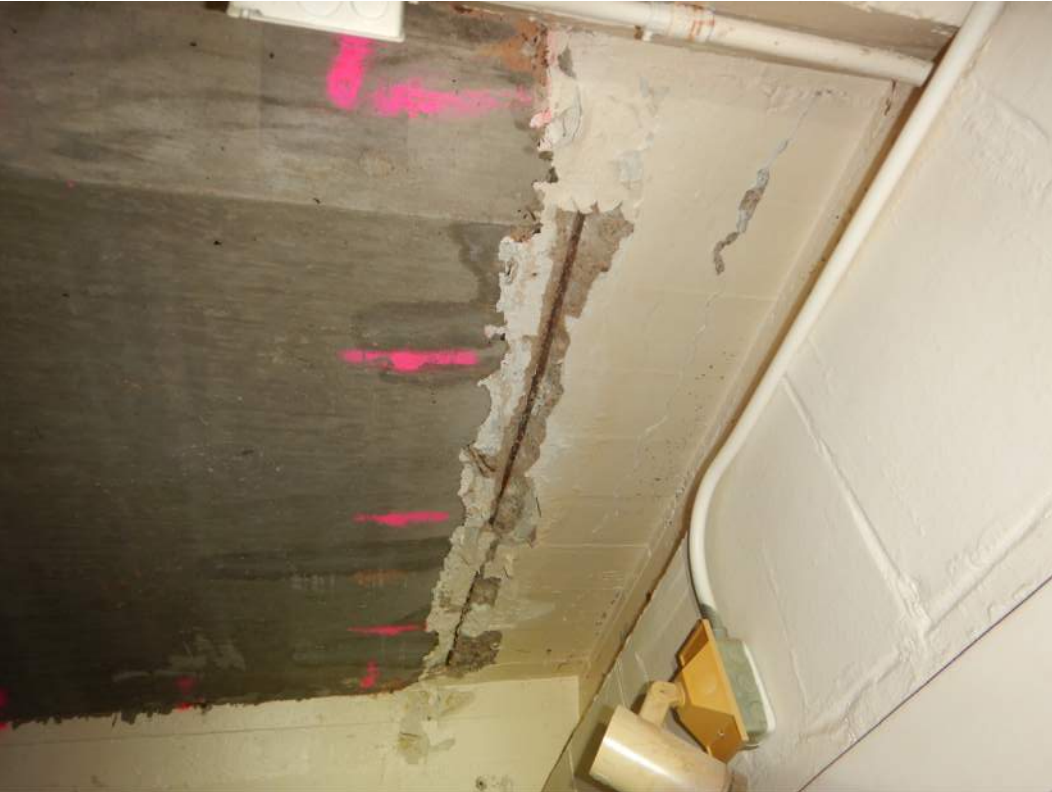
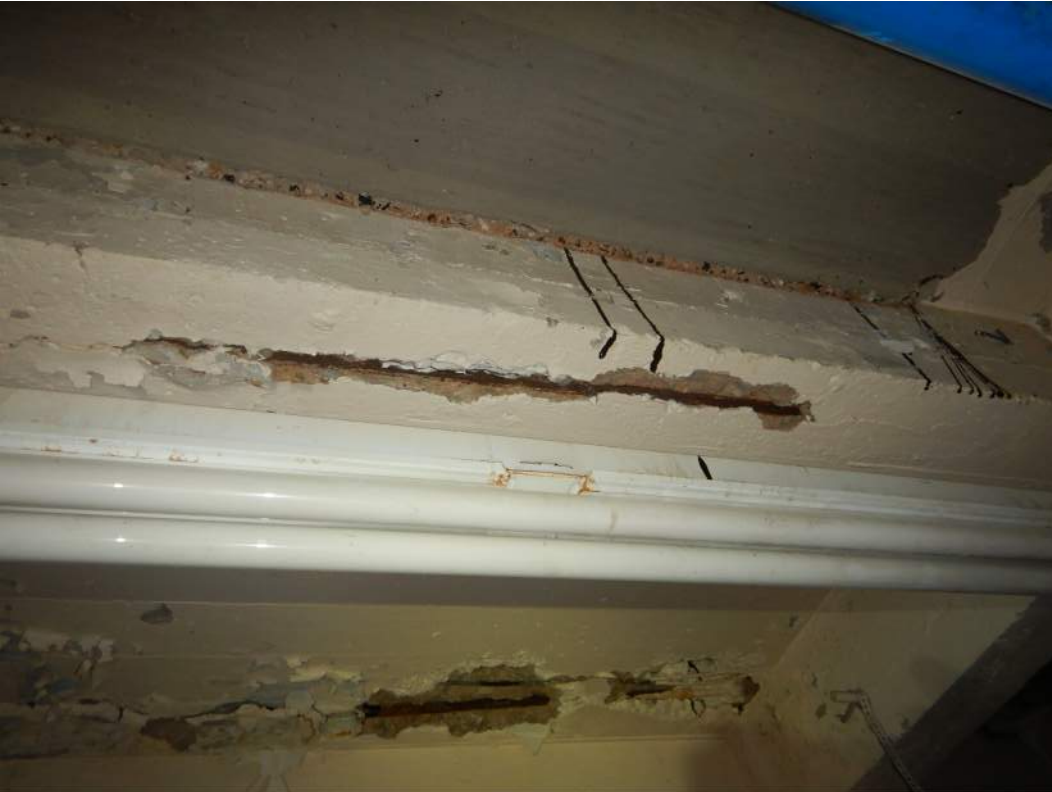
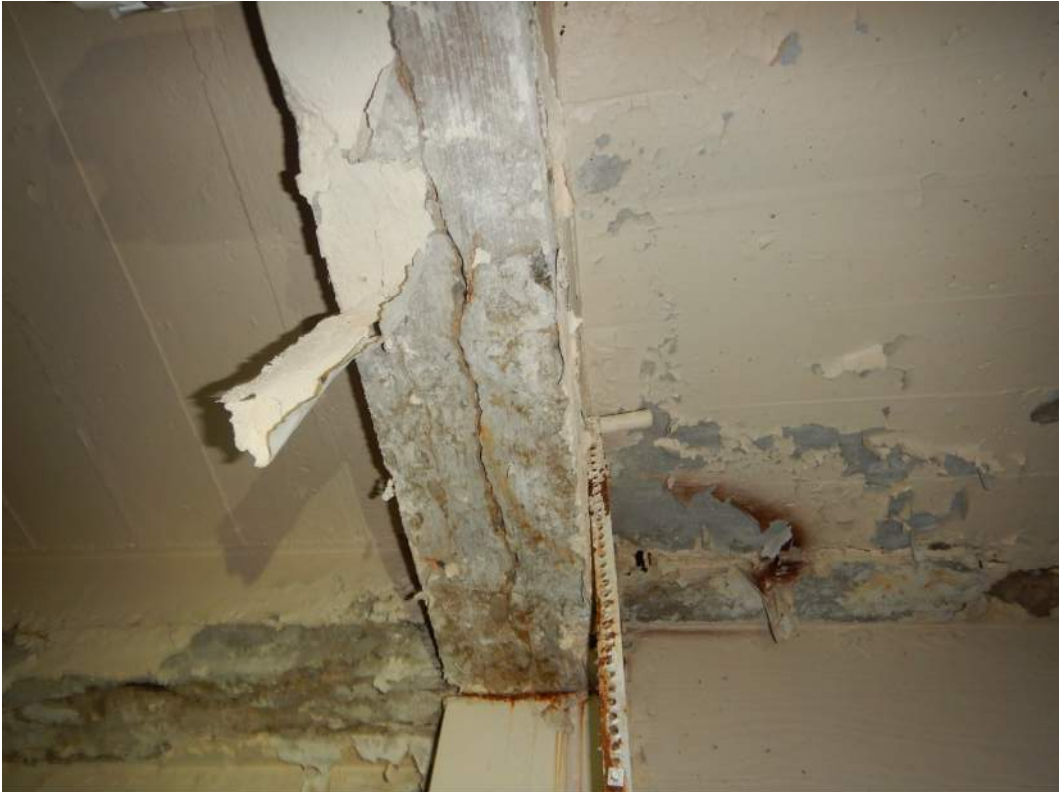
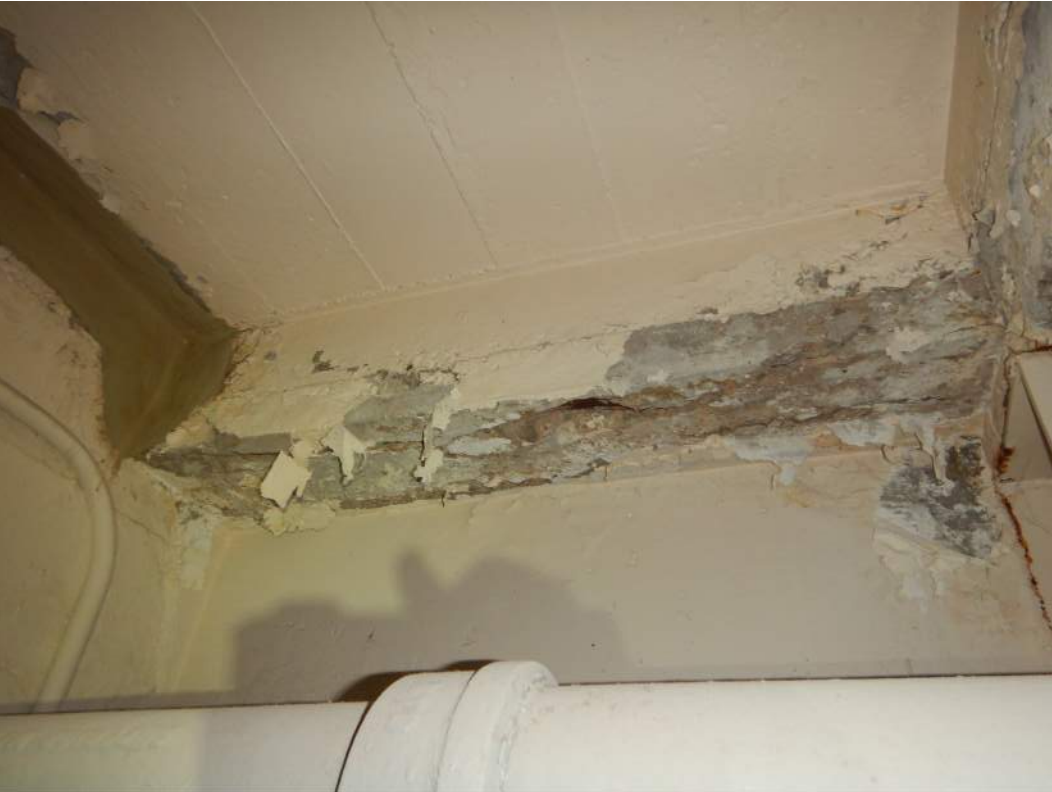
| CATEGORY 'B' | <div><p>DESCRIPTION:<br/>CRACKING OR SPALLING HAS OCCURRED. REBAR MAY BE EXPOSED.</p><p>REPAIR:<br/>REMOVE ANY LOOSE OR DAMAGED REBAR TO A POINT WHERE NO CORROSION HAS OCCURRED. REMOVE ALL CORROSION FROM REINFORCING IF REBAR HAS LOST MORE THAN 25% OF AREA REPLACE REBAR PER DETAIL 2/S3.0, OTHERWISE REPAIR PER DETAIL 1/S3.0.</p></div> <div></div> |
