## I. Project Identification

Property Address:  
301 Cypress Street  
Abilene, Taylor County, Texas 79601

Phase Engineering, LLC  
Report # 202510014

### Sample Location Map - October 9, 2025

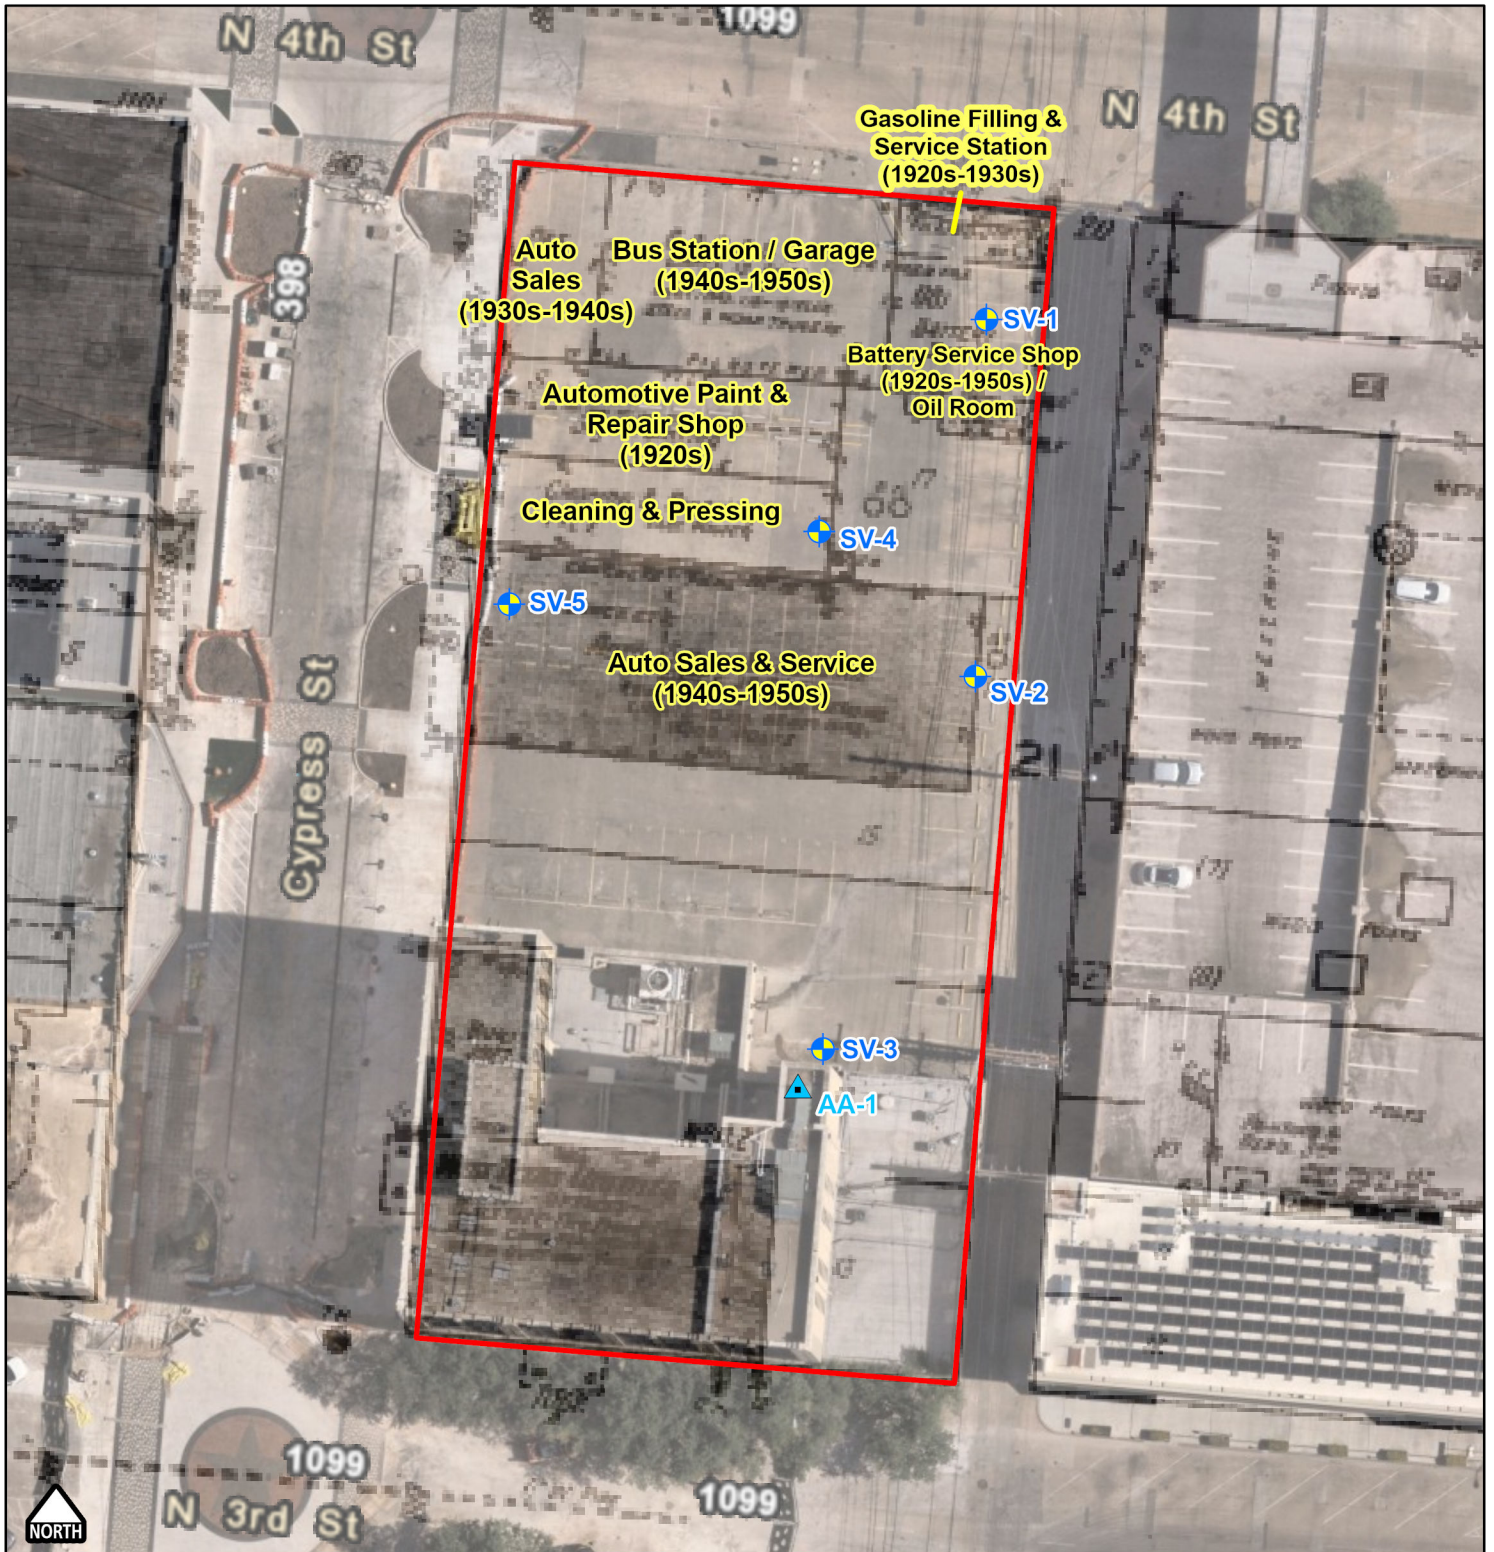
- Subject Property
- ⊕ Soil Vapor Port
- Area of Interest
- ▲ Ambient Air Station

| SUMMARY OF SAMPLE LOCATIONS | |
|---|---|
| SV-1 | Near northeast corner of subject property / location of historical battery service shop with oil room and proximate to former gasoline filling and service station and associated gas tank |
| SV-2 | East-central portion of subject property, near center of east property boundary / proximate to former automotive sales and service building and former gasoline tank |
| SV-3 | South-central portion of subject property, north exterior of onsite building / evaluation of migration of impact in areas proximate to existing buildings |
| SV-4 | North-central portion of subject property / proximate to cleaning and pressing operations, automotive paint and repair shop, and former gasoline tanks |
| SV-5 | West-central portion of subject property, along west property boundary / proximate to former automotive sales and service and cleaning and pressing operations as well as offsite gasoline tank |
| AA-1 | South-central portion of subject property, interior of existing building / evaluation of migration of impact and potential exposure in existing buildings |

Refer to the attached Sample Location Map for depiction of sample locations.

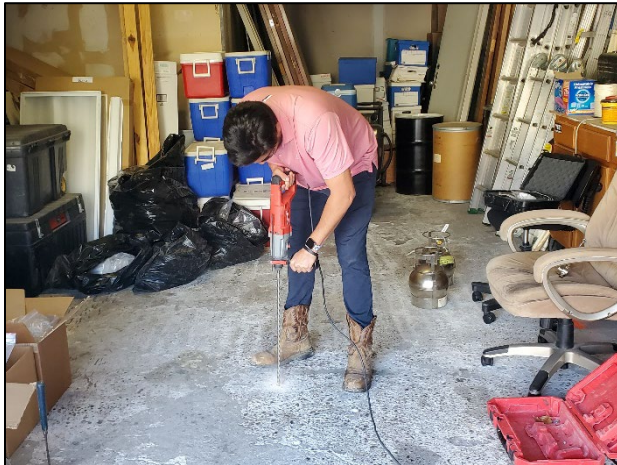
*Image 1 – Initial drilling activities*

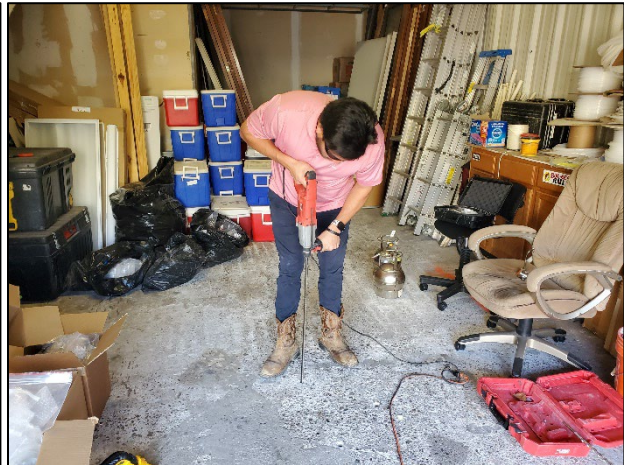
*Image 2 – Drilling with longer drill bit*

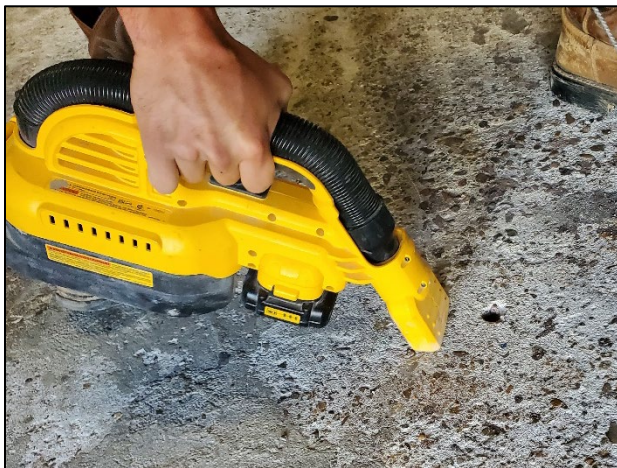
*Image 3 – Clear and sweep/vacuum sample area*

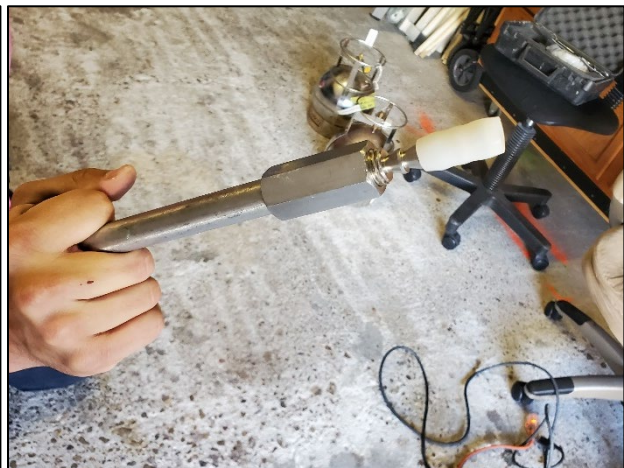
*Image 4 – Vapor pin assembly*

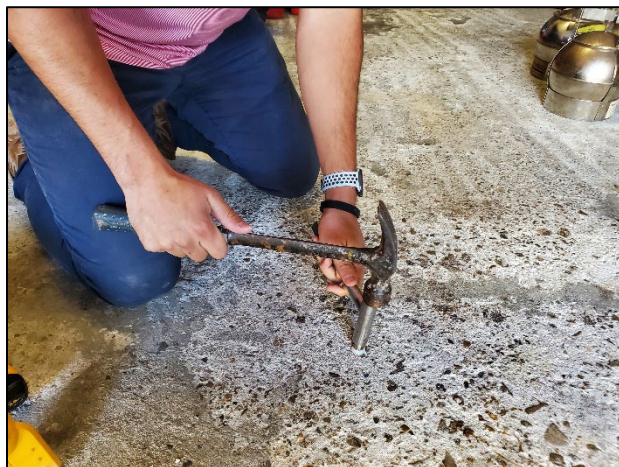
*Image 5 – Installation of vapor pin*

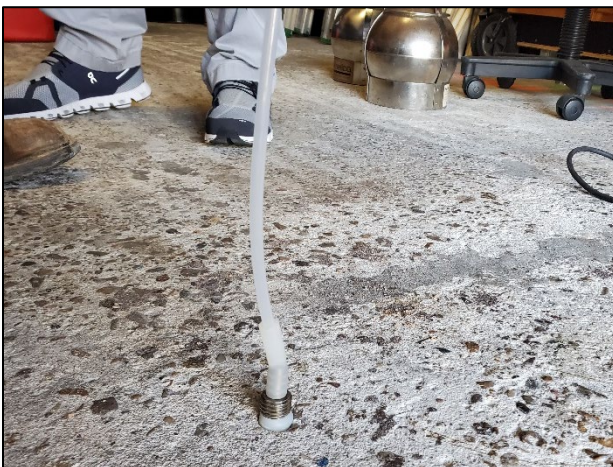
*Image 6 – Connection of tubing to vapor pin*

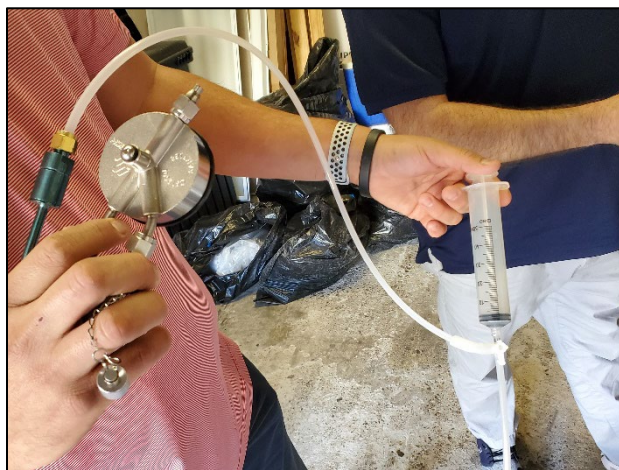
*Image 7 – Set up leak-test assembly*

19. Connect straight end of junction valve to poly line in ground/vapor pin
20. Photograph tube/sample assembly
21. Leak test: Pull syringe back with valve turned to the flow valve and then to the vapor pin\*

- a. Poly to vapor pin should offer no resistance
  - b. Poly to control valve should offer resistance
  - c. If leak test fails, reinstalling the vapor pin with new silicone seal and new polyline may be necessary

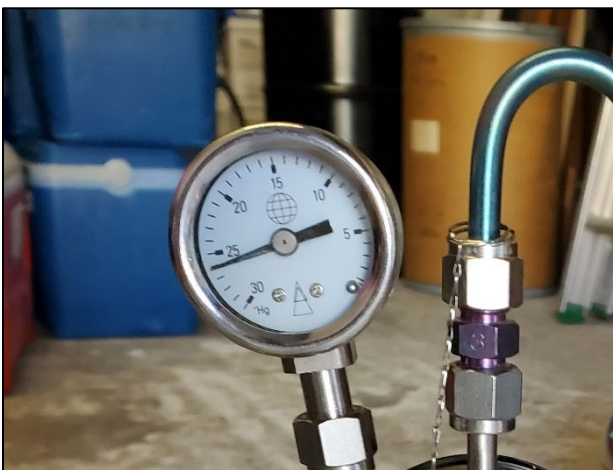
*Image 8 – Initial pressure check*

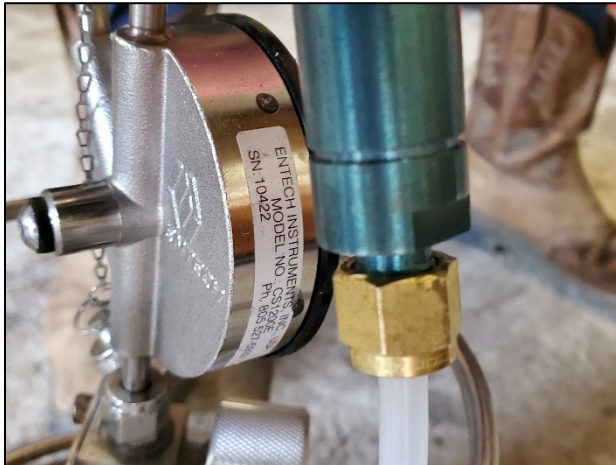
*Image 9 – Female connection and valve S/N*

25. Note serial numbers (See *Image 9* and *Image 10*) and pressures of flow valves and cannister with location descriptions
26. Double check connections, mitigate tripping hazards, clearly mark area (cone) if necessary

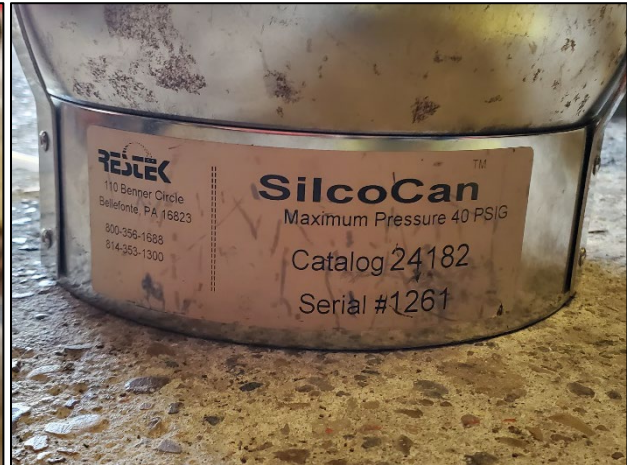
*Image 10 – Location of cannister ID number*

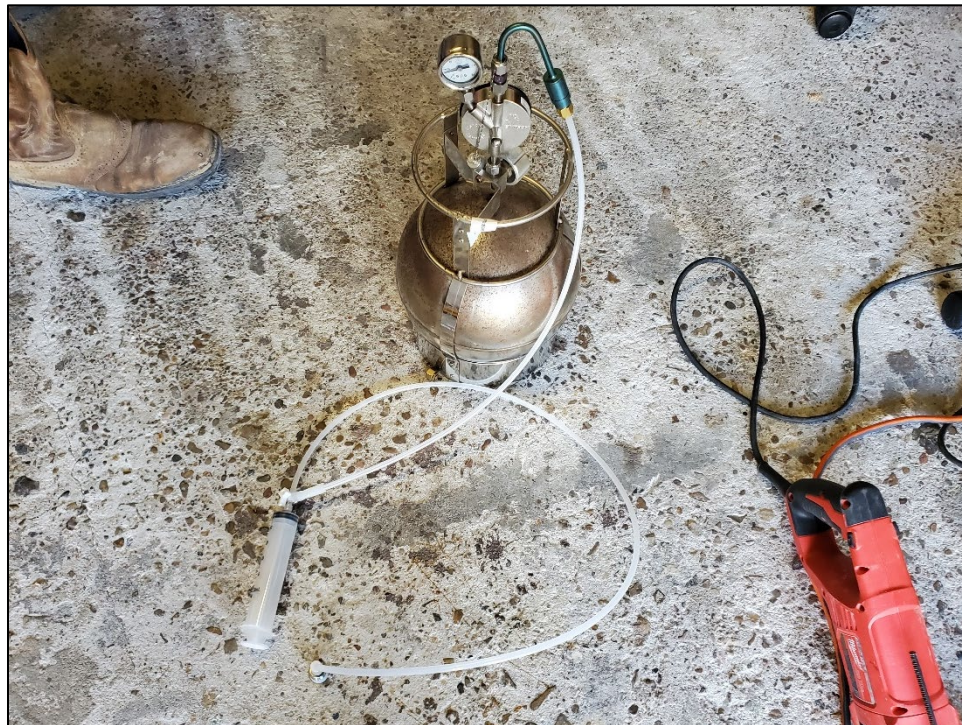
*Image 11 – Full sample assembly*
