1 FIRST FLOOR FRAMING PLAN  
1/8" = 1'-0"

LANDMARK ON CYPRESS  
HISTORIC REHABILITATION - APARTMENTS  
ABILENE, TEXAS

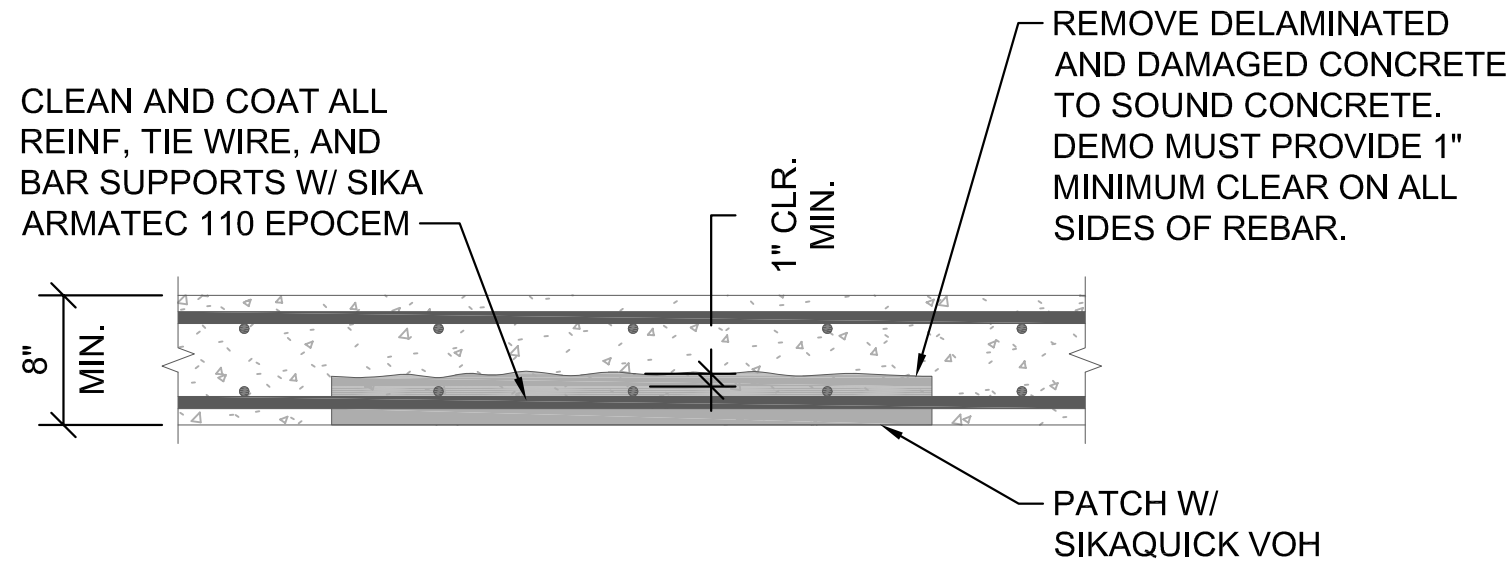
1 TYPICAL BOTTOM SIDE REPAIR DETAIL  
NOT TO SCALE

| CATEGORY 'B' | <div><p>DESCRIPTION:<br/>CRACKING OR SPALLING HAS OCCURRED. REBAR MAY BE EXPOSED.</p><p>REPAIR:<br/>REMOVE ANY LOOSE OR DAMAGED REBAR TO A POINT WHERE NO CORROSION HAS OCCURRED. REMOVE ALL CORROSION FROM REINFORCING IF REBAR HAS LOST MORE THAN 25% OF AREA REPLACE REBAR PER DETAIL 2/S3.0, OTHERWISE REPAIR PER DETAIL 1/S3.0.</p></div> <div></div> |
