Jones Gillam Renz Architects

Roosevelt Lofts – Historic Rehabilitation & New Apartments – 22-3281

ADDENDUM NO. 1

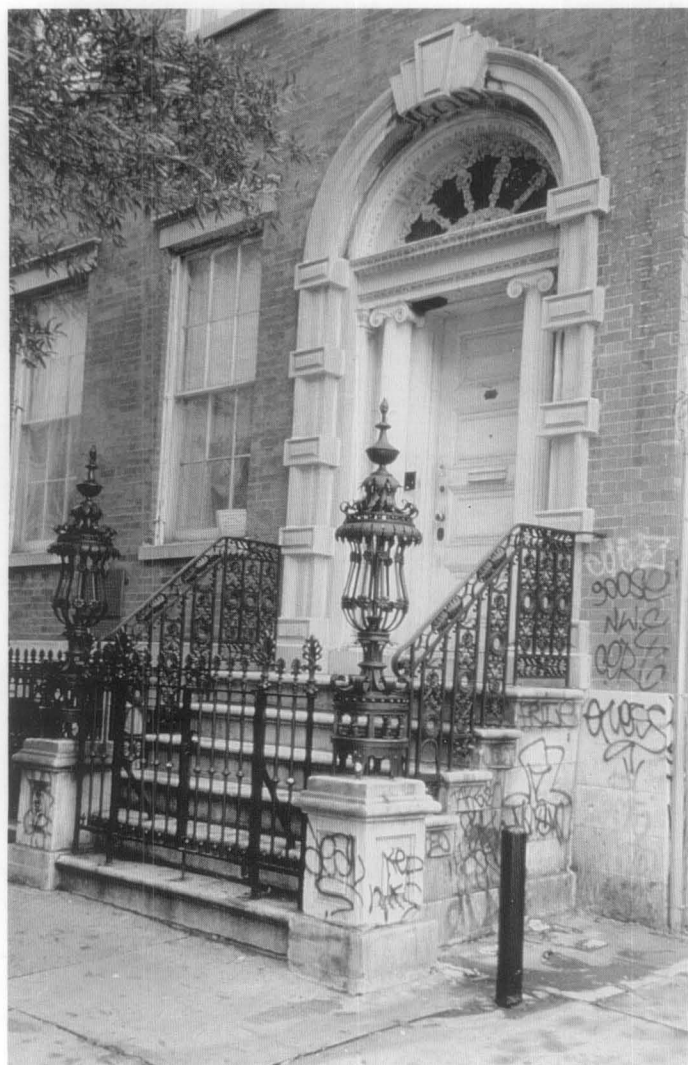
Figure 1. Many stones resemble others, and even concrete can sometimes be mistaken for stone. The stone trim on the Old Merchant's (Seabury Tredwell) House (1832), in Greenwich Village, New York City, is documented as Vermont marble. After establishing the stone type, cleaning methods should be tested in a discrete location in order to determine the most effective means of removing the graffiti without damaging the stone. More than one kind of removal technique may be required when both stone and brick require cleaning. Photo: Mark A. Weber

Successful graffiti removal from historic masonry depends on achieving a balance between breaking the bond between the graffiti and the masonry surface without damaging the masonry. This generally requires knowledge both of the materials used to make the graffiti and the masonry on which the graffiti has been executed, as well as knowledge of cleaning methods and materials (Fig. 1). Without this, masonry surfaces can be badly disfigured or damaged during graffiti removal.

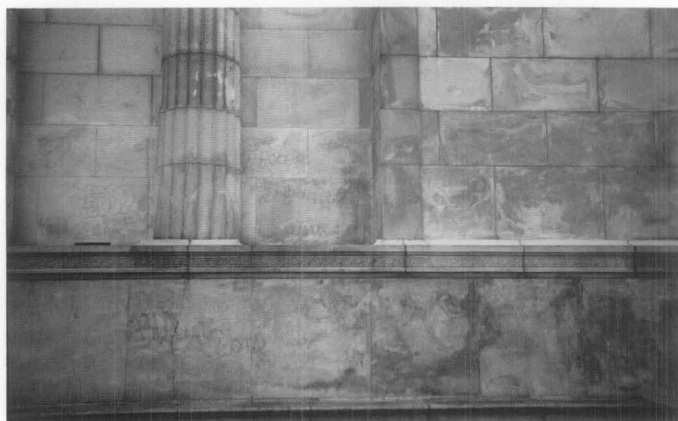
Figure 2. Harsh, but ineffective, graffiti removal methods have resulted in permanent damage to granite walls at the General Grant National Memorial in New York City. Photo: Judith M. Jacob

more difficult, or even impossible, to remove. Poorly thought-out and generally hasty attempts to remove graffiti using harsh chemicals or abrasives can also cause permanent damage to the masonry that may be worse than the graffiti (Fig. 2).

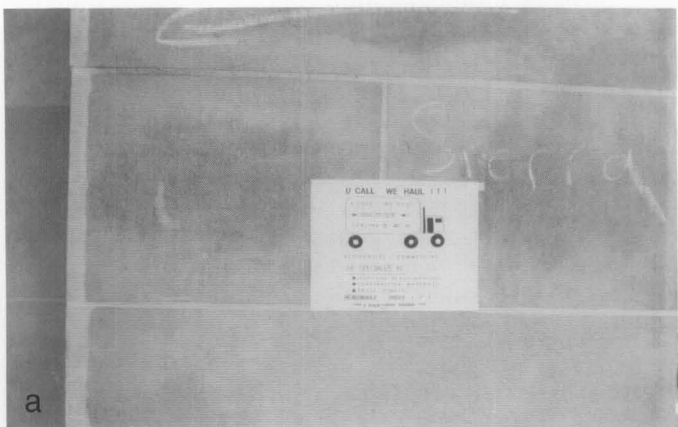
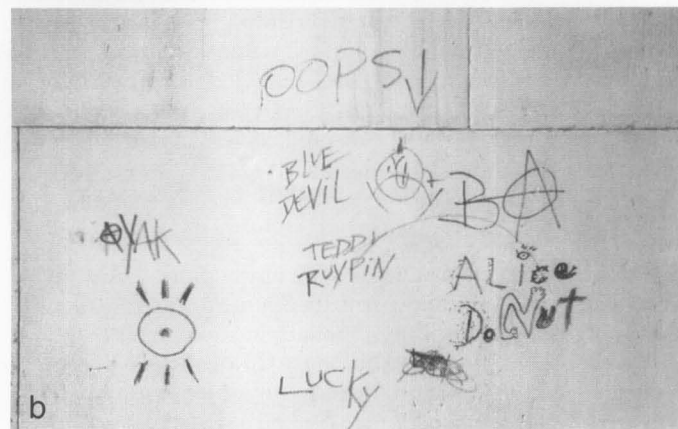
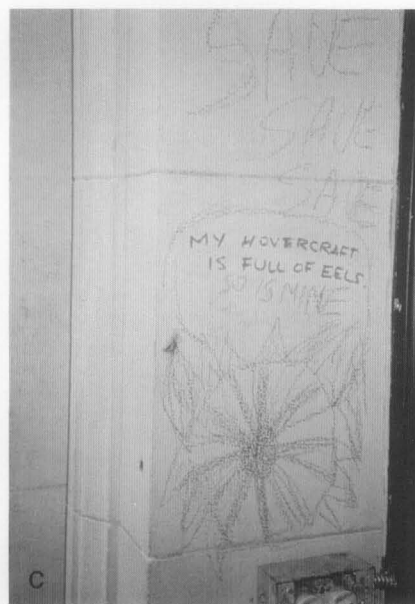
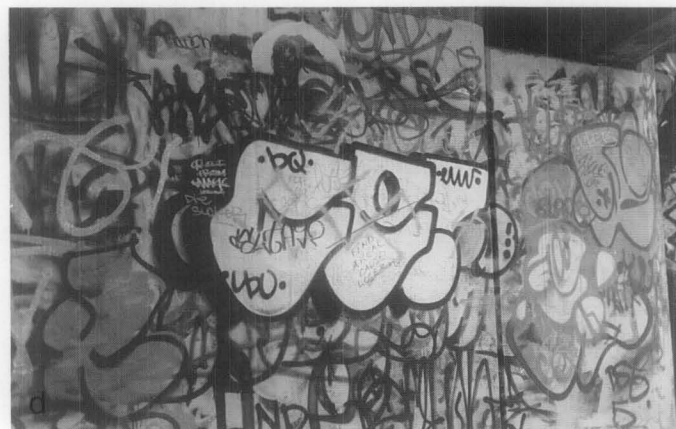
Figure 3 (a-d). A wide variety of materials is used to make surface-applied graffiti on masonry, including (a) chalk, (b) felt-tip marker, (c) felt-tip marker combined with crayon, and (d) felt-tip marker and spray paint on concrete. Photos: (a) Anne Grimmer, (b) Frances Gale, (c) Martin Weaver, (d) Anne Grimmer.

The ability to identify the graffiti material is an important step in successful removal. Numerous kinds of spray paint (polyurethanes, lacquers, and enamels), and brush-applied paints (oils and synthetic resins such as vinyls, acrylics, acetates, methacrylates, or alkyds), as well as permanent felt markers are the materials most often used to make graffiti. But other materials are also used for graffiti, including water-soluble felt markers, ballpoint pens, chalk, graphite and colored pencils, pastels, wax and oil crayons, liquid shoe polish, and lipstick (Fig. 3). The range of materials adopted by graffiti artists continues to expand.

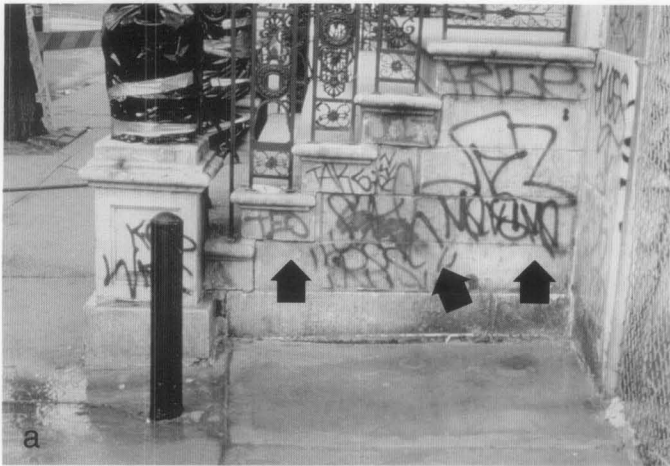
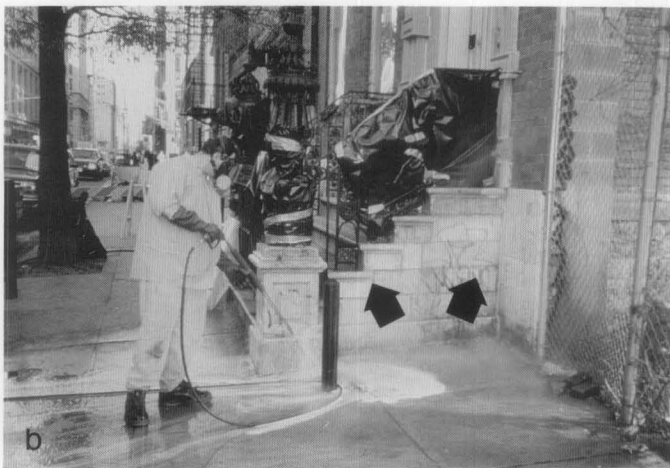
Figure 4 (a-b). After cleaning with an alkaline paint remover, remnants or ghosts of black spray-painted graffiti are still visible and may require poulticing, while the blue paint has been almost completely removed. Photos: Mark A. Weber.

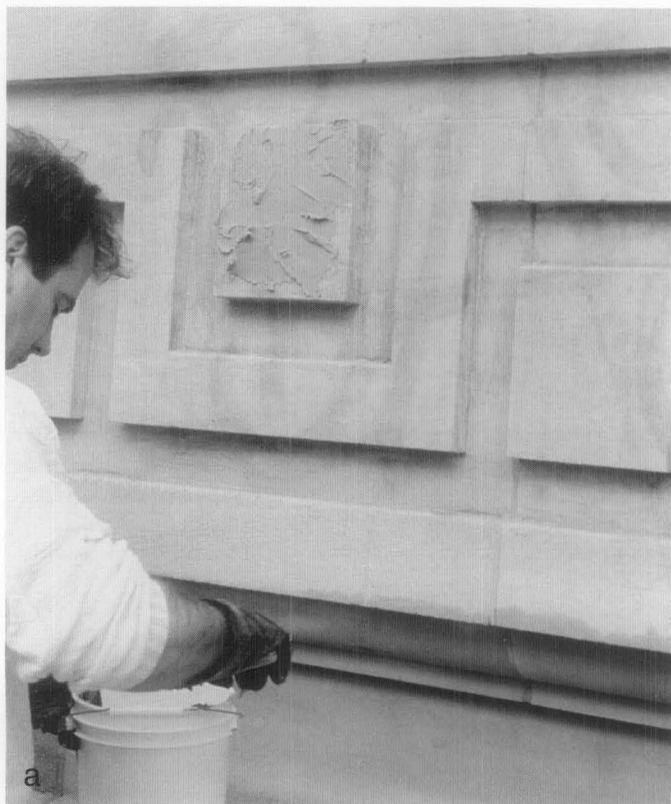
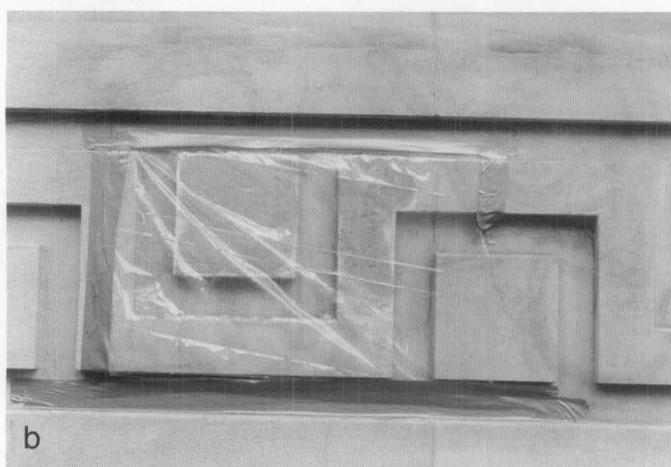
Figure 5. (a) Here, a commercially-manufactured poultice is being applied to the graffiti ghost that remains on this limestone building after an initial treatment with paint remover; (b) a plastic sheet has been taped over the poultice to slow down the rate of evaporation of the solvents contained in the poultice. Photos: Ken Lustbader.

The most effective method of removing graffiti from masonry usually involves the use of a poultice. A poultice consists of an absorbent material or powder—inert clays such as kaolin or sepiolite, diatomaceous earth (fuller's earth); or cellulose products such as fluff pulp cellulose or shredded paper—mixed with a cleaning solution (a liquid reagent such as water, organic solvent, paint stripper or bleach) to form a paste or slurry. The purpose of a poultice is twofold: it enables a cleaning solution to be kept in contact with the stained area as long as possible, while allowing the cleaning solution to pull the staining material out of the substrate via the poultice without redepositing it in, or restraining, the masonry. A poultice is often covered with a plastic sheet to retard evaporation (Fig. 5). With some extremely porous types of stone, such as marble, although a poultice may remove a stain from one side of the stone, stains can pass completely through the stone and be redeposited on the other side of the masonry slab. Thus, caution should always be exercised in stain and graffiti removal.

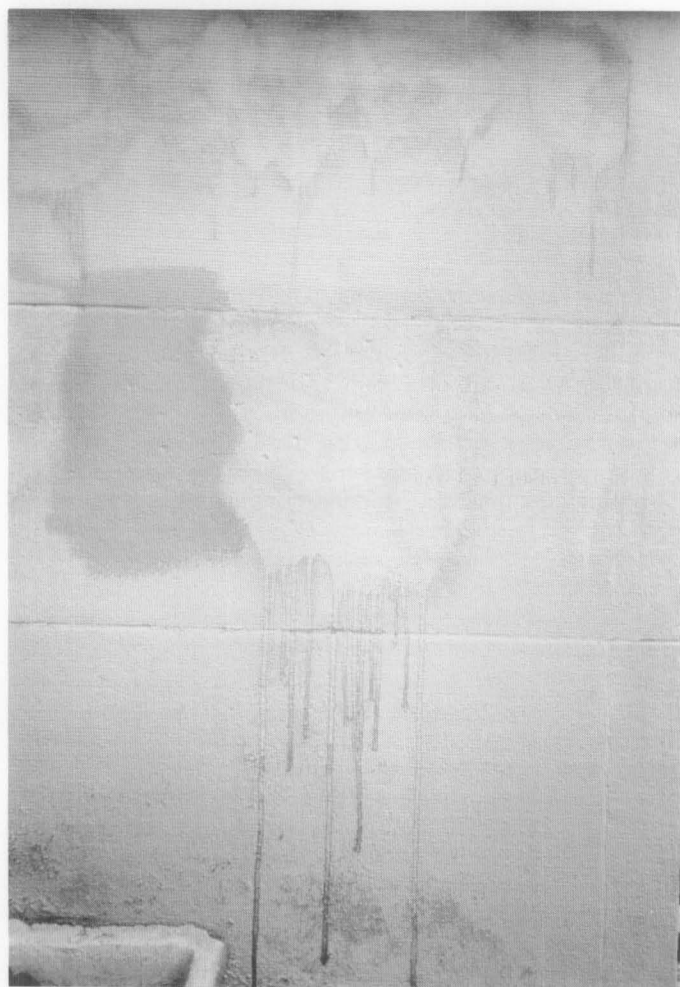
Figure 6. Although an aerosol graffiti remover has taken off much of the graffiti, it has left new stains where it dripped down the masonry surface. Photo: Ken Lustbader.

graffiti-removal products and commercial paint strippers containing organic solvents. But, these products should always be tested and used in accordance with manufacturer's instructions included in the product literature. Normally, solvents should be used in a poultice form to prevent them from penetrating into the substrate, and permanently discoloring or staining the masonry. A number of paint-removers are manufactured as thick gels or pastes that cling to the surface, and some commercial paint-removal products include a tough fiber-reinforced paper or cloth backing that retards evaporation and also facilitates neat and clean removal of the used stripper. The advantage of using organic solvents is that they evaporate completely, leaving no residual material in the masonry. However, organic solvents may present a severe health hazard, and workers using them must wear adequate protection. "Off-the-shelf" aerosol graffiti removers generally should not be used because the dissolved paint being removed may run down the wall "staining" a previously clean area; or pigments may also be redistributed by the rinsing and scrubbing recommended by the product manufacturer (Fig. 6).

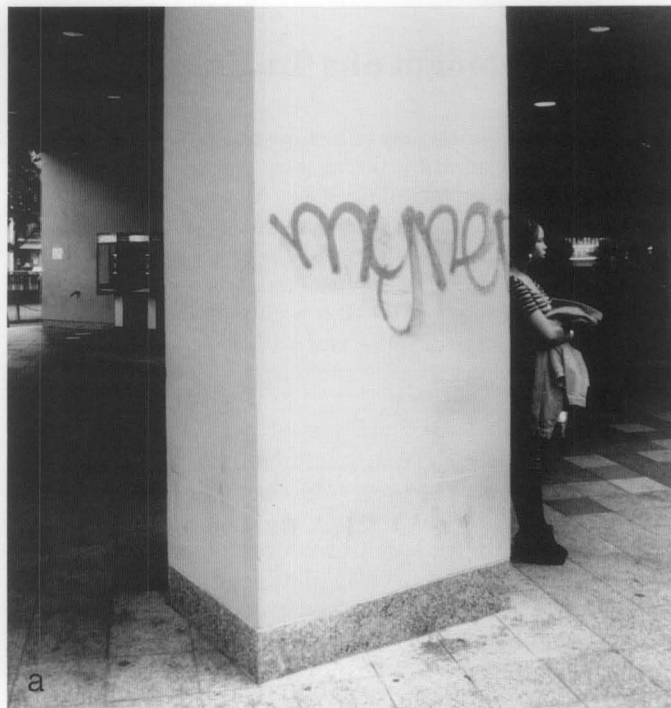
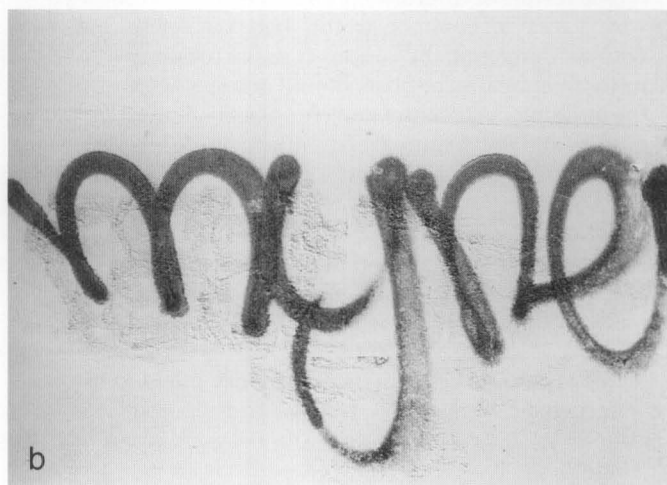
Figure 7 (a-b). The first time this spray-painted graffiti appeared it was removed abrasively. As a result, the graffiti was permanently etched into the limestone and cannot be concealed even by the pigmented barrier coating painted over it later. The barrier coating did, however, facilitate non-abrasive removal of graffiti the next time it was applied. Photos: Anne Grimmer.

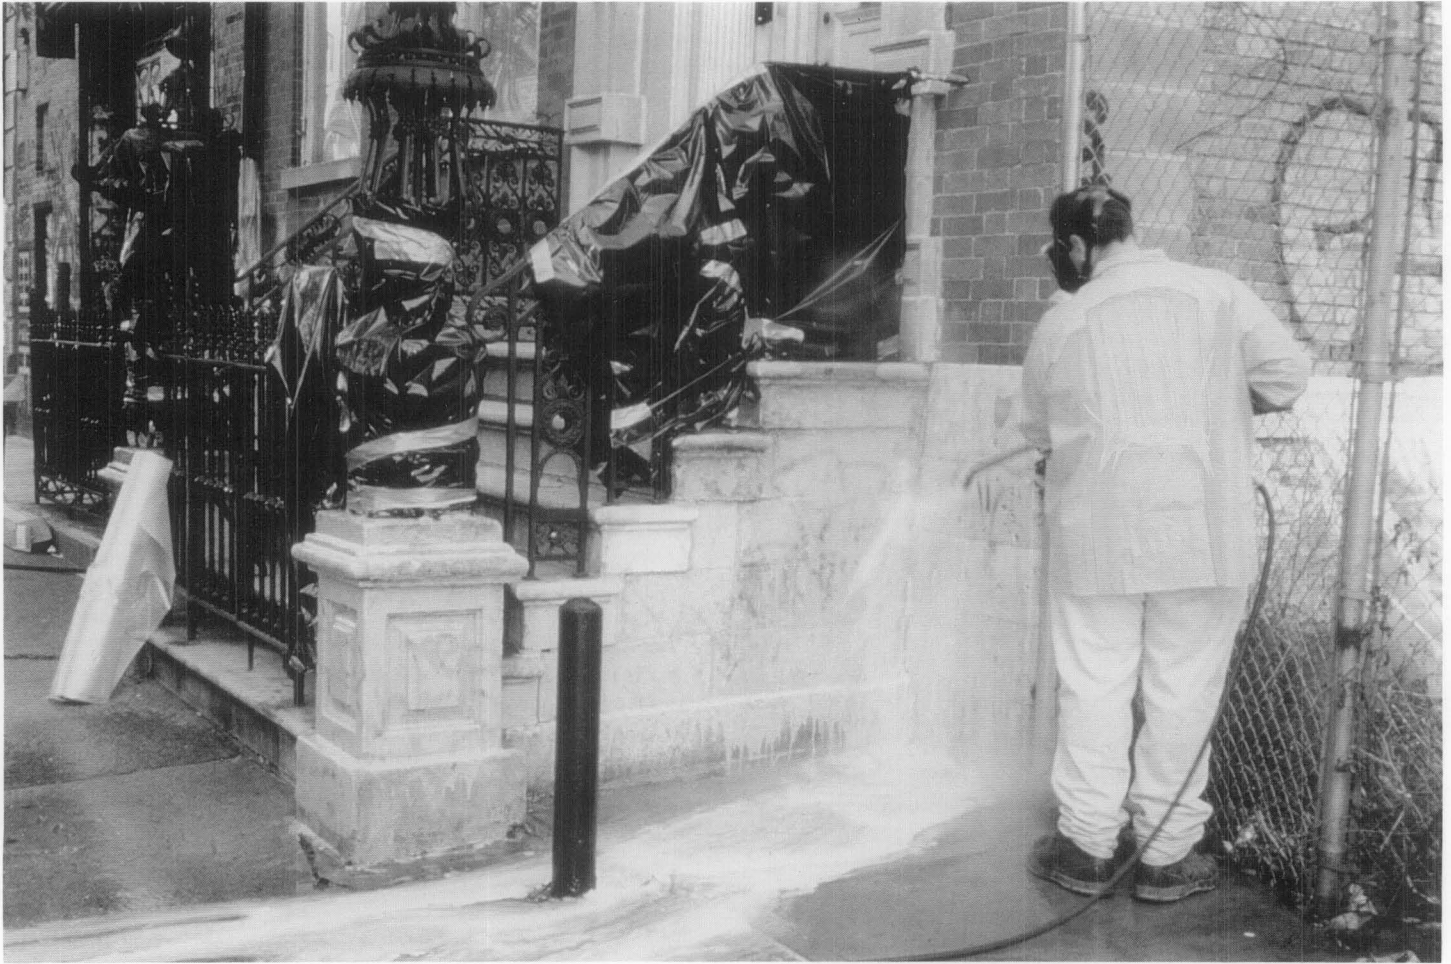
Figure 8. The cast-iron railing and light fixtures on this stone stoop have been wrapped with plastic sheeting to protect them from damage by chemicals being used to remove the graffiti. Photo: Mark A. Weber.

As with any construction project, attention should always be directed toward the general safety of the workers and passers-by, but also toward possible damage to the resource itself that might result from careless placement of ladders, or scaffolding. Chemicals used for masonry cleaning can also damage adjacent metals, glass, and painted surfaces, as well as vegetation (Fig. 8). Product manufacturers' instructions should always be closely followed to avoid such inadvertent "collateral" damage.

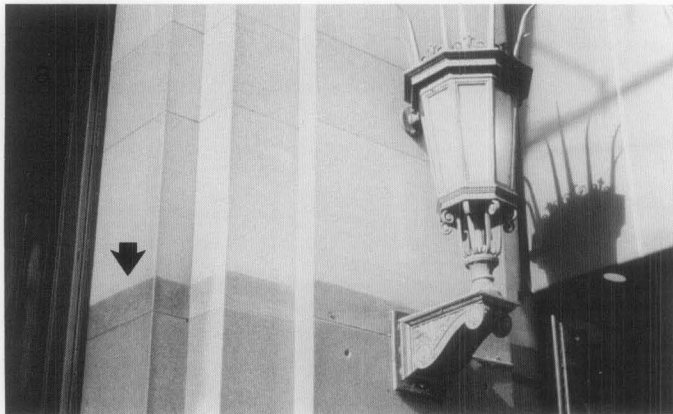
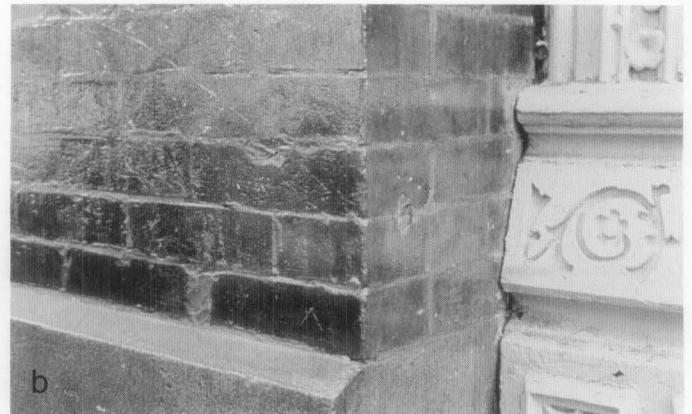
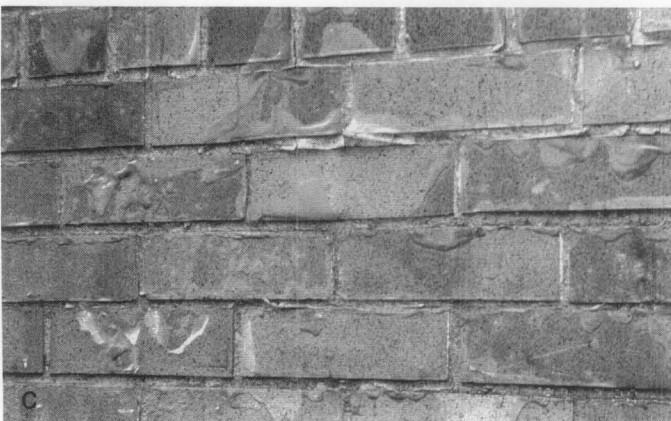
Figure 9. These photographs illustrate some of the problems inherent in clear barrier coatings. (a) The transparent coating applied to the lower portion of this granite entranceway has darkened it, thus changing the character of the historic masonry. (b) But it is not nearly so obvious or damaging to the building's historic character as the thick and shiny clear coating applied here which resembles a plastic sheathing over the brick. Scratches are highly visible and a surface haze indicates that the coating has begun to deteriorate. (c) This transparent coating is peeling and has failed completely; not only is it an eyesore, but it may also be hard to remove from the brick. Photos: (a-b) Mark A. Weber, (c) Martin E. Weaver.

generally prevent their being recommended for use on historic masonry. First, clear coatings may alter the color of the masonry surface and add a gloss that may be highly visible, or apparent only in certain lighting conditions or when it rains. Second, clear coatings may reduce the water-vapor permeability of the masonry, thereby contributing to possible water-related deterioration. Third, the coating may discolor and change over time. Exposure to ultra-violet light can cause a coating to yellow; dirt build-up may darken the treated surface; and some coatings acquire a sheen when rubbed or brushed against. Such changes are especially noticeable when only a portion of the building has been coated. Furthermore, if coatings are not maintained on a regular basis, usually through periodic removal and reapplication, many coatings tend to fail. What often results is an uneven, "patchy" look to the masonry that can have a very negative impact on the character of the historic building (Fig. 9).

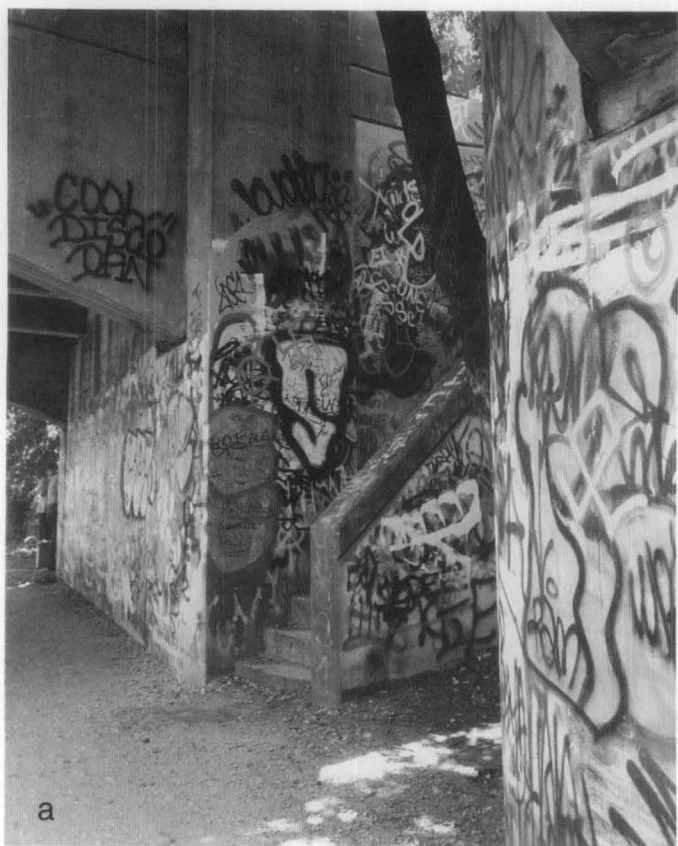
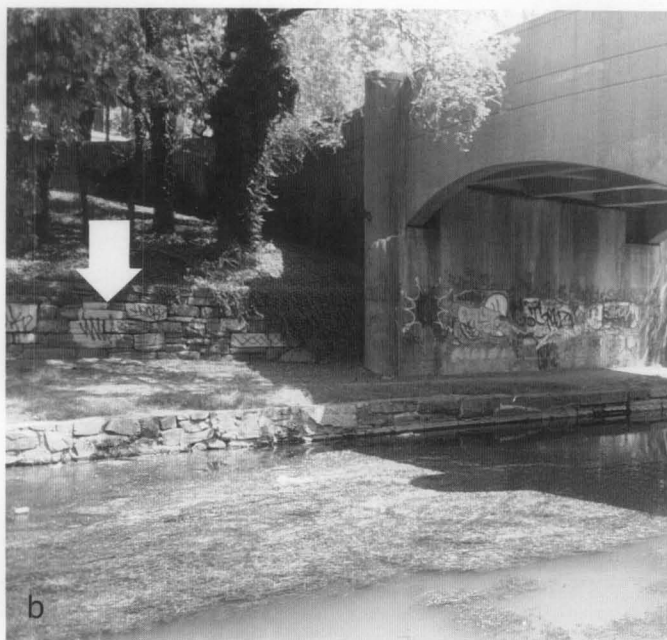
Figure 10 (a) It may be appropriate to consider the application of a barrier coating in order to facilitate removal in some out-of-the-way locations where full-time security is not possible, such as this stairway and bridge underpass next to the C&O Canal. (b) Overpainting graffiti on the stone wall at the left has not been successful; it has resulted in highlighting the defaced stones, thereby attracting more graffiti. Photos: Anne Grimmer.

frequent recurrence of graffiti, and when constant surveillance is not possible (Fig. 10). Although there are some instances in which pigmented barrier coatings may be appropriate on painted historic masonry, they are **not** recommended for unpainted historic masonry because they will change the appearance of the masonry. There is also another kind of pigmented coating that is specially formulated to be used as a *temporary* measure to conceal graffiti that cannot be removed right away. This temporary, vapor-permeable paint is removed when the graffiti is removed.

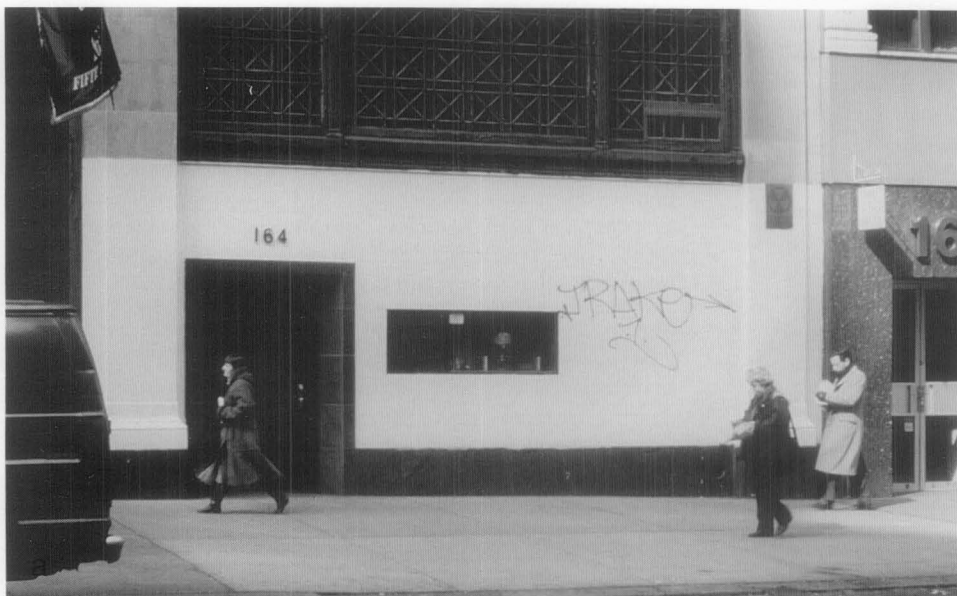
Figure 11. (a) The first floor of this limestone storefront was painted in an effort to cover graffiti. However, because the paint is poorly matched to the color of the building stone, it is highly visible and now acts as a "magnet" for new graffiti. (b) Similarly, the lowest horizontal band on this stone building, overpainted to cover graffiti, has also attracted more graffiti. Photos: (a) Mark A. Weber, (b) Martin E. Weaver

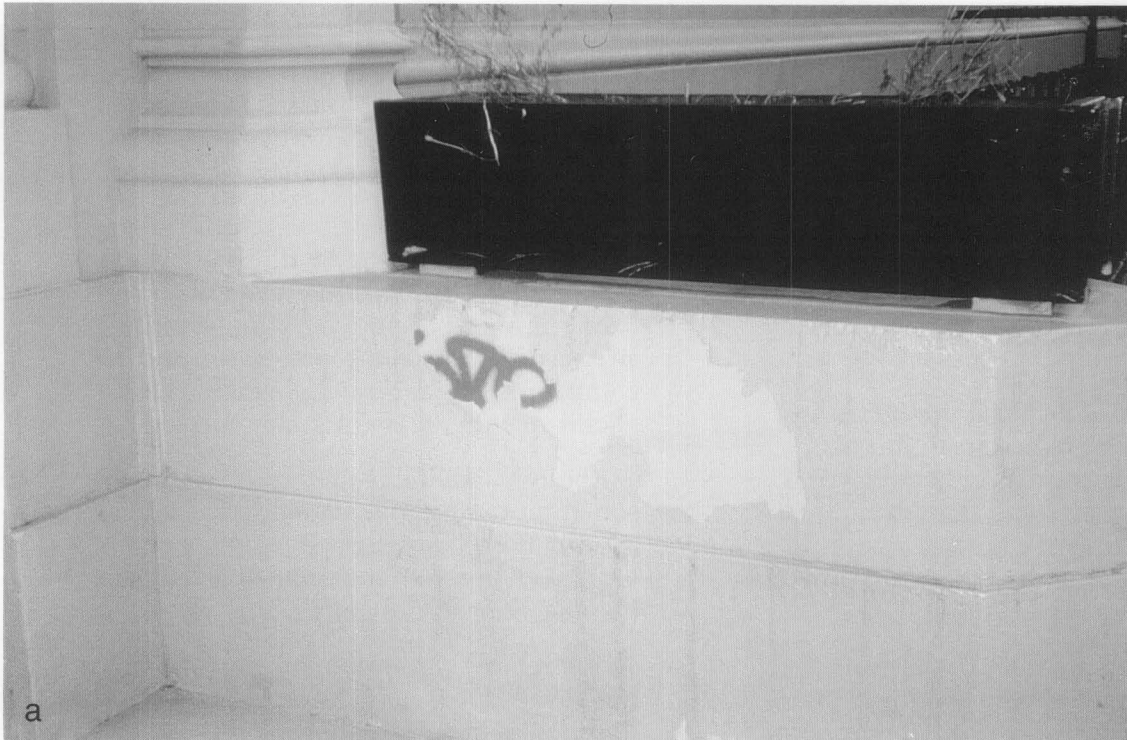
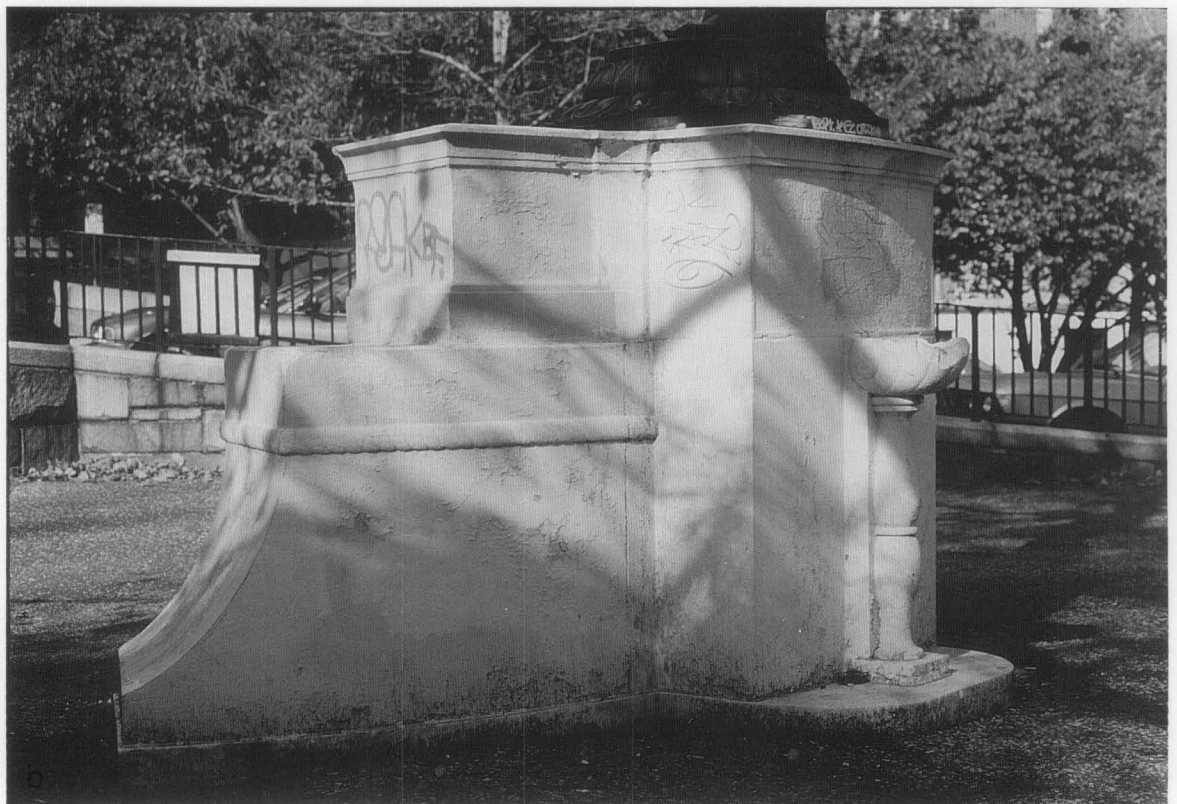
Figure 12. (a) Graffiti that was overpainted has been exposed here as a result of the coating's failure. The uneven edges where the overpainting has peeled away will make inconspicuous touch-up difficult. (b) The unsightliness of graffiti bleeding through layers of cracked and peeling paint makes an obvious point that using a pigmented coating was not an appropriate maintenance technique for this stone sculpture base. Photos: (a) Martin E. Weaver, (b) Judith M. Jacob.

Pigmented coatings are also not generally recommended as a permanent measure to cover up graffiti. Some graffiti materials, particularly felt markers, bleed through the coating; and repeated applications of the coating or paint can result in a heavy paint build-up on a masonry surface. Another disadvantage of using paint or a pigmented coating to hide graffiti is that it usually appears as an obvious patch on unpainted masonry and tends to attract more graffiti unless the paint can be applied in a discrete, and well-defined area (Fig. 11). If incompatible with either the masonry or the graffiti, such a coating may peel off the masonry surface in an unsightly manner. Like transparent coatings, pigmented coatings may be difficult or impossible to remove completely once their performance or appearance is no longer satisfactory (Fig. 12).

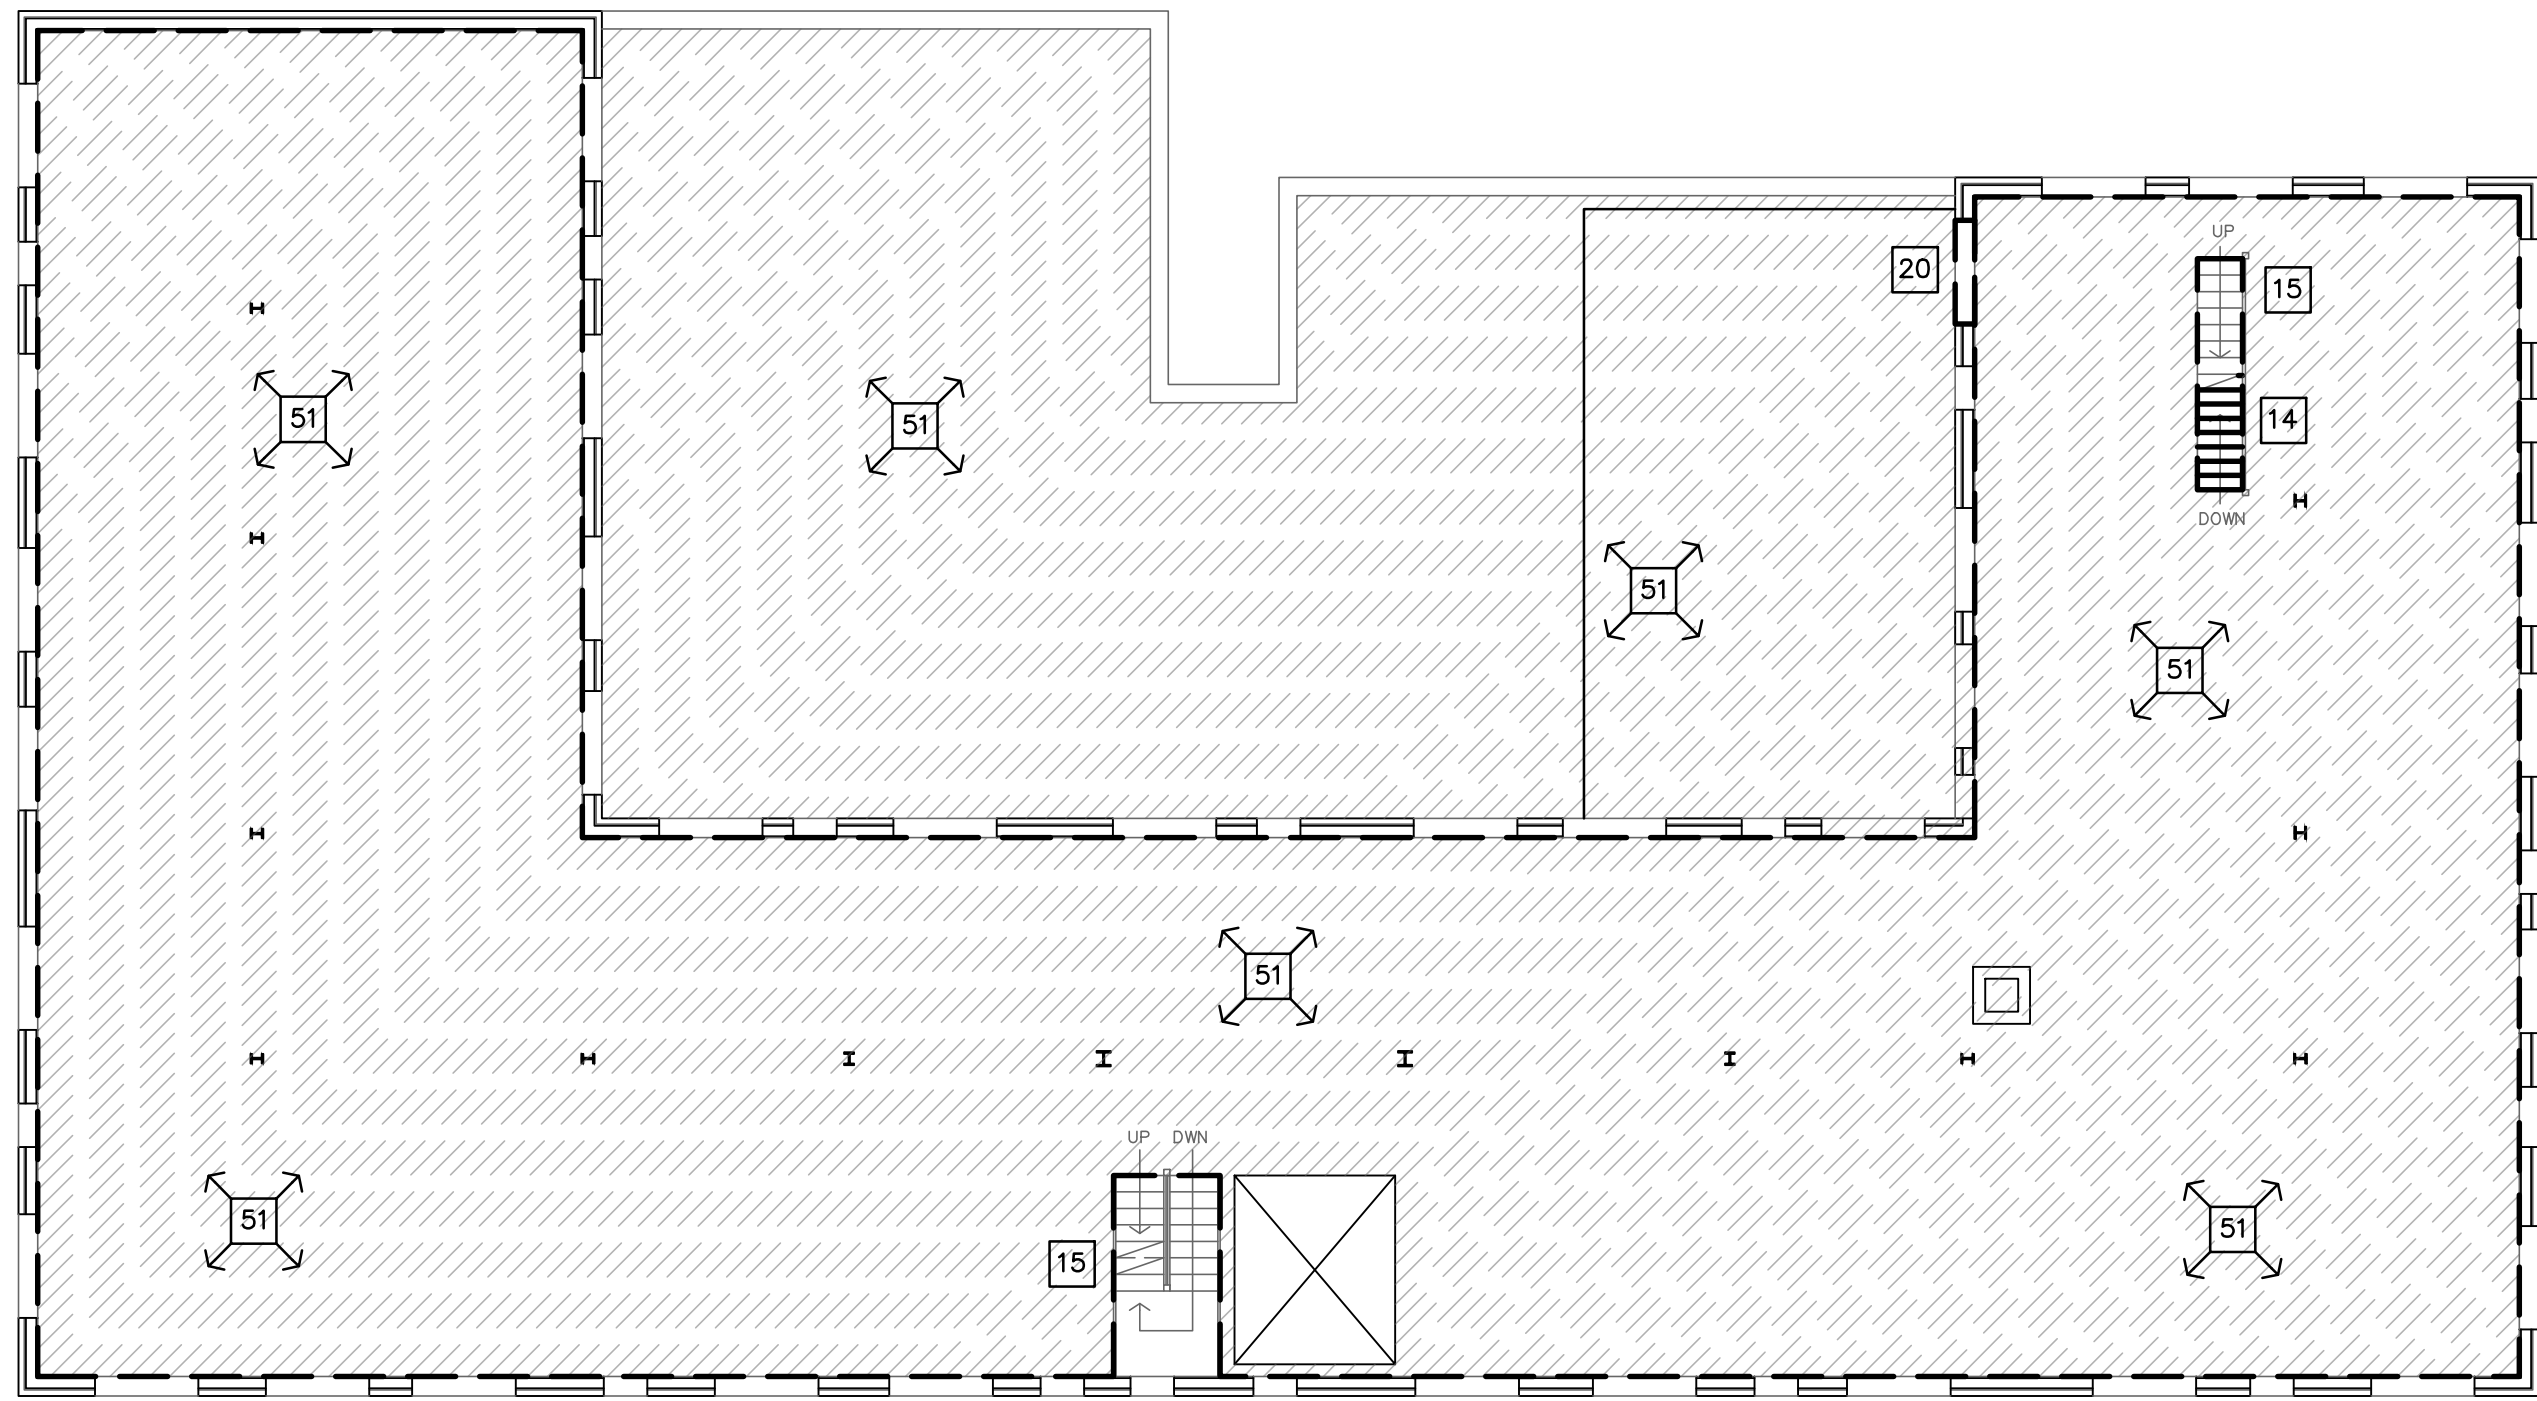
SECOND FLOOR
DEMOLITION PLAN
3/32"=1'-0"

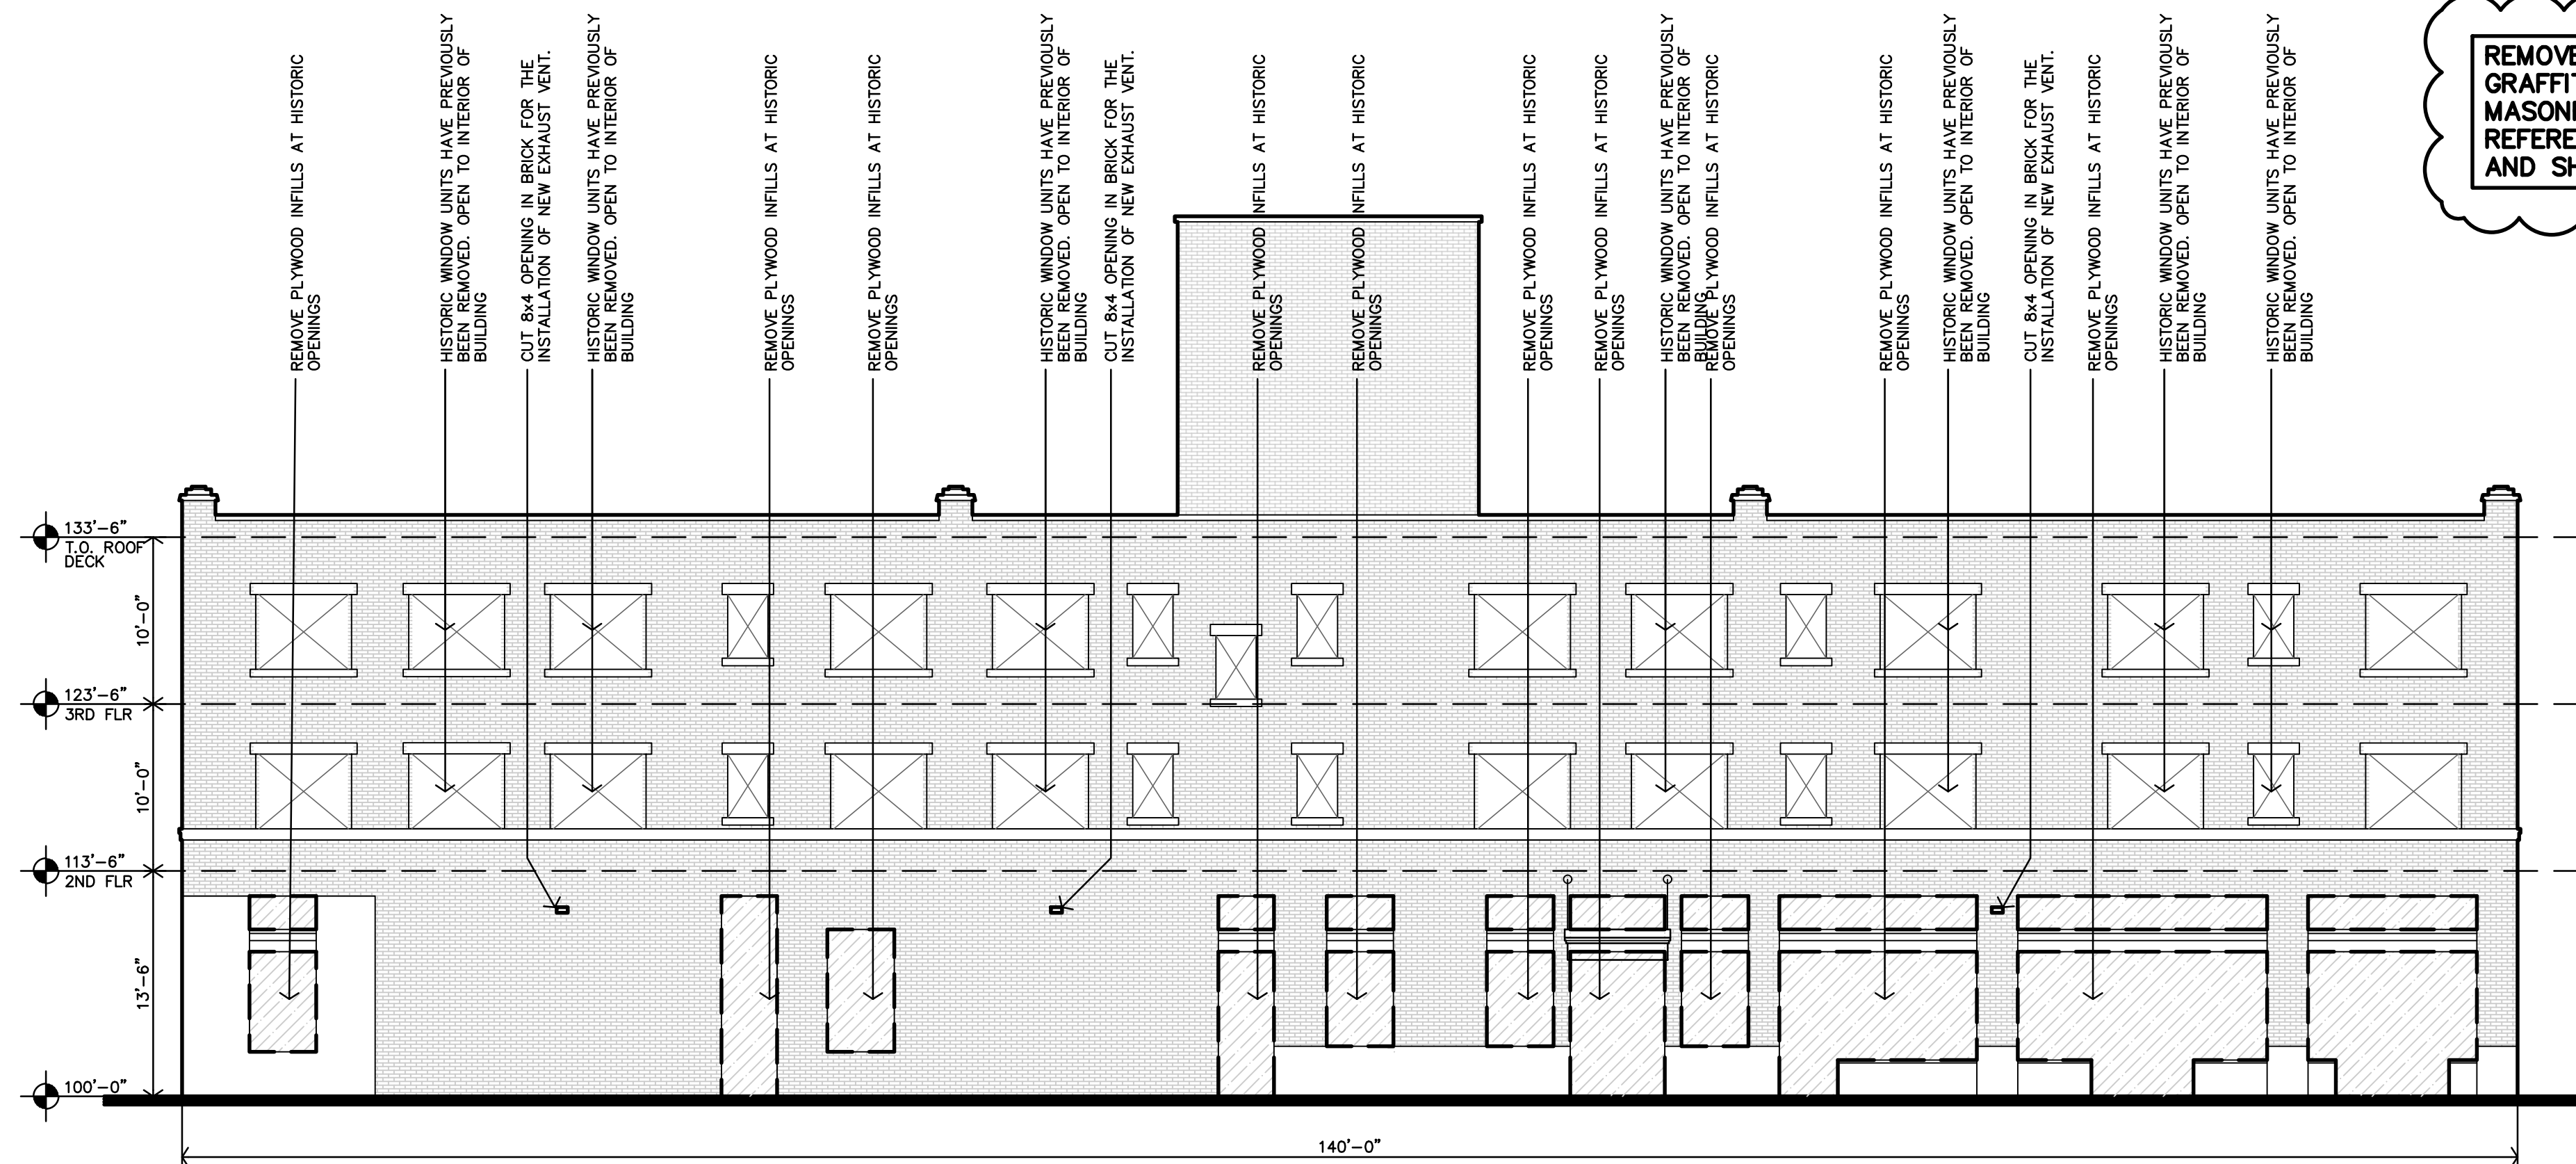
B DEMOLITION SOUTH ELEVATION
1/8"=1'-0"

- REMOVE ALL EQUIPMENT, LIGHTS, CONDUIT, DEBRIS, PIPING, DUCTWORK, ETC.
- MEDIA BLAST GRAFFITI (PER PRESERVATION BRIEFS) OFF ALL WALLS.
- REMOVE ALL EXISTING EQUIPMENT, DEBRIS, ETC. IN BASEMENT. MAKE REPAIRS AT JOISTS, BEAMS, COLUMNS, FOUNDATION WALLS, ETC. AS NEEDED. CLEAN UP FLOOR, WALLS, ETC.
- REPAIR EXISTING STAIRS TO BASEMENT AS NEEDED FOR SAFE ACCESS.
