Jones Gillam Renz Architects

Roosevelt Lofts – Historic Rehabilitation & New Apartments – 22-3281

ADDENDUM NO. 1

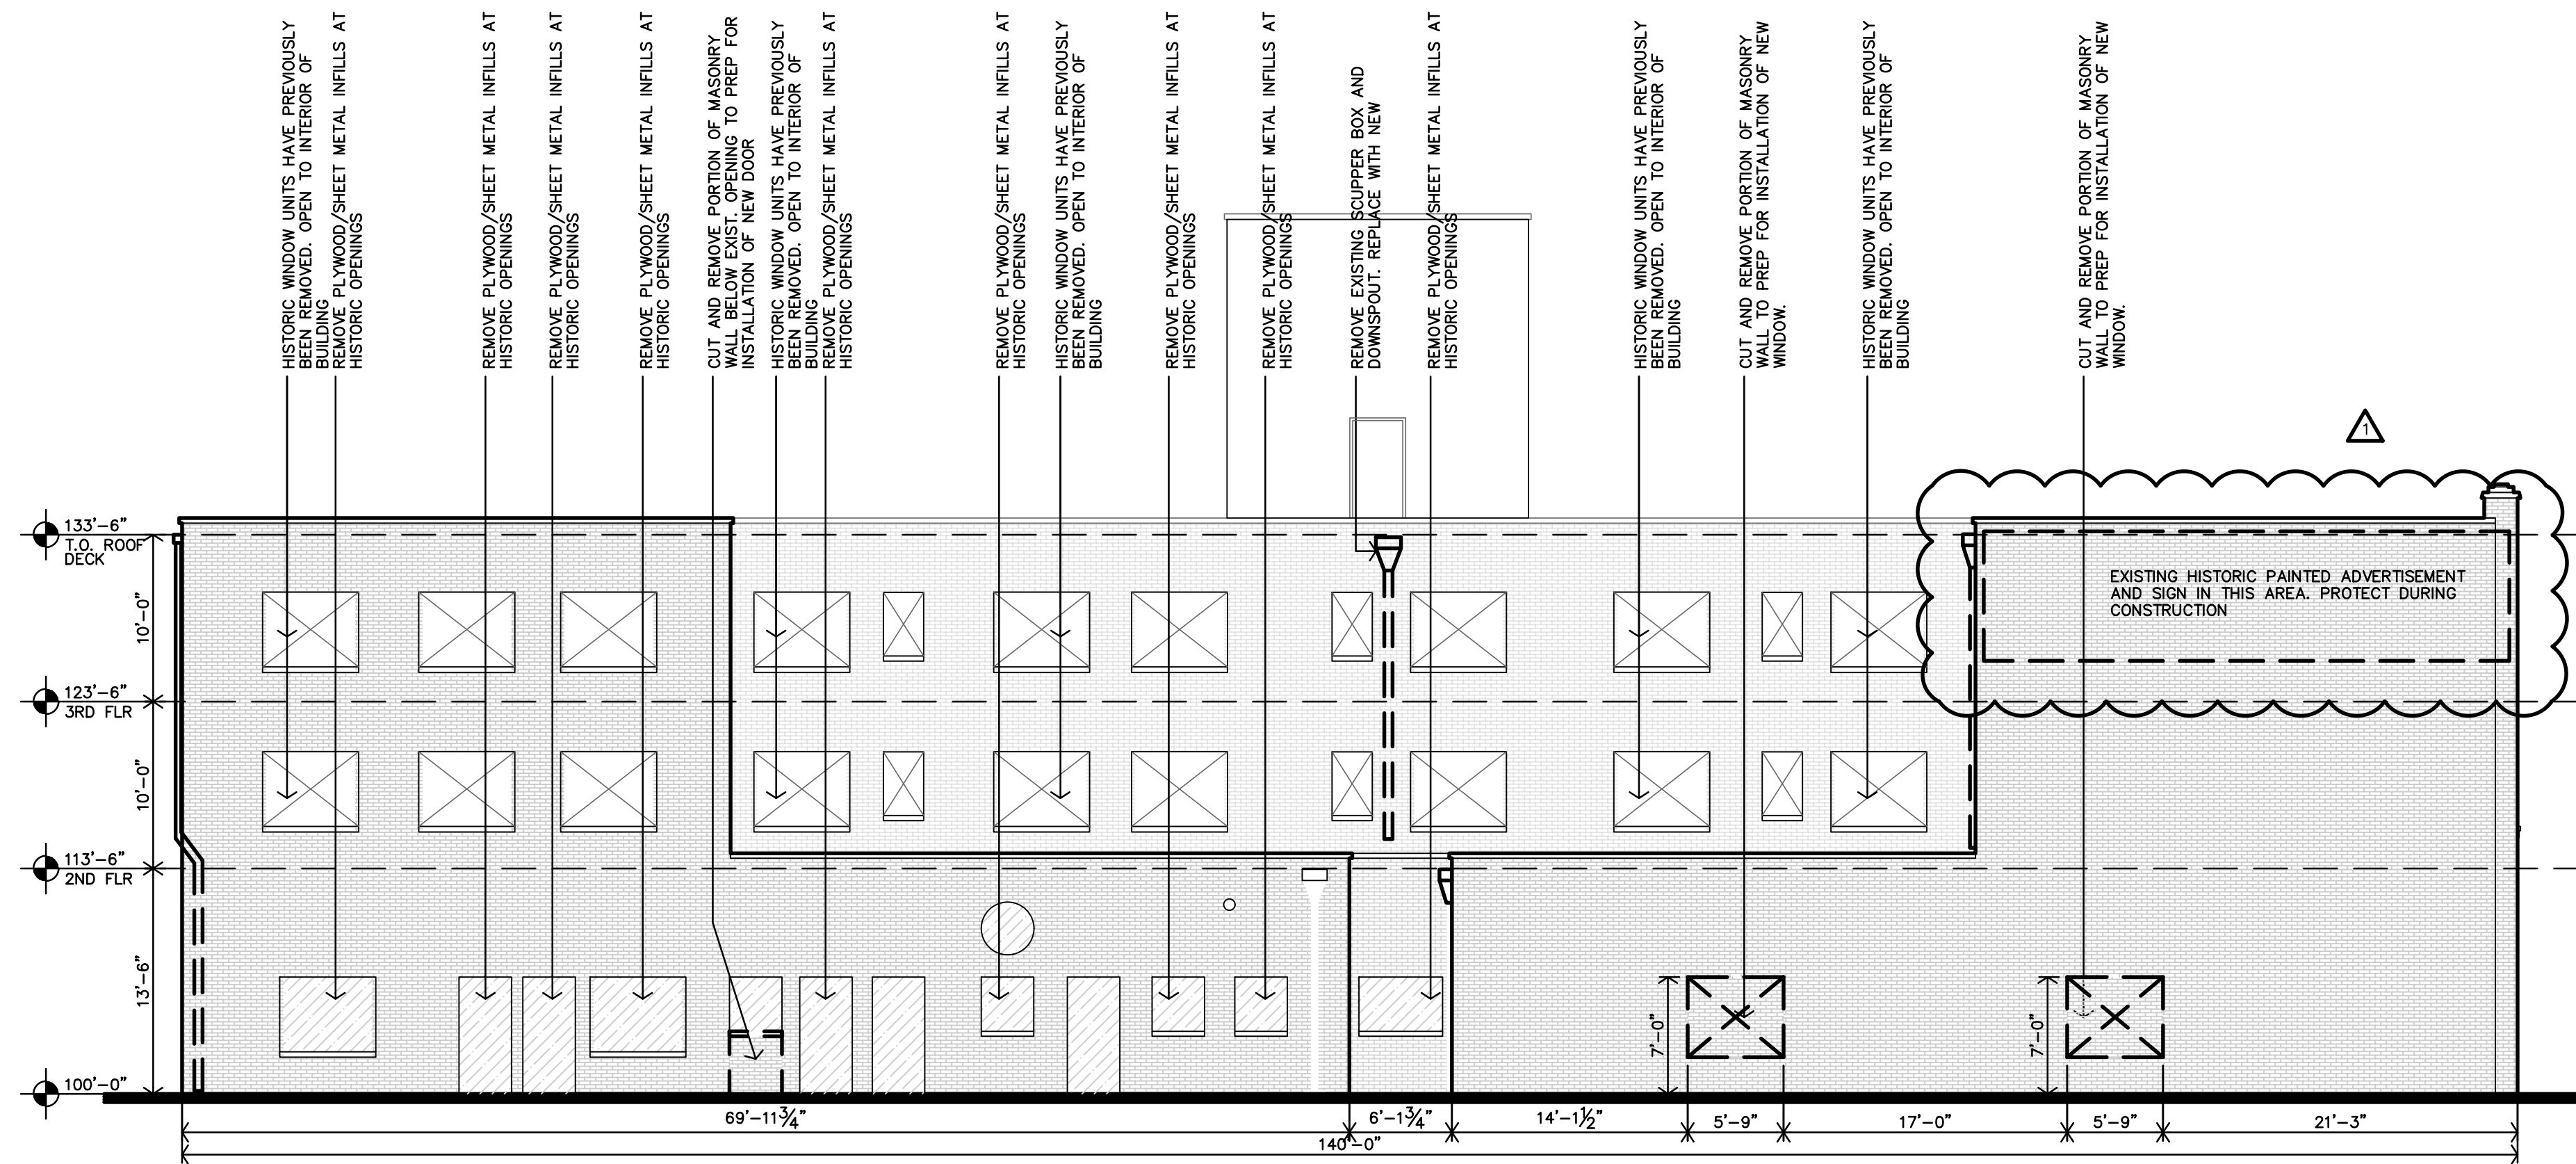
D DEMOLITION NORTH ELEVATION
1/8"=1'-0"

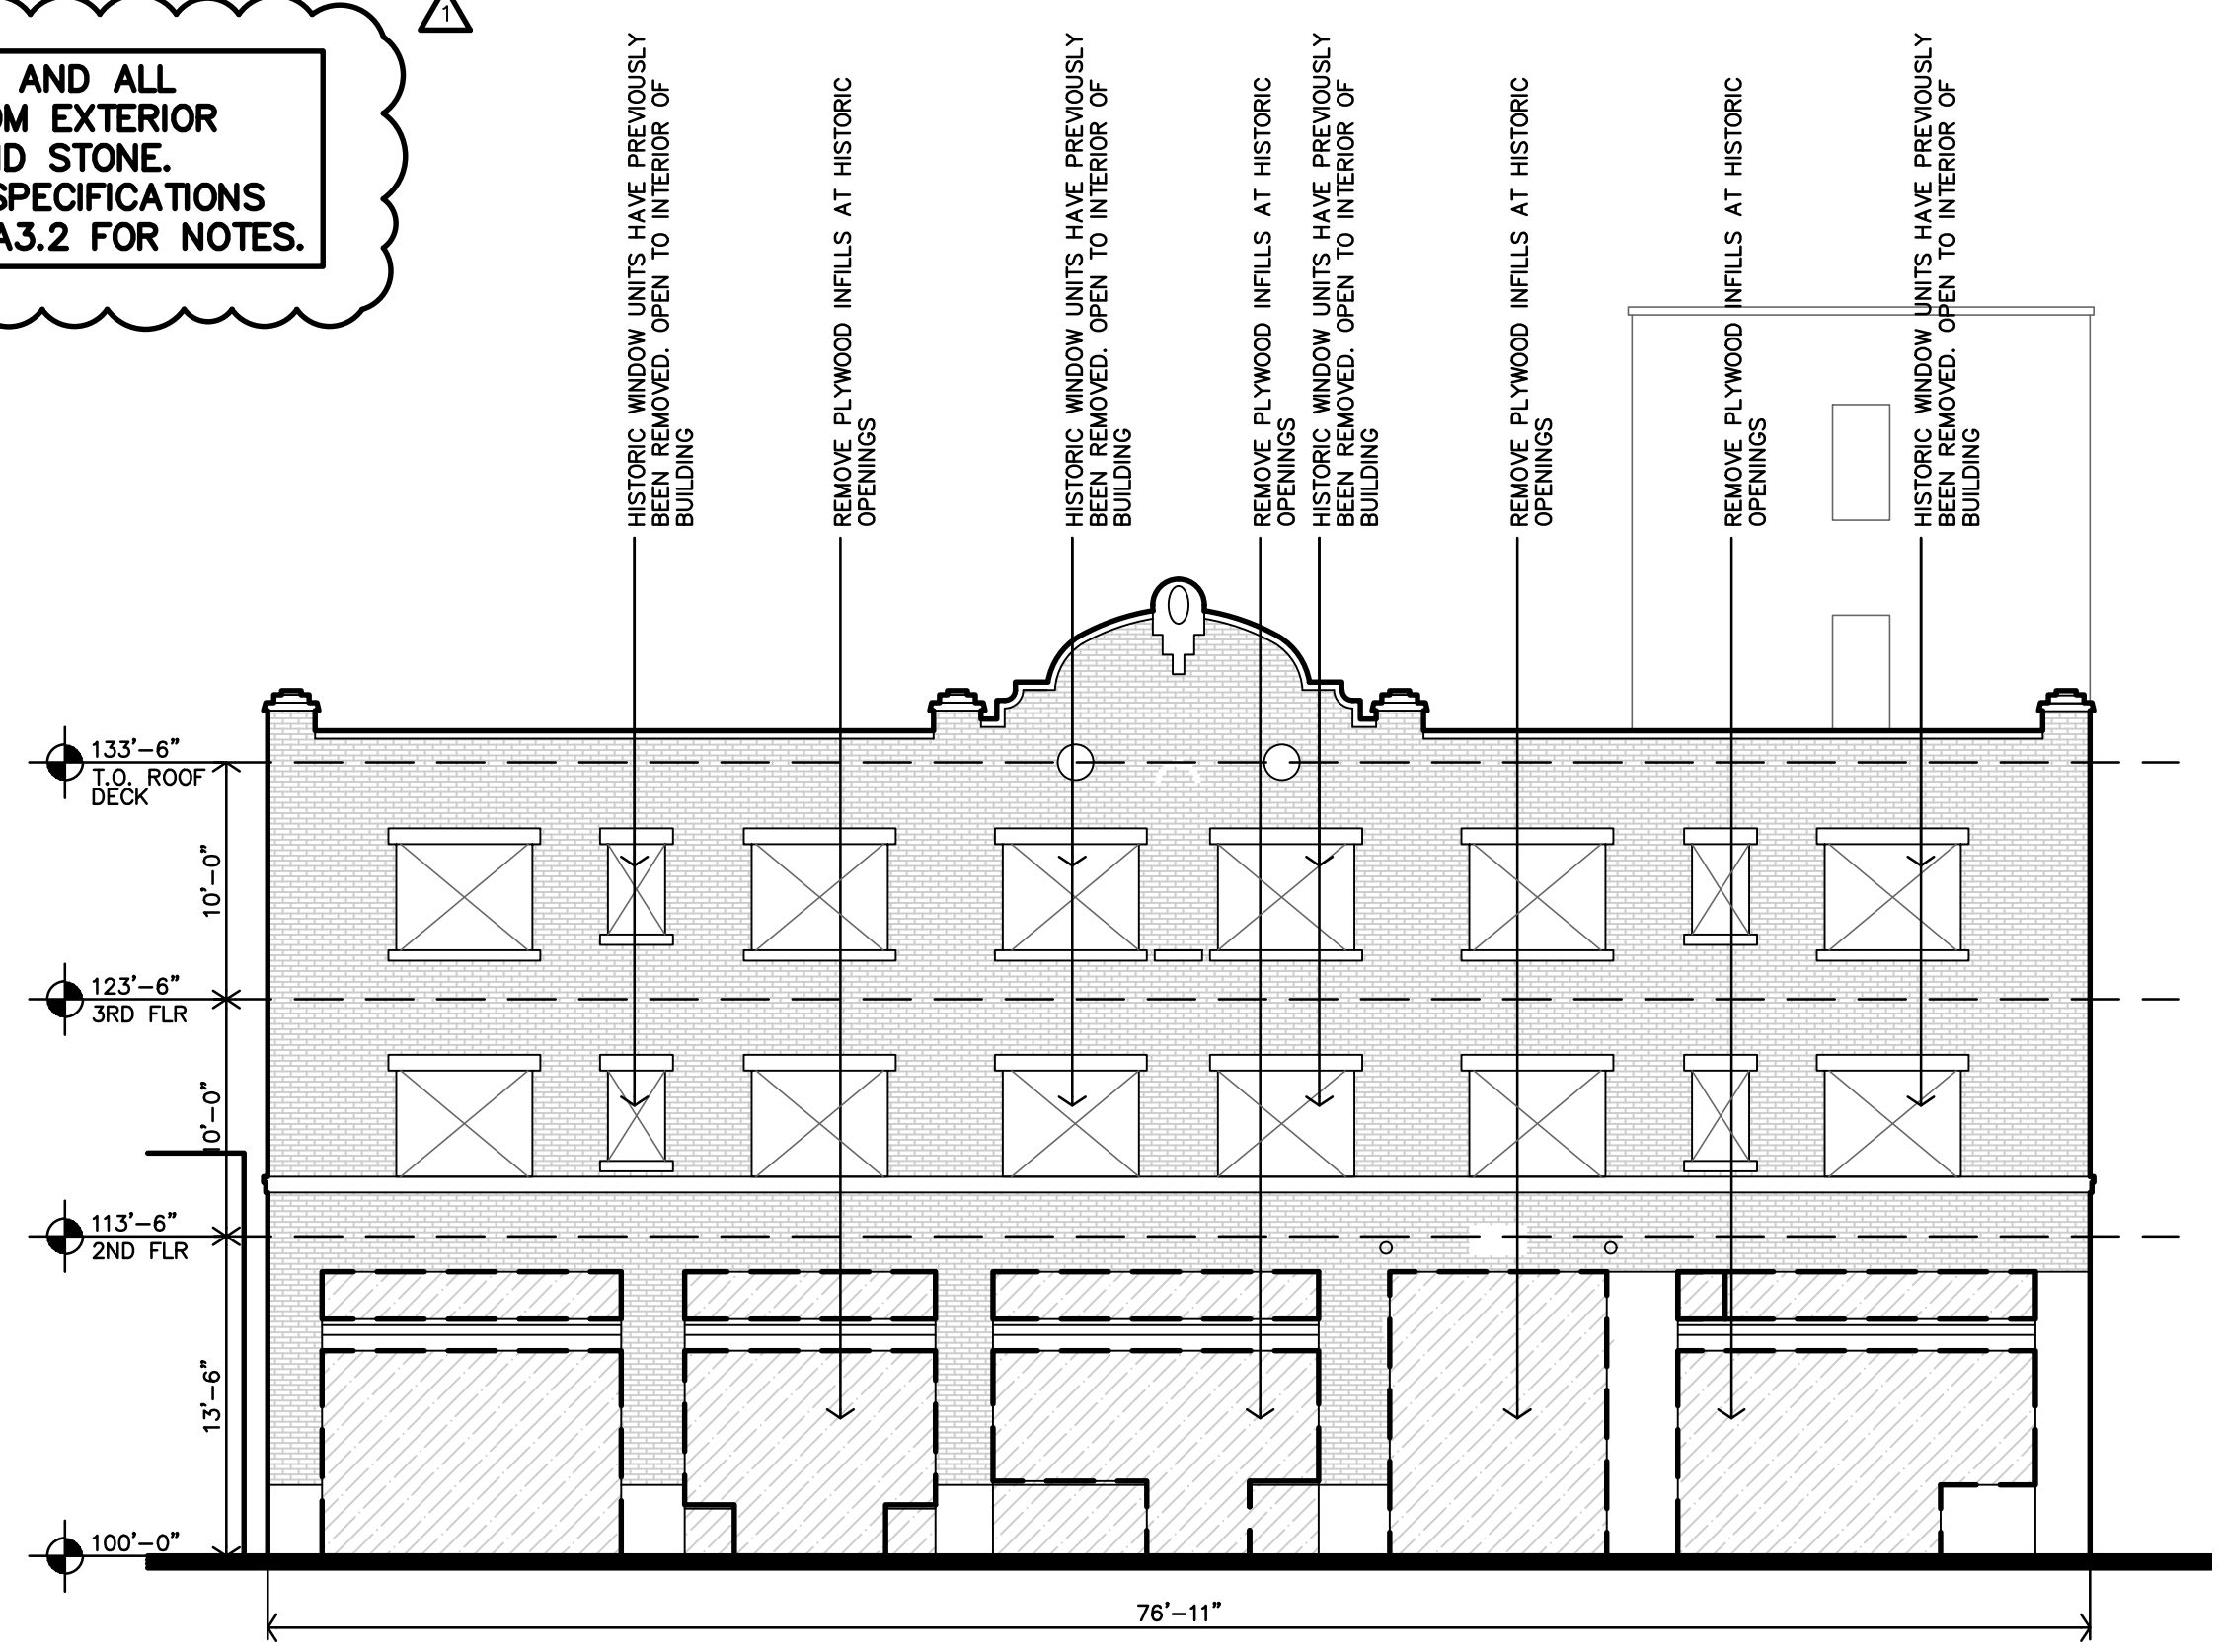
A DEMOLITION WEST ELEVATION
1/8"=1'-0"

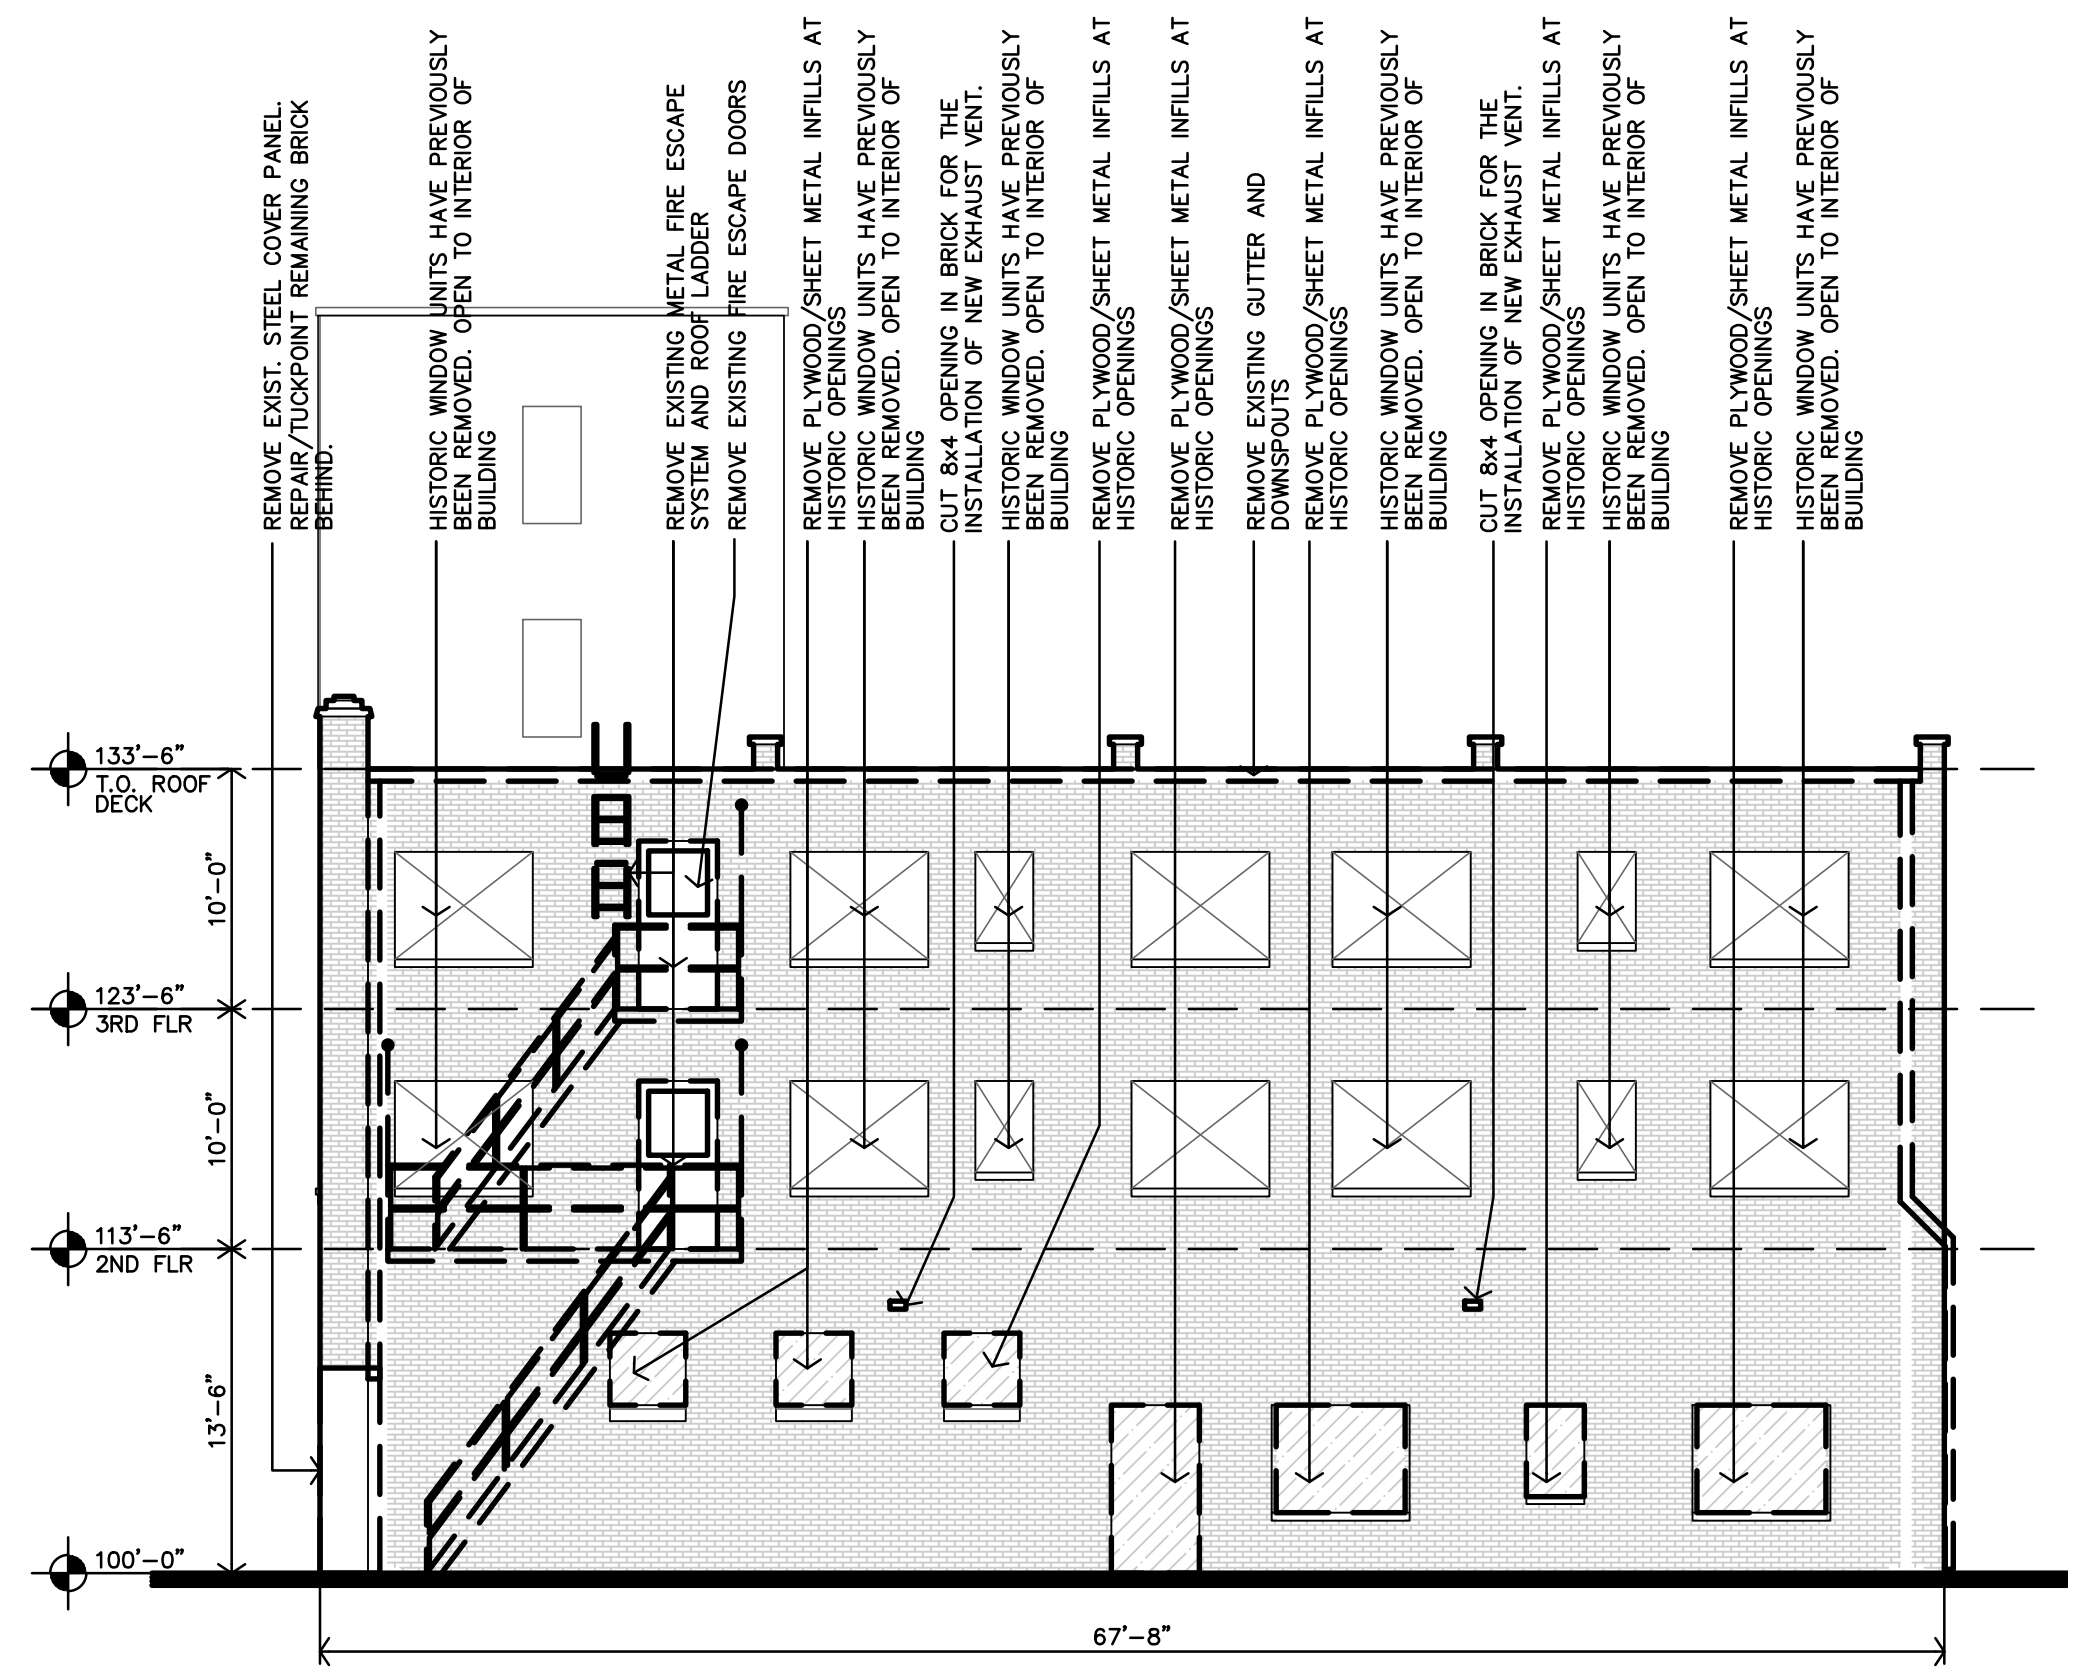
C DEMOLITION EAST ELEVATION
1/8"=1'-0"

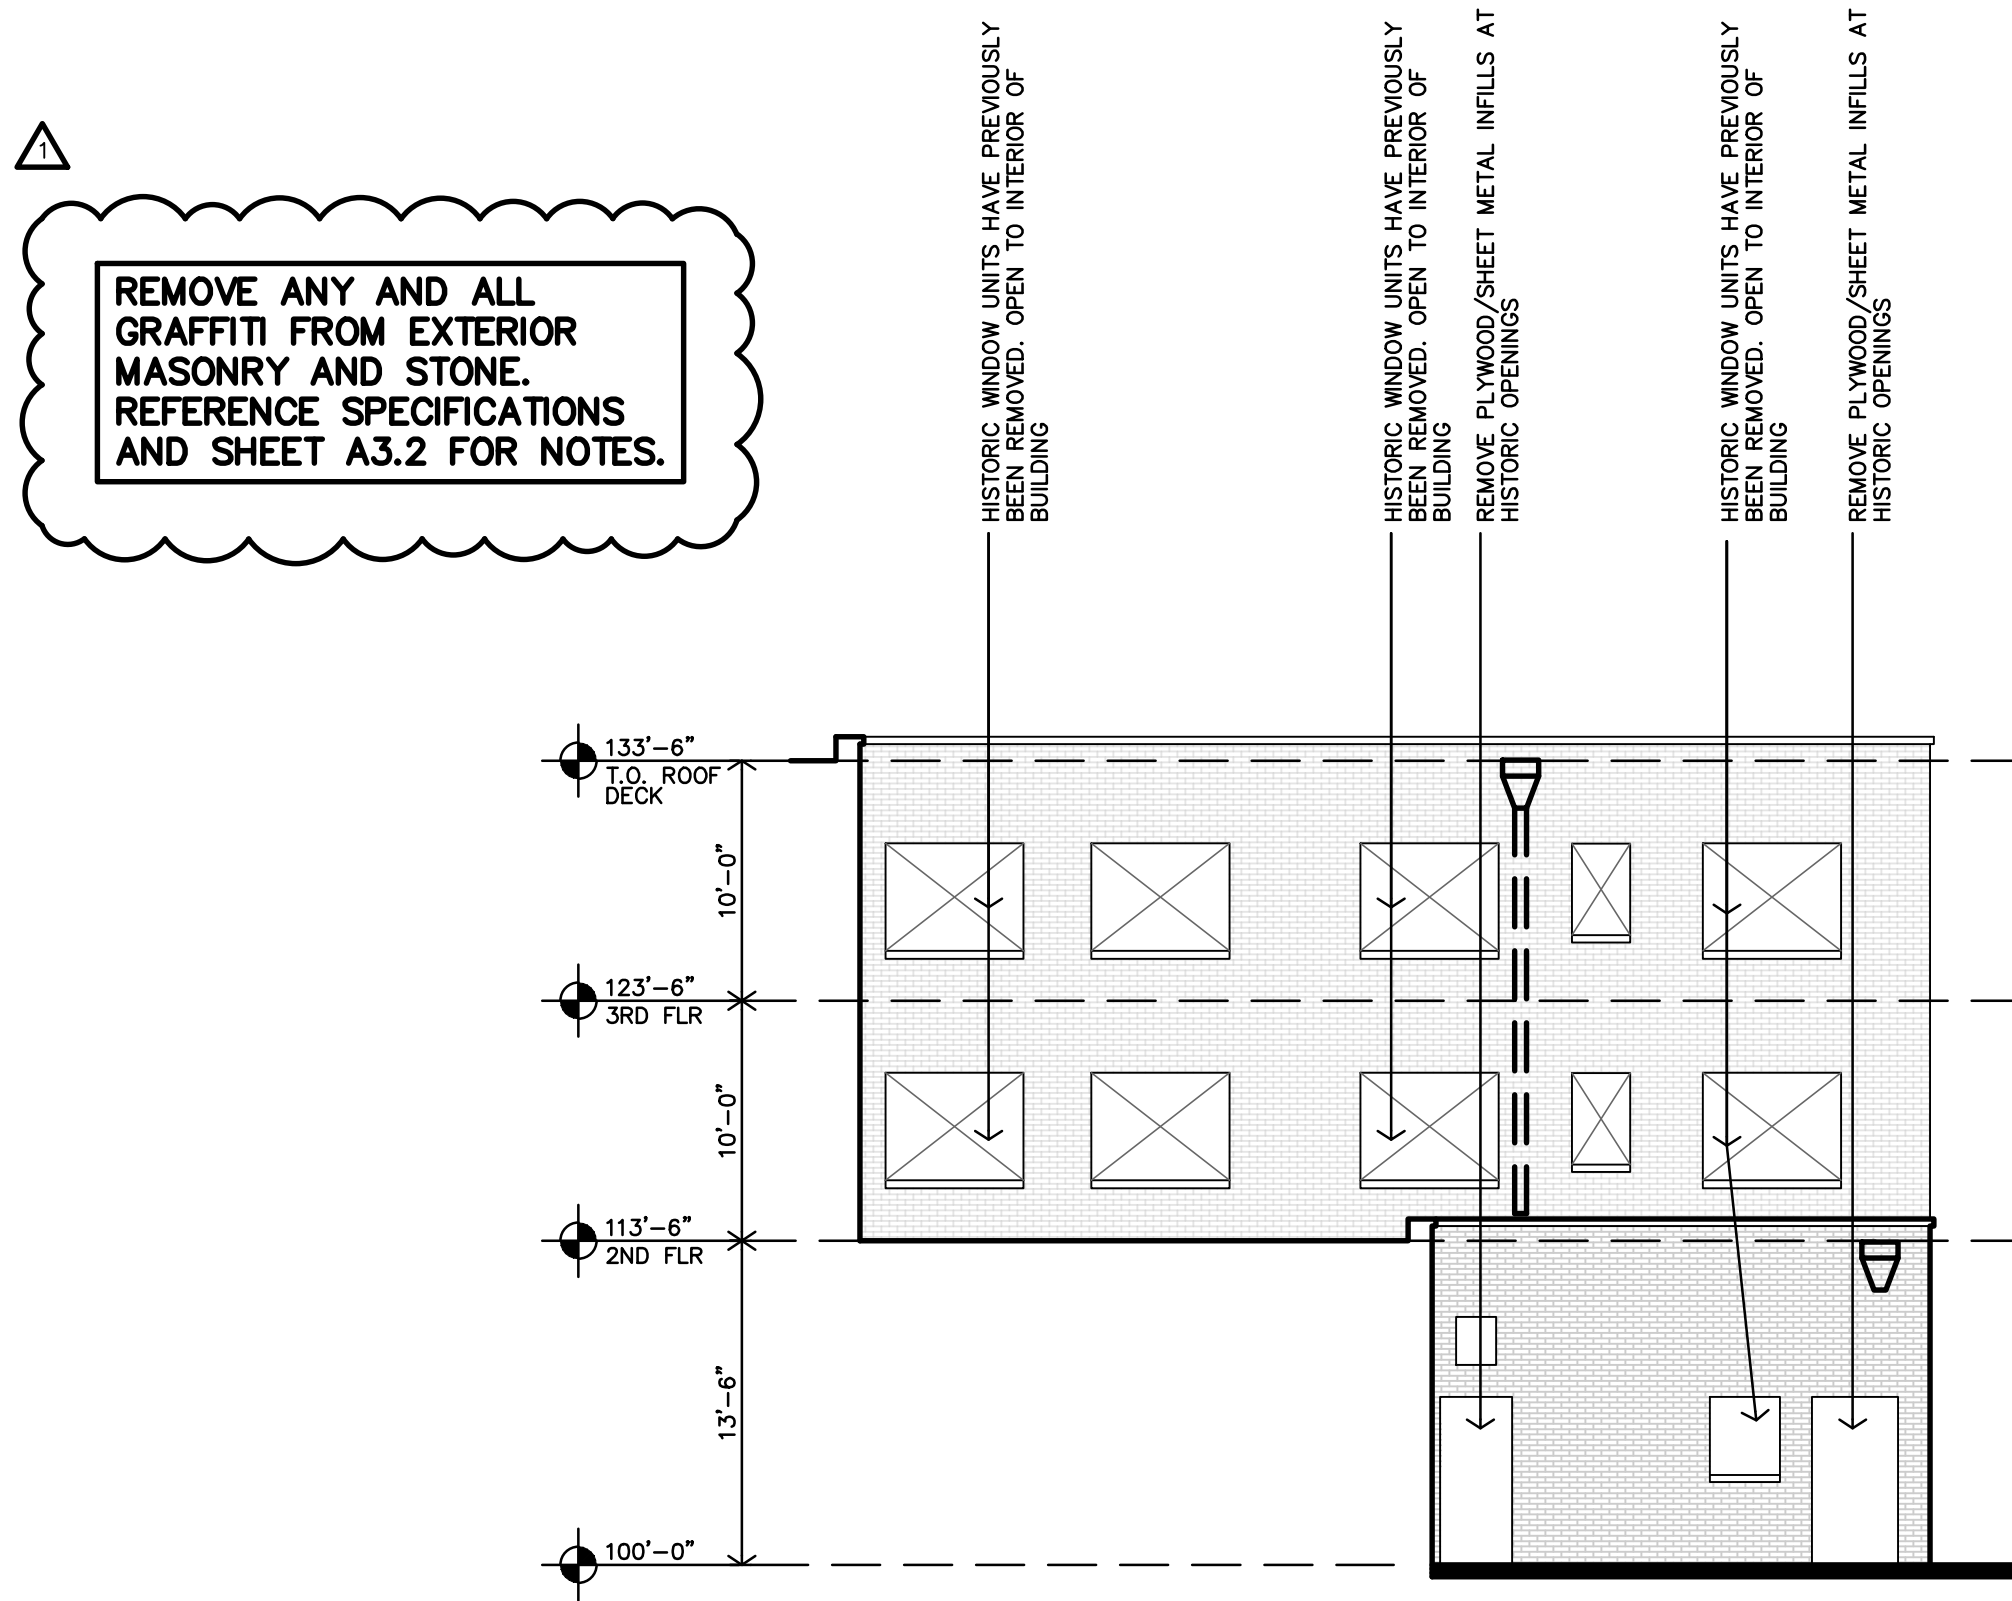
B DEMOLITION EAST ELEVATION
1/8"=1'-0"

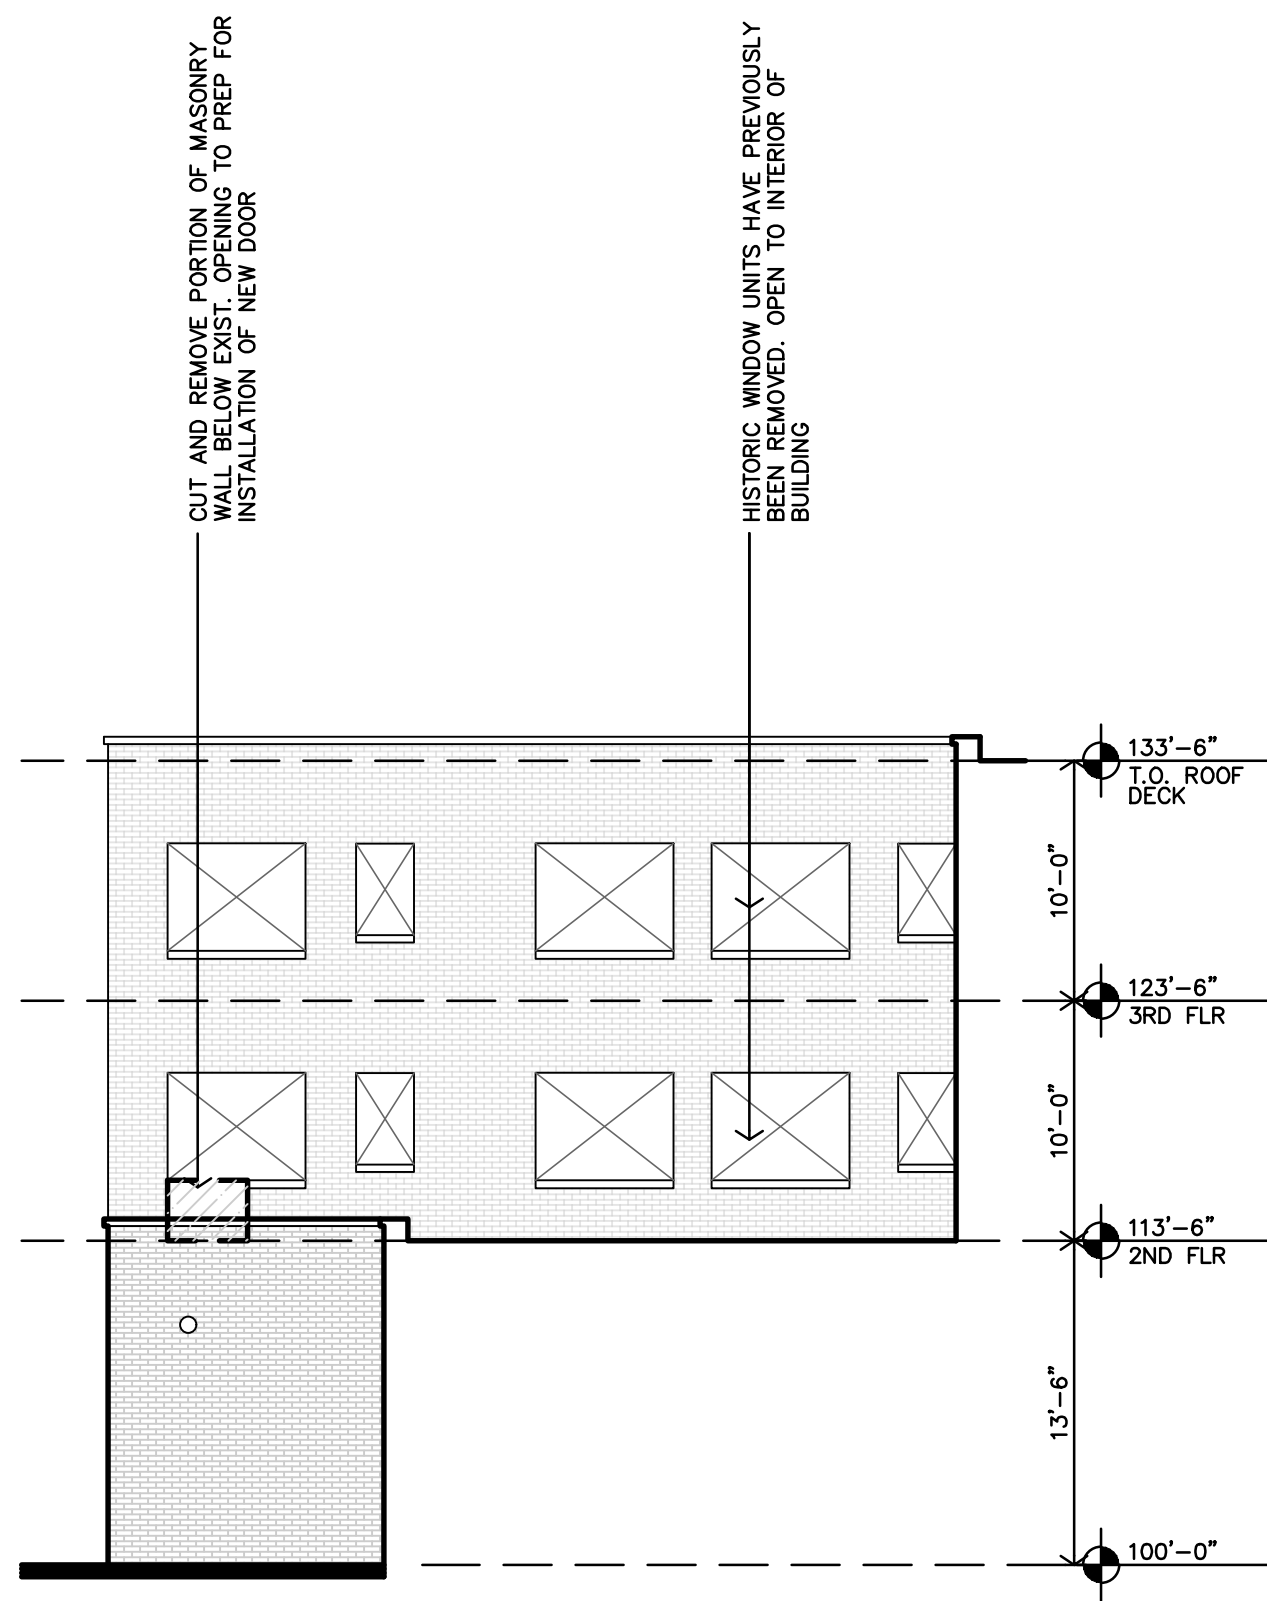
A DEMOLITION WEST ELEVATION
1/8"=1'-0"

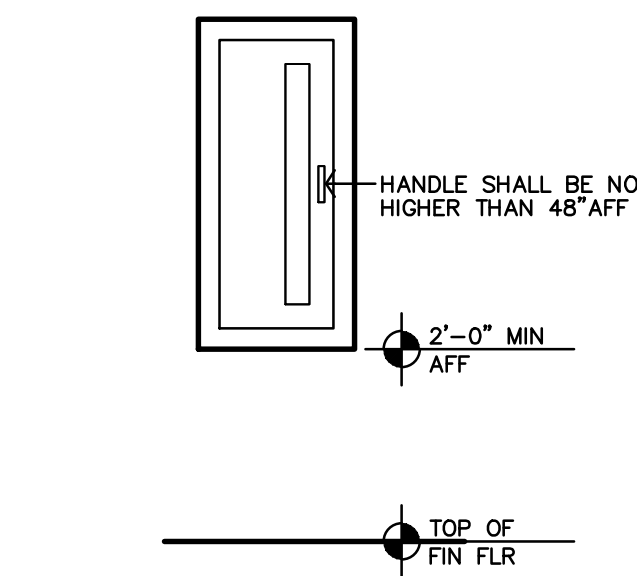
TYPICAL FEC MOUNTING HGT

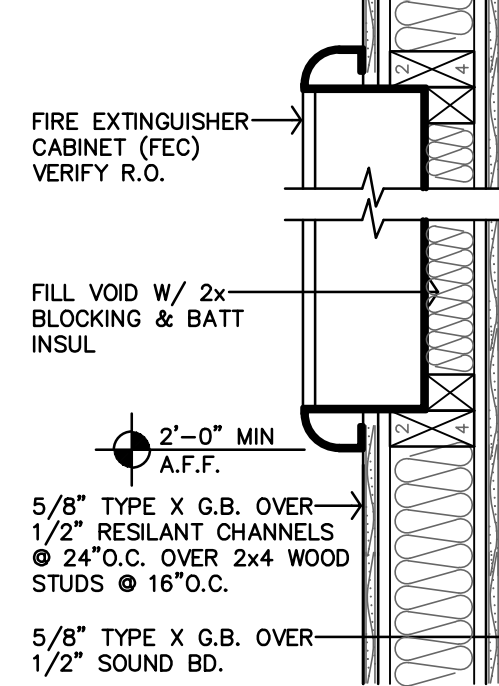
FIRE EXTINGUISHER CABINET DTL @ 1HR WALL

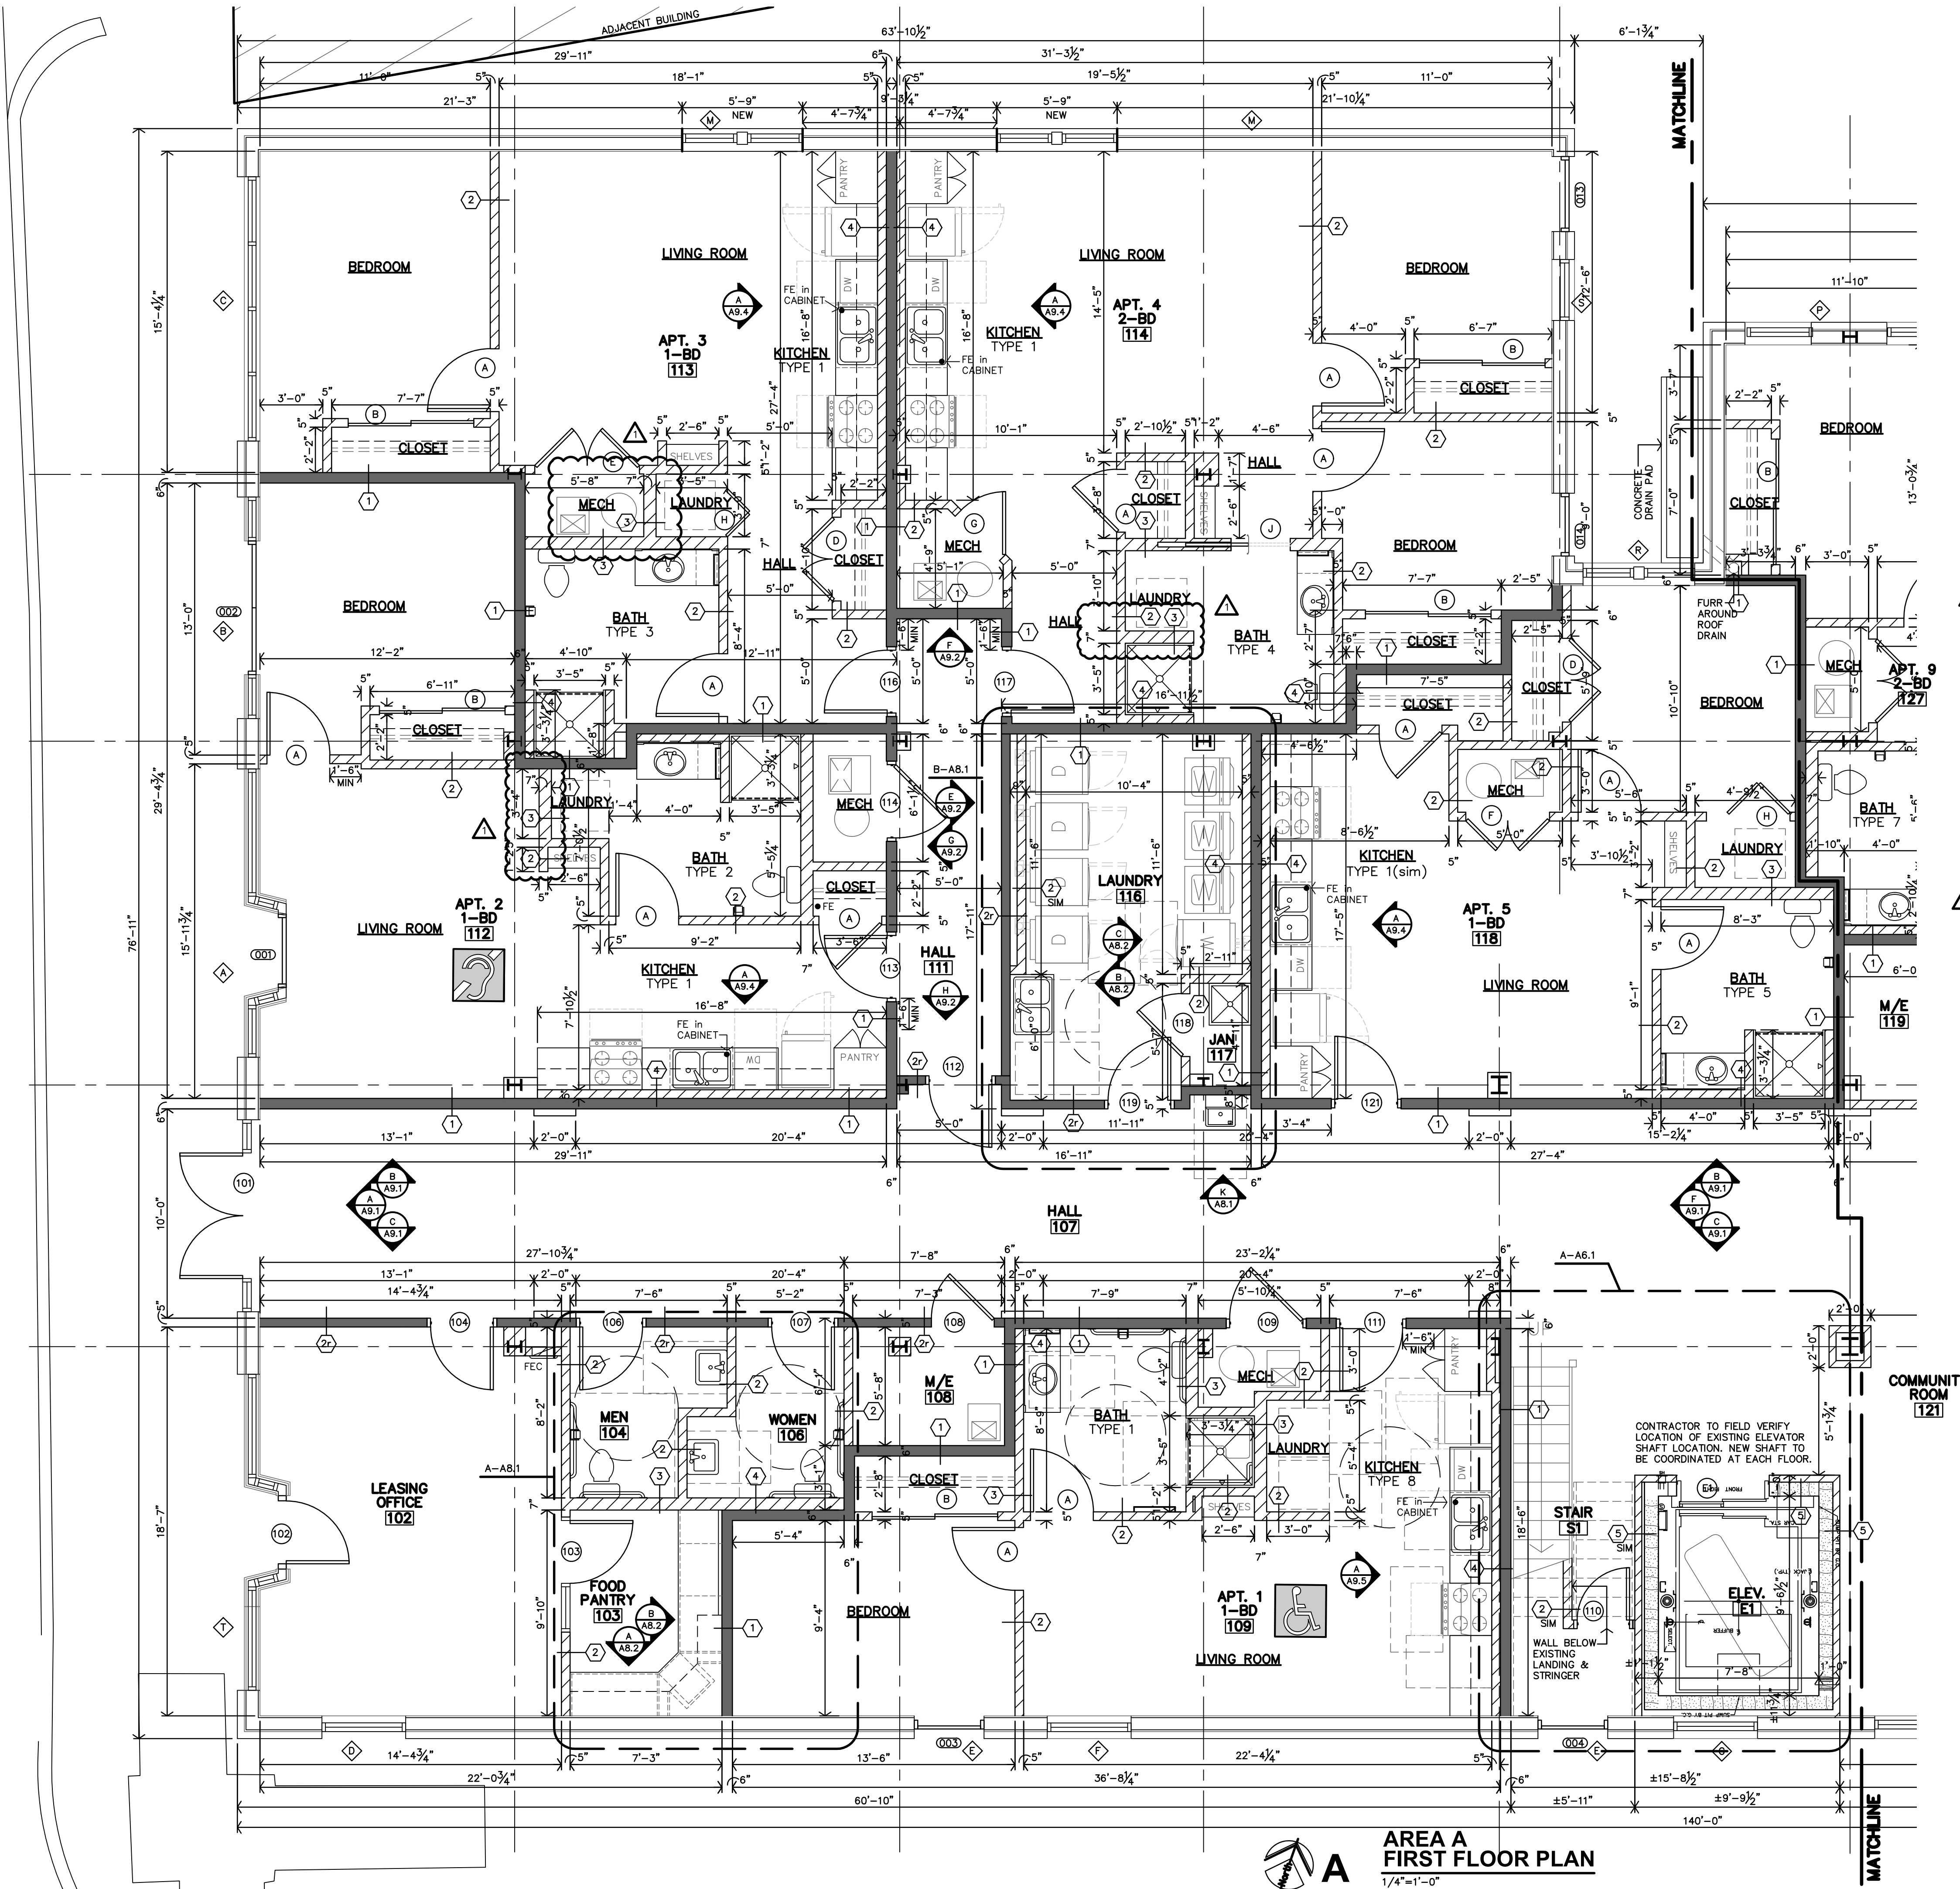
**AREA A
FIRST FLOOR PLAN**
1/4"=1'-0"
