Jones Gillam Renz Architects

Roosevelt Lofts – Historic Rehabilitation & New Apartments – 22-3281

ADDENDUM NO. 1

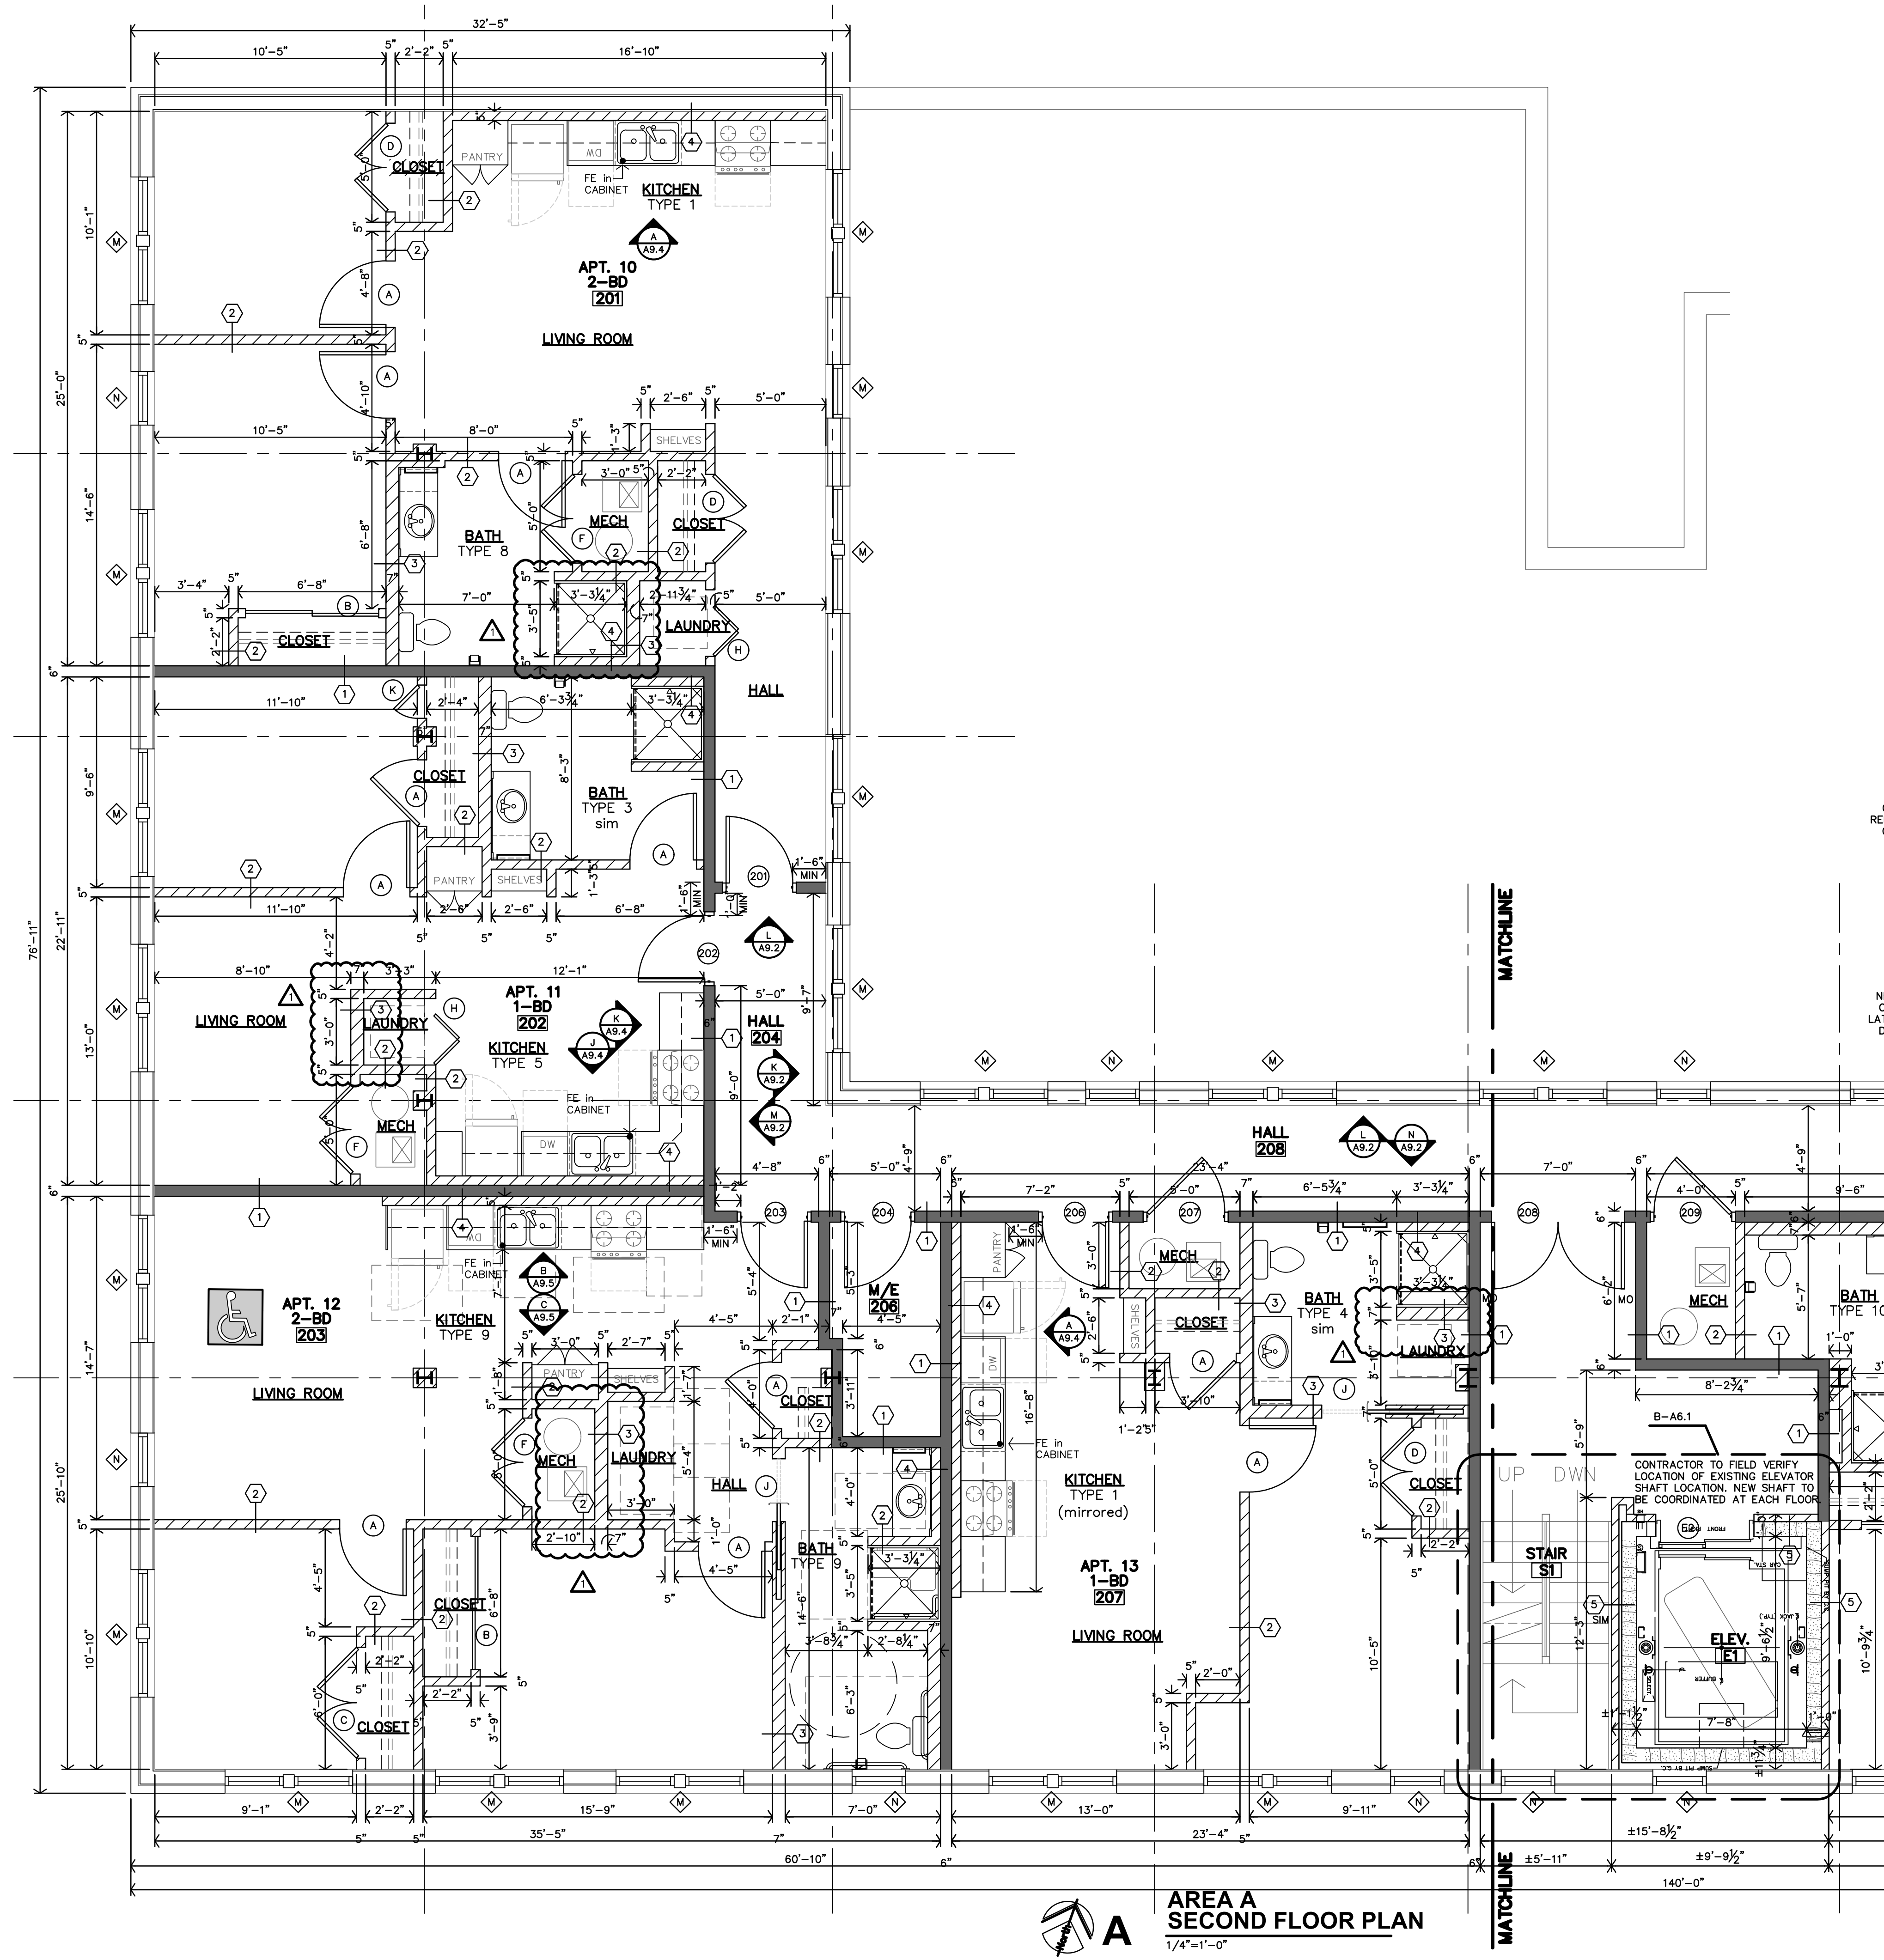
**AREA A
SECOND FLOOR PLAN**
1/4"=1'-0"

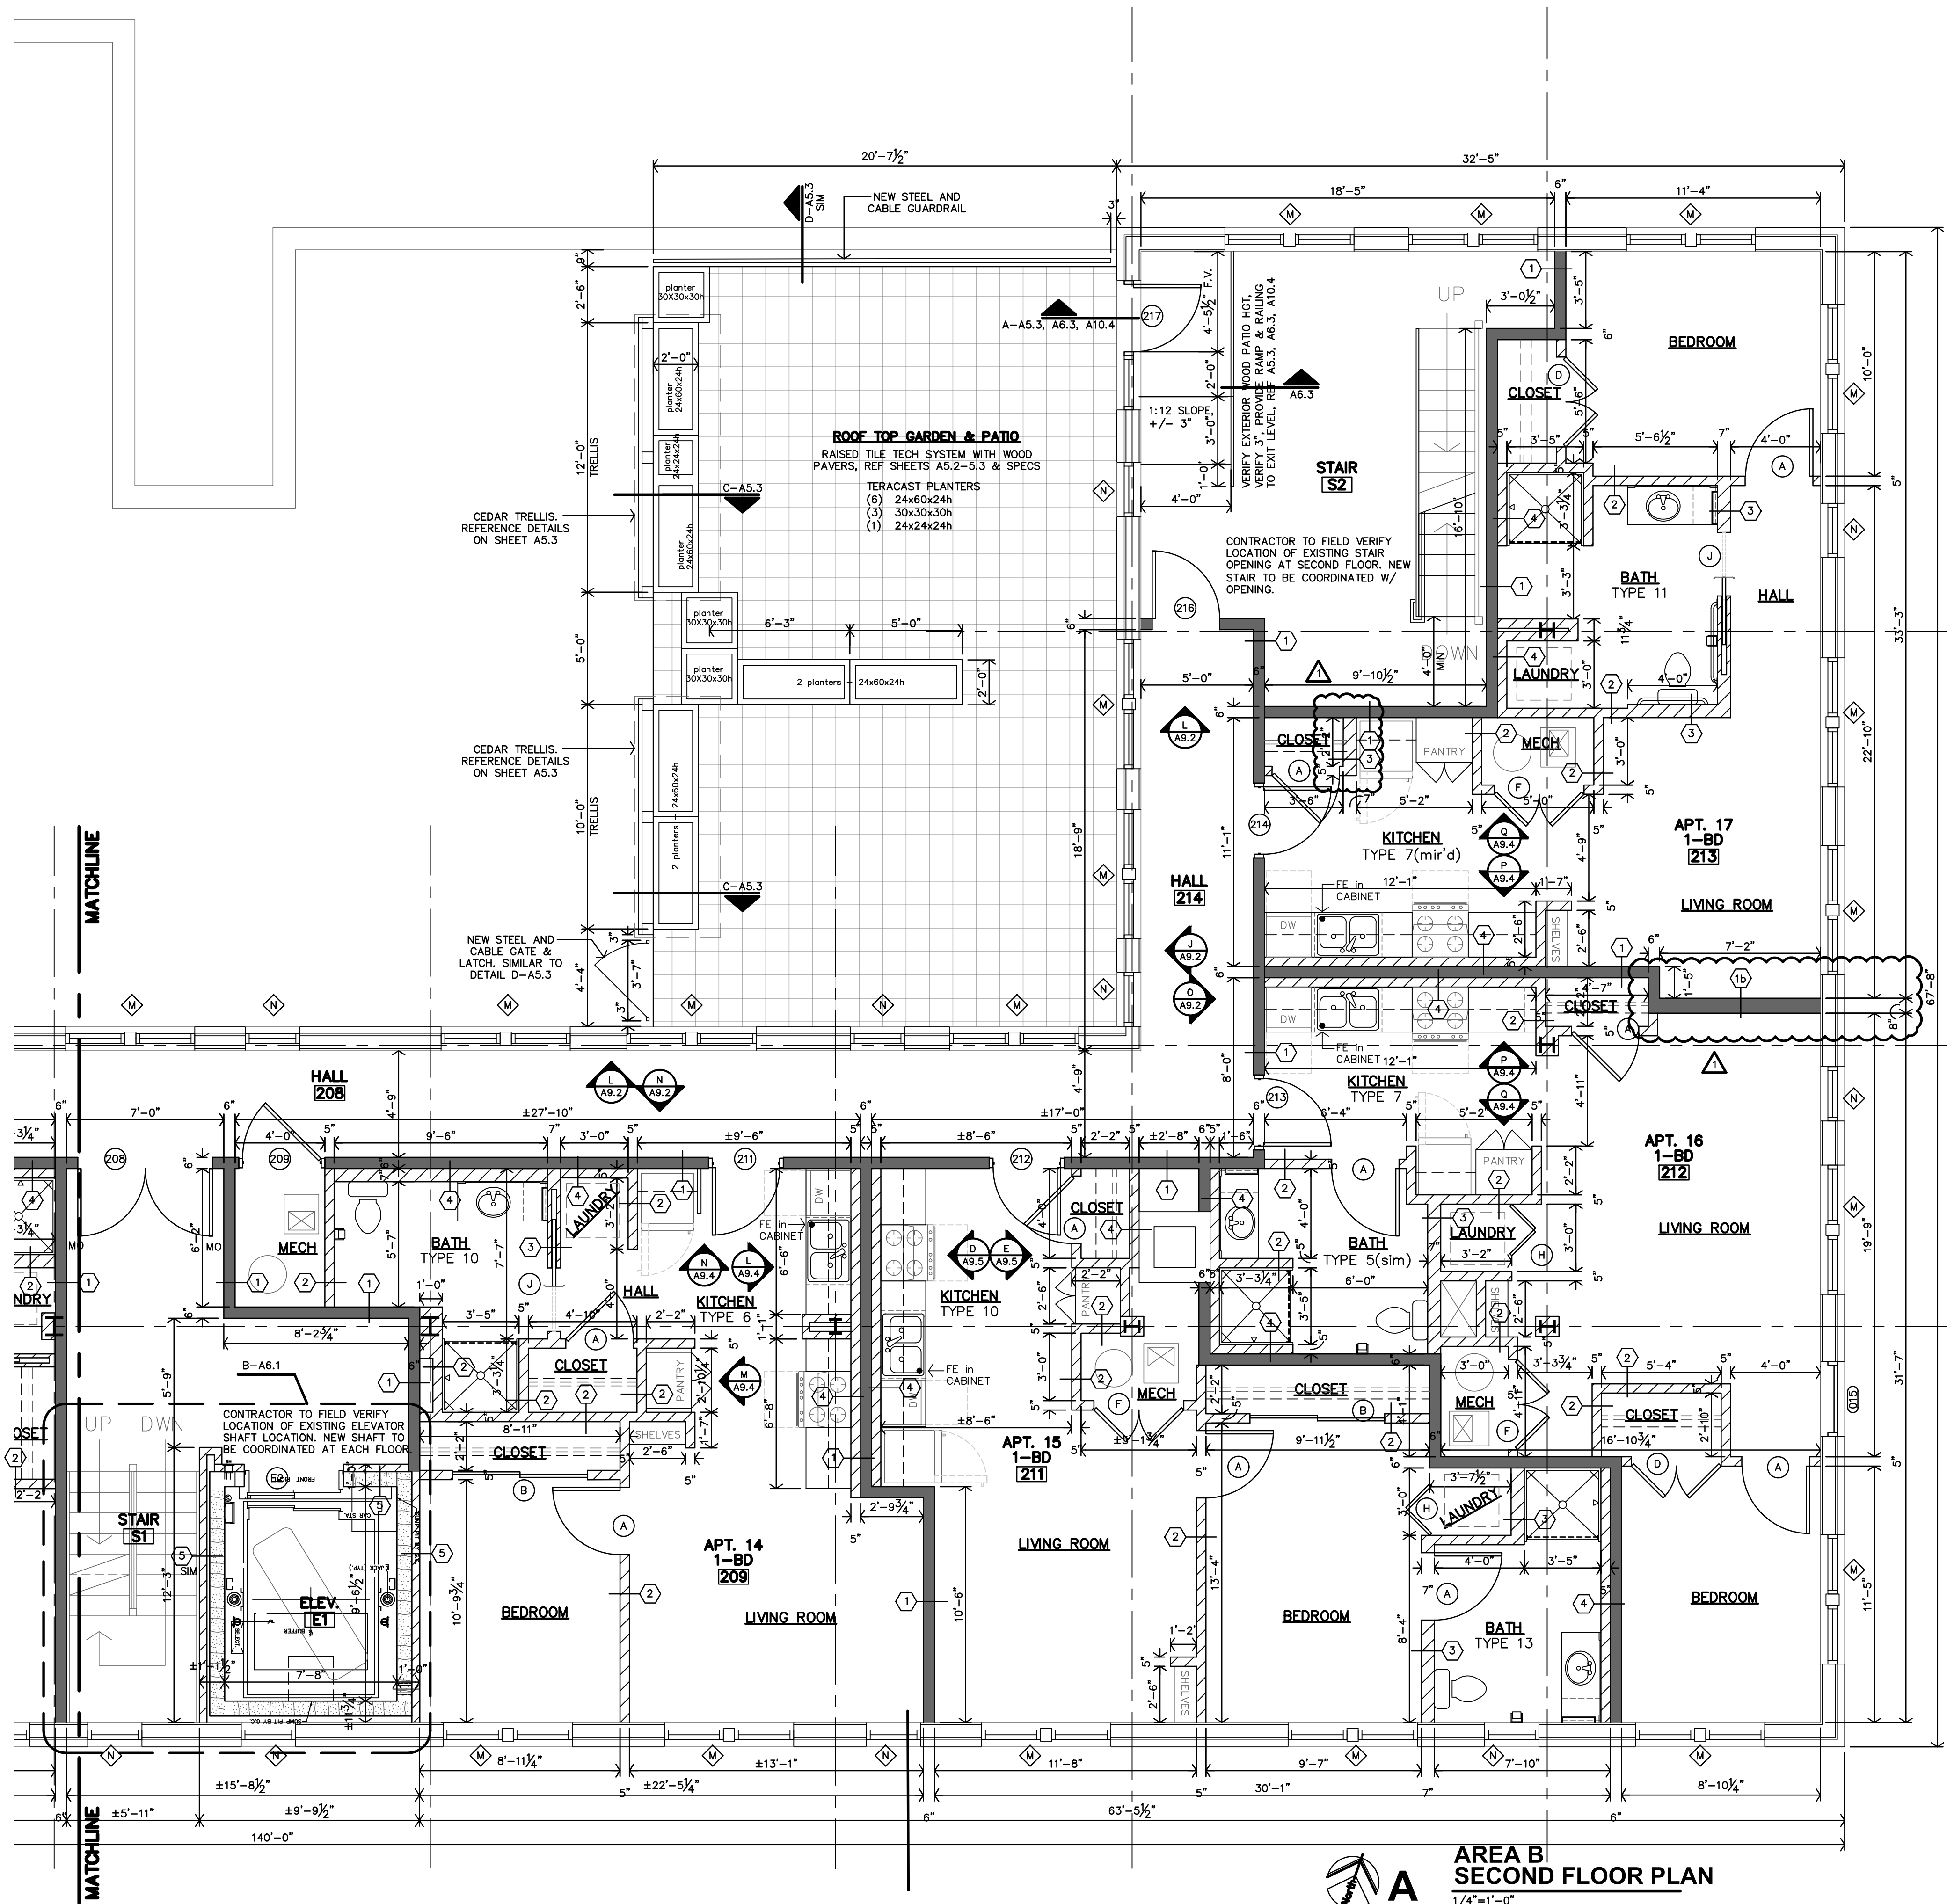
**AREA B
SECOND FLOOR PLAN**
1/4"=1'-0"

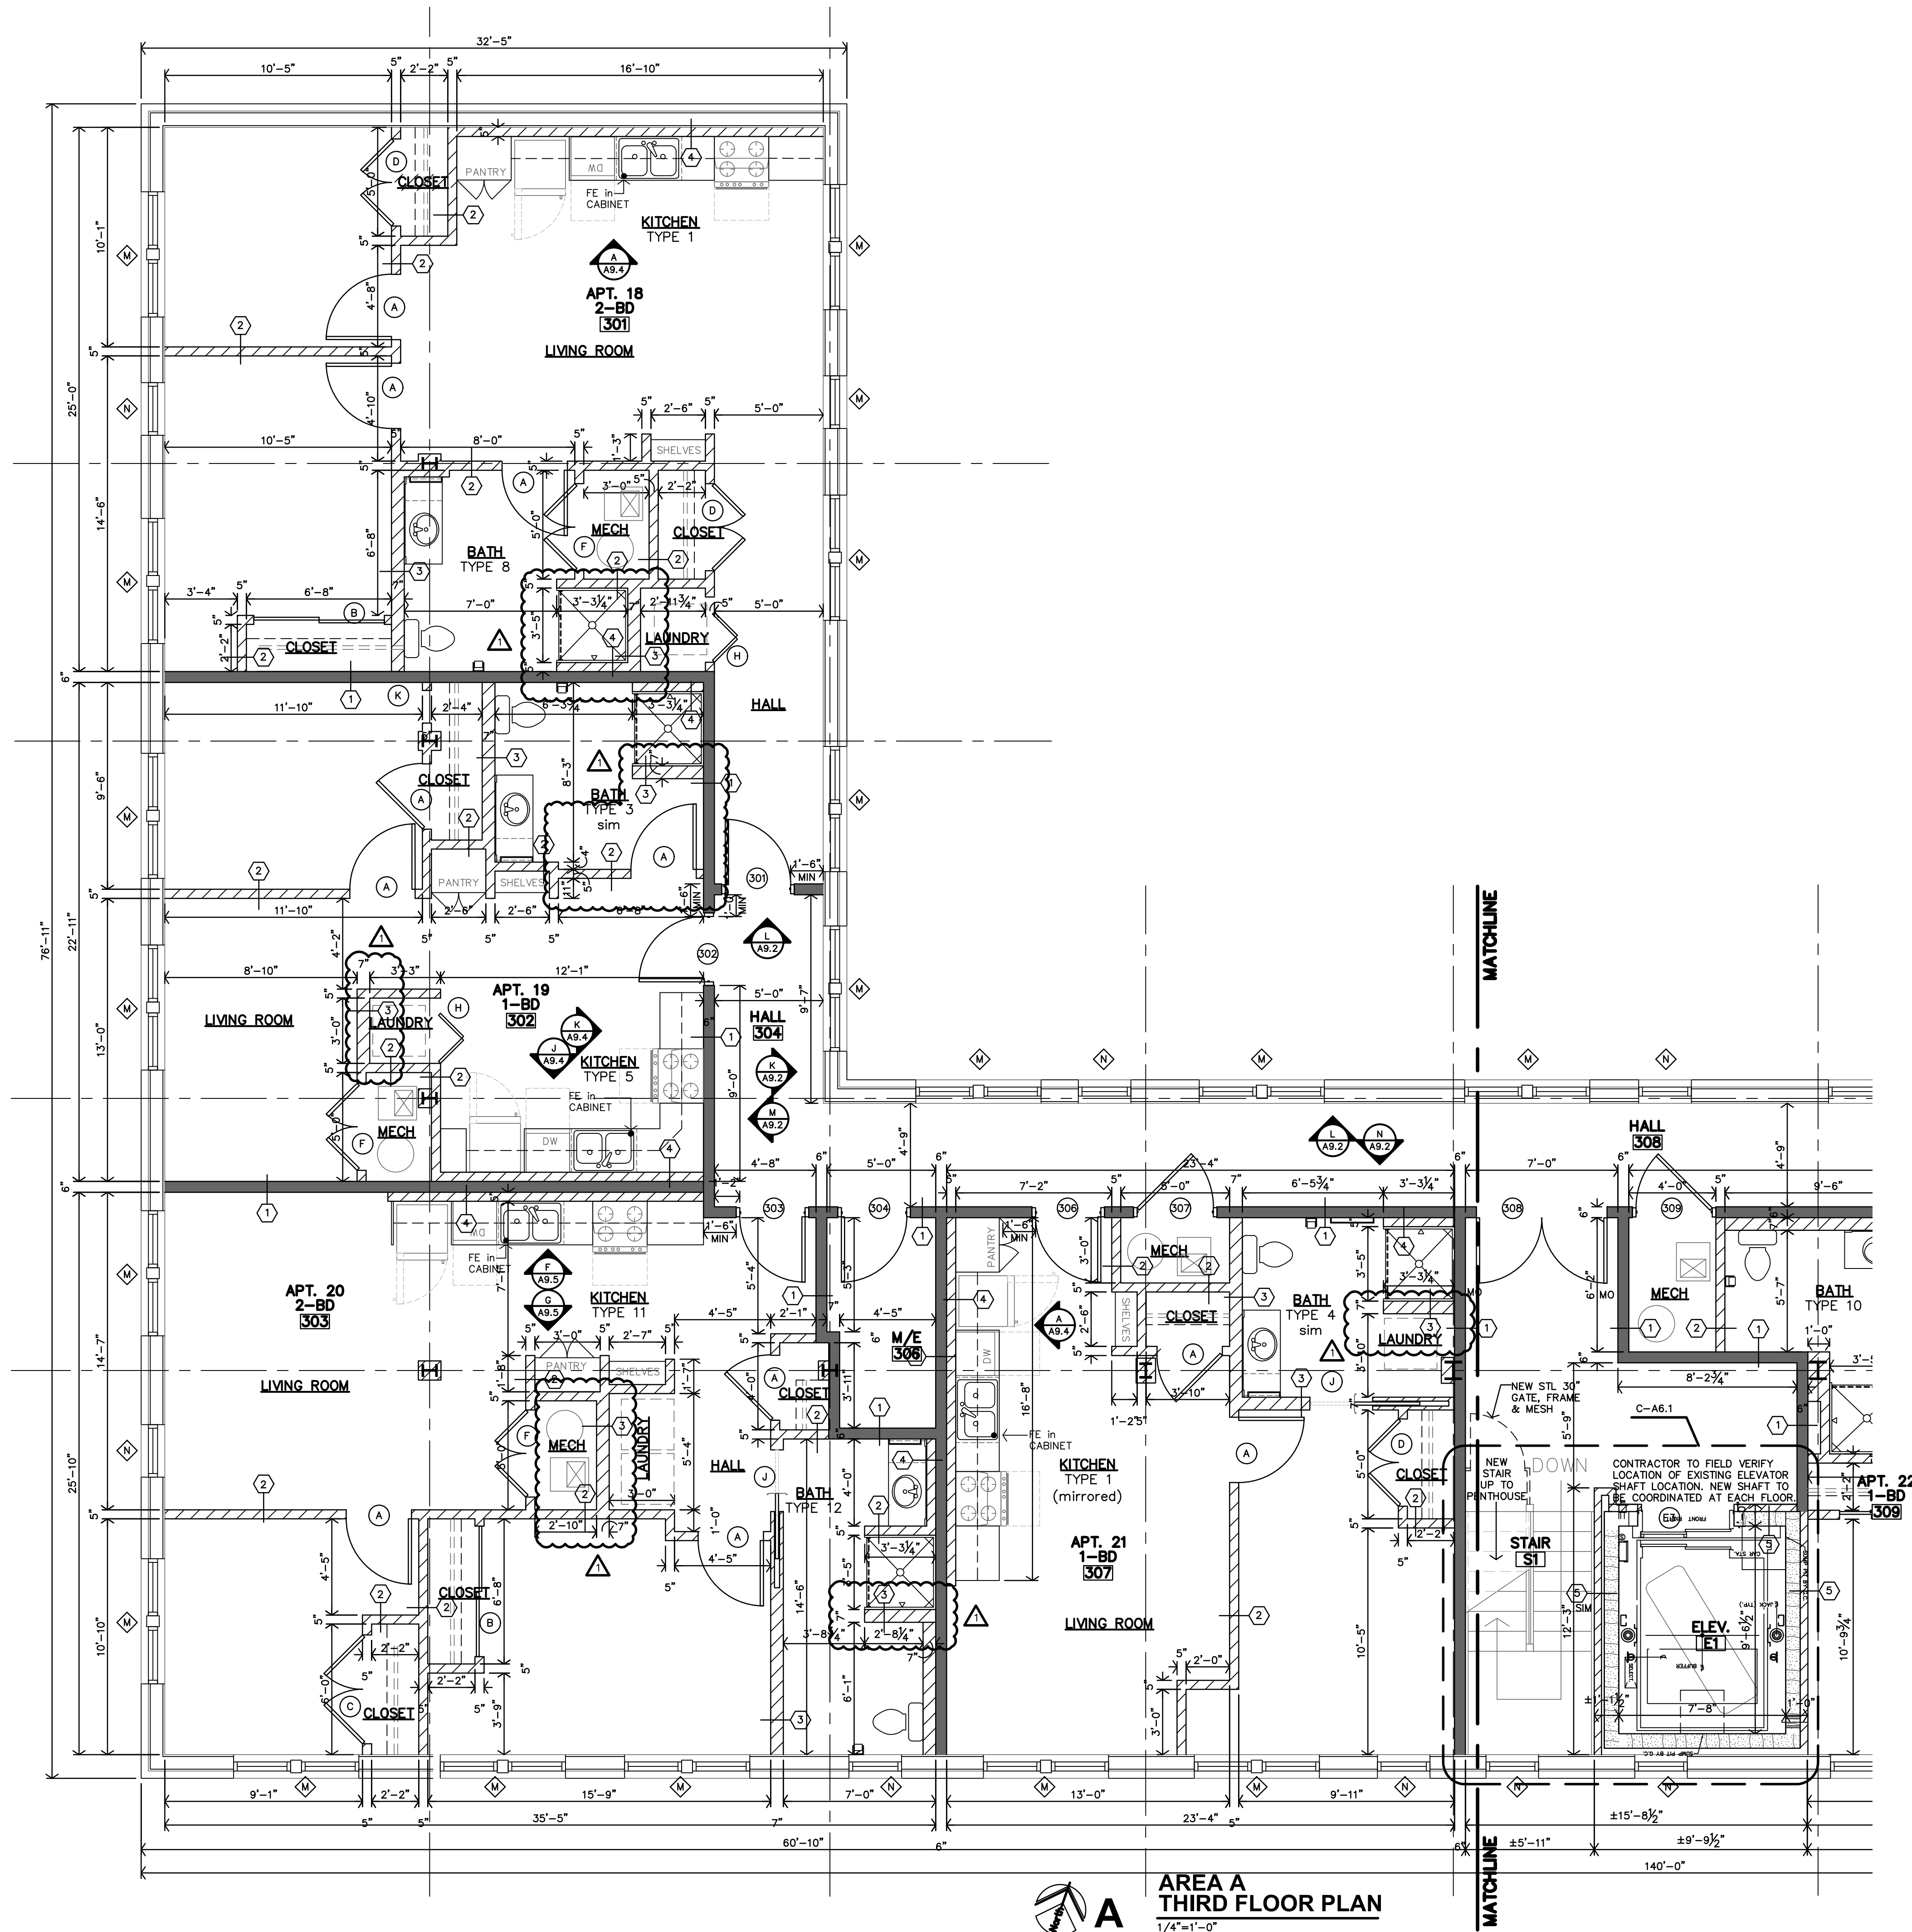
**AREA A
THIRD FLOOR PLAN**
1/4"=1'-0"

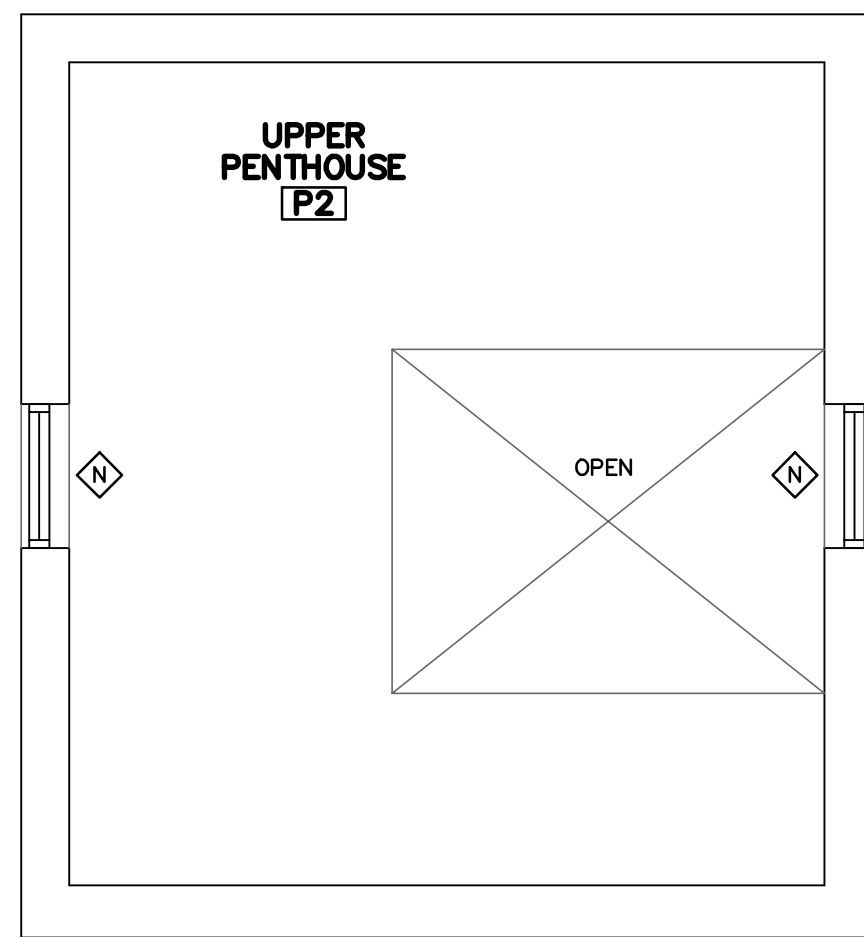
UPPER PENTHOUSE PLAN
1/4"=1'-0"

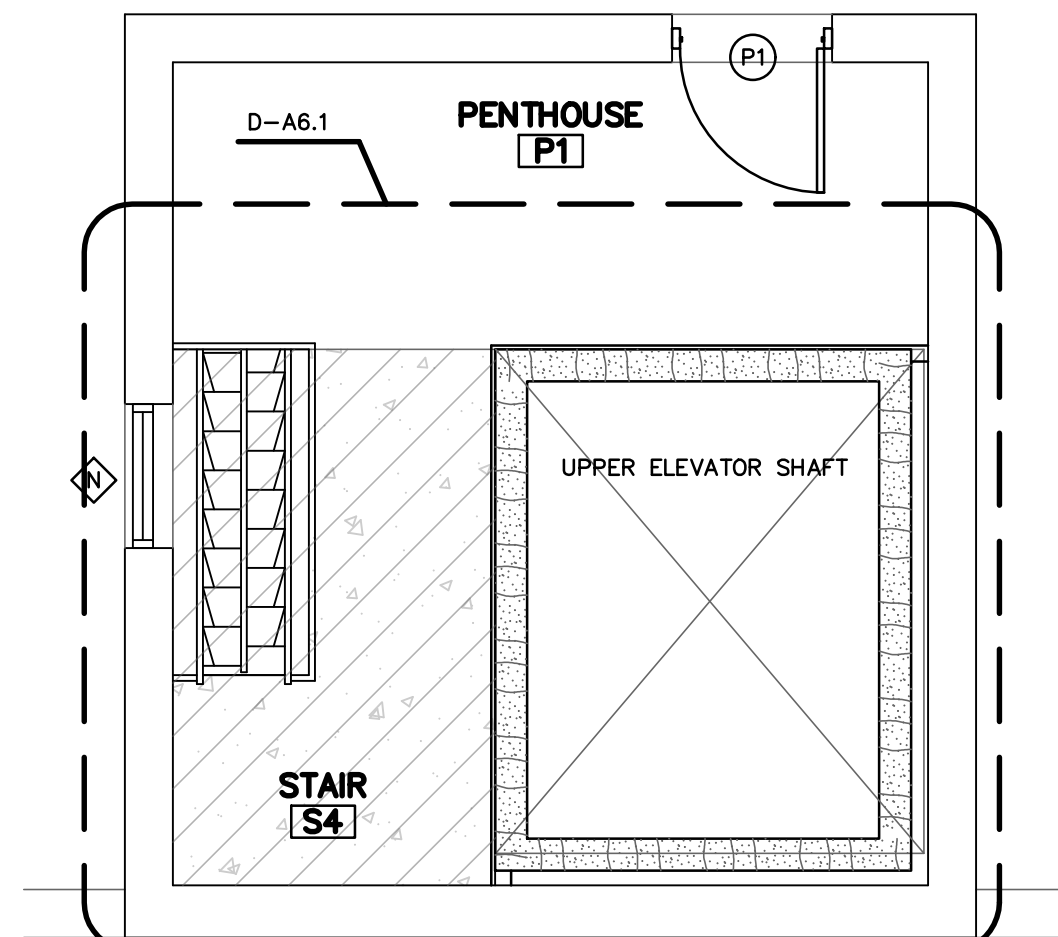
PENTHOUSE PLAN
1/4"=1'-0"

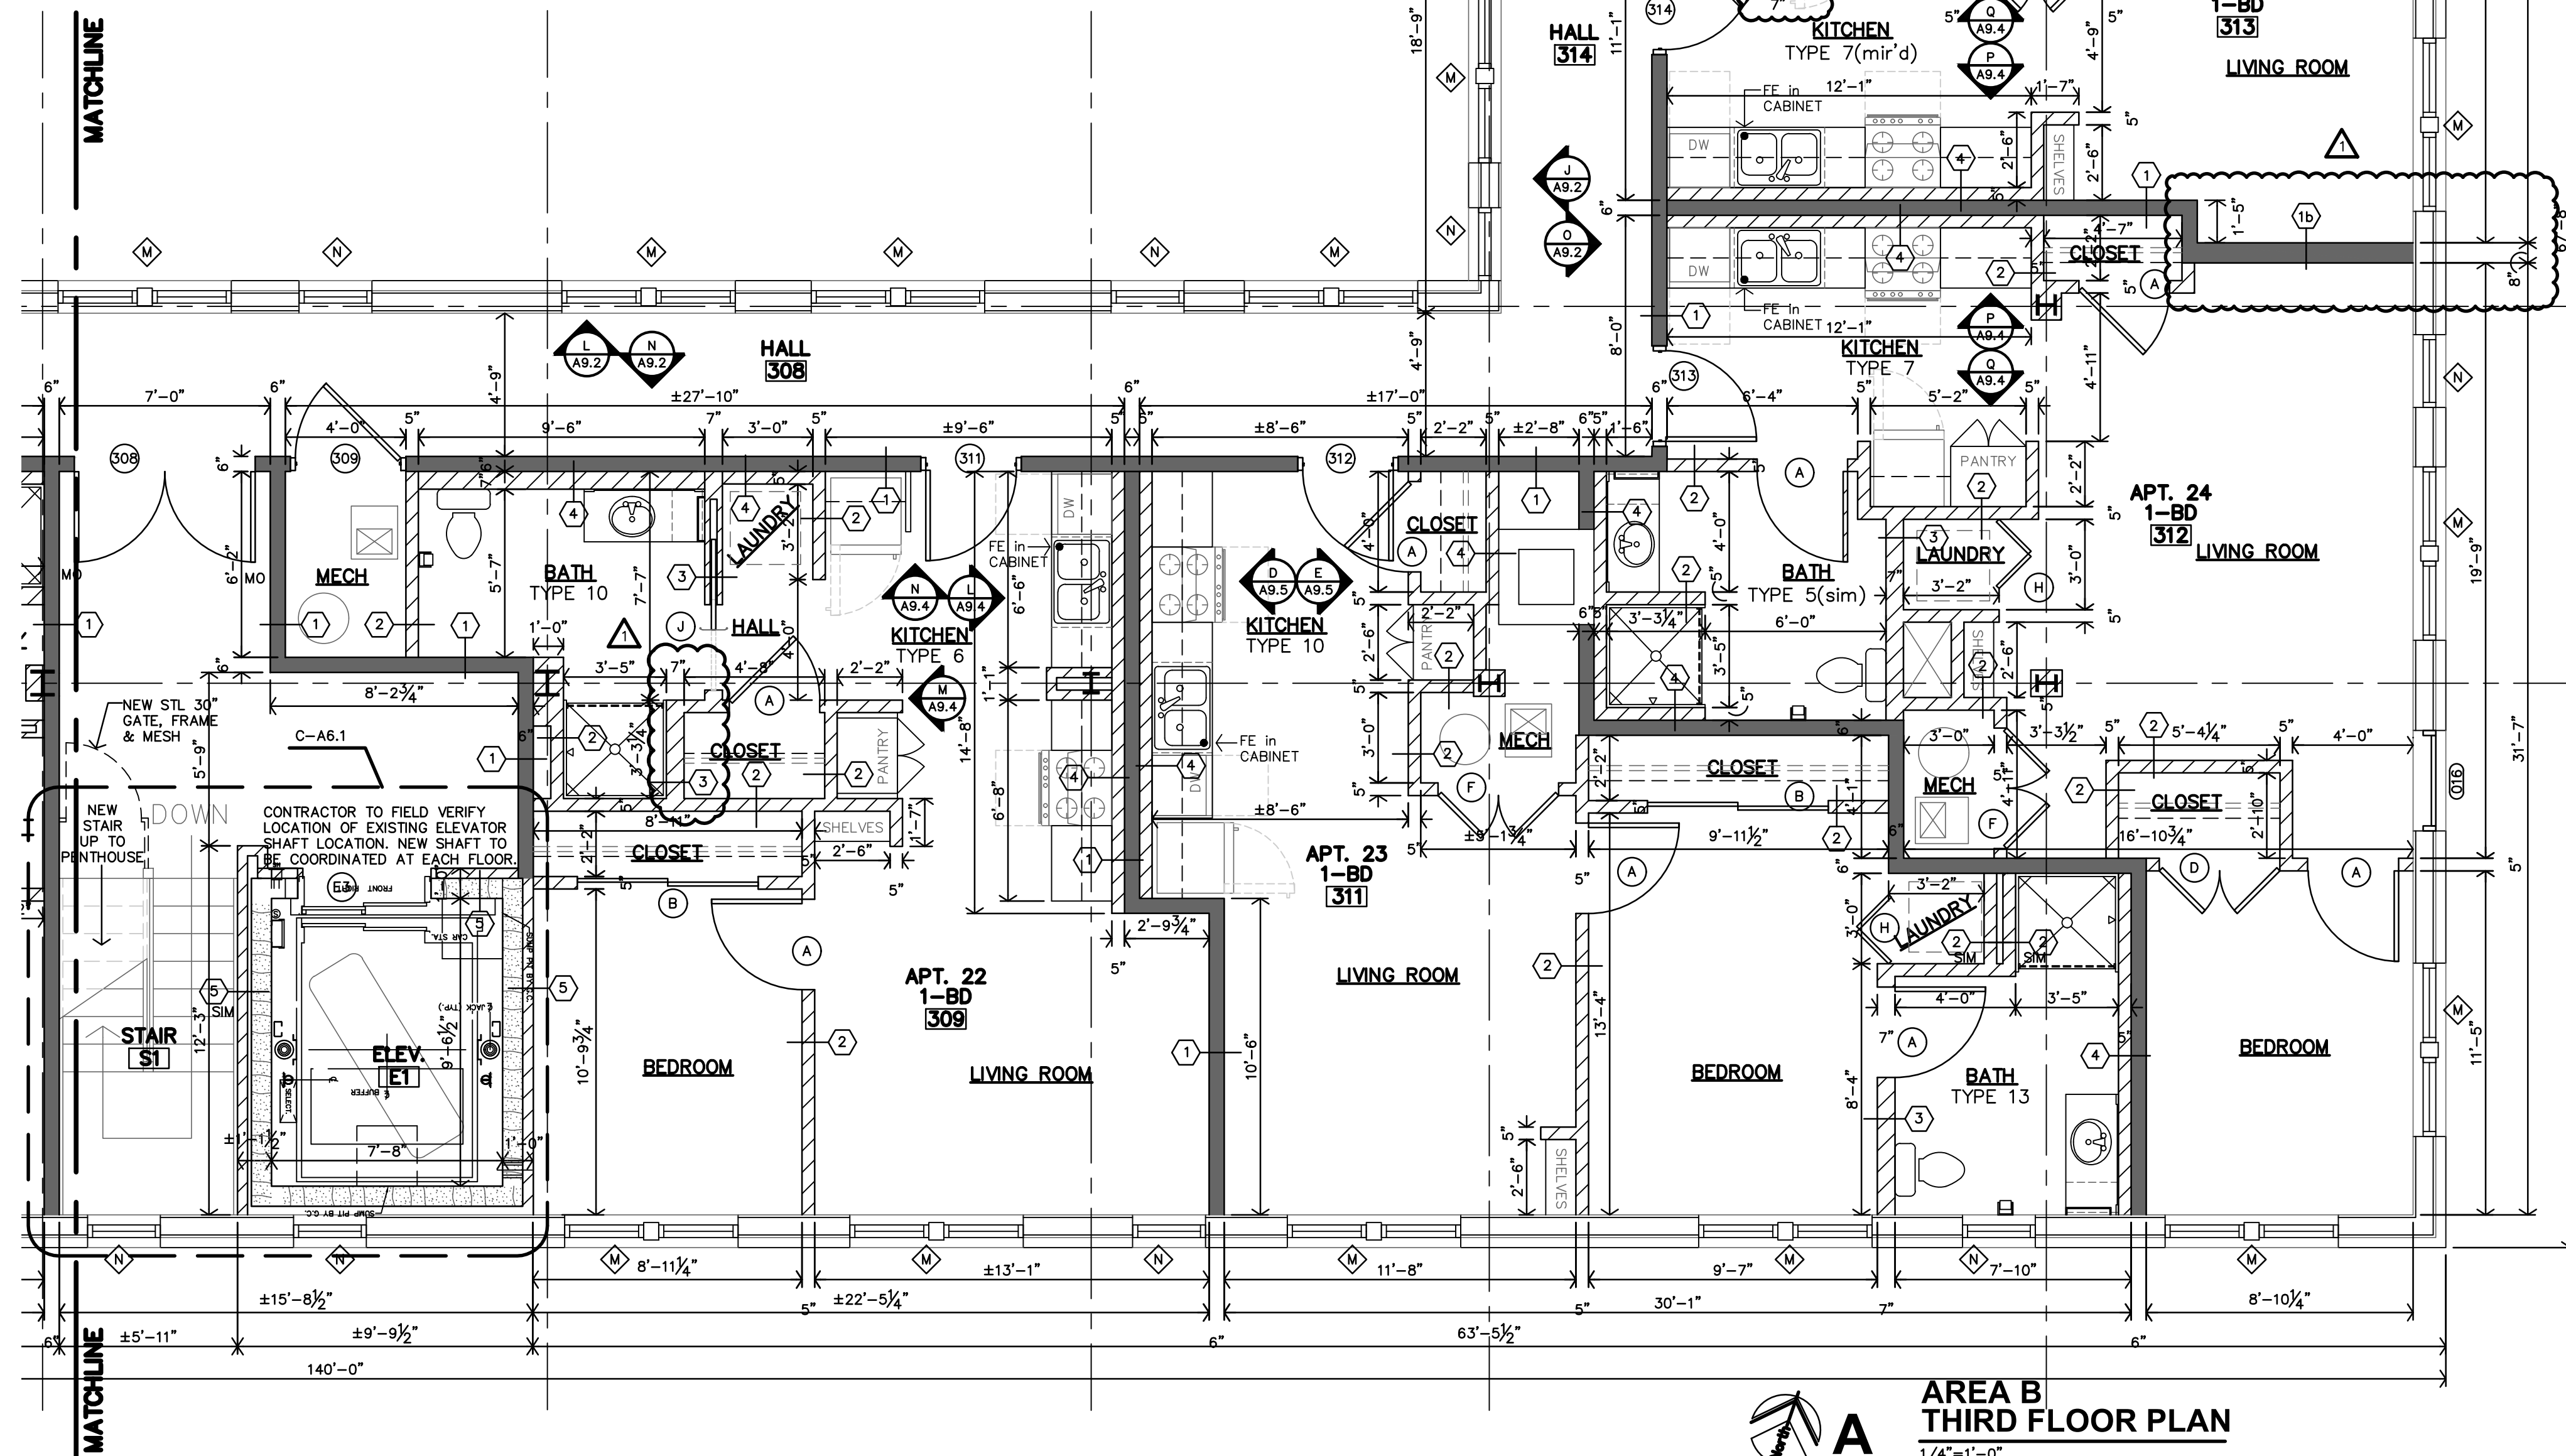
**AREA B
THIRD FLOOR PLAN**
1/4"=1'-0"

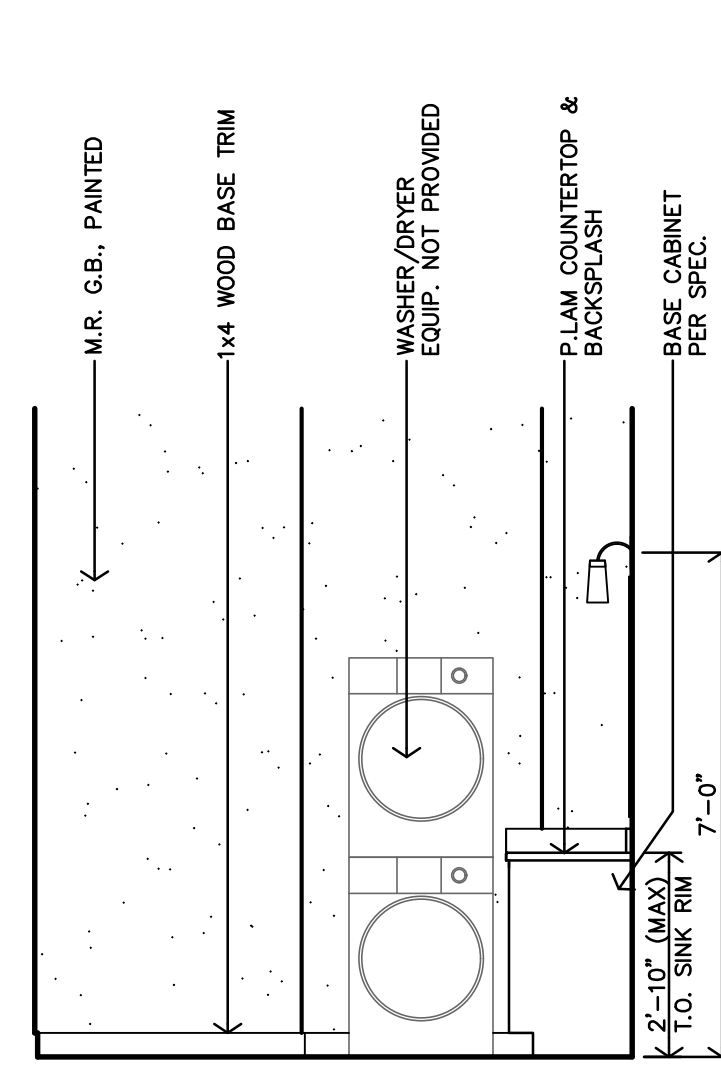
M
ADAPTABLE BATH - TYPE #2
INTERIOR ELEVATION
3/8"=1'-0"

ENLARGED BATH GENERAL NOTES:	
1.	REF. UNIT GENERAL NOTES FOR ADDITIONAL DIRECTION ON SHEET A2.0.
2.	ALL DIMENSIONS ARE TO FACE OF GYP. BD. UNLESS NOTED OTHERWISE.
3.	CONTRACTOR TO INSTALL 2x8 BLOCKING IN WALLS FOR ALL WALL MOUNTED/SUPPORTED COUNTERTOPS & BRACES, SHOWER UNIT, TOWEL BARS & FUTURE GRABS BARS, FUTURE SHOWER SEAT AS REQ'D. (REF. SHEET AAB.3).
4.	SHOWER SEAT TO BE INSTALLED PER TENANT REQUEST IN ADAPTABLE UNITS.
5.	REMOVABLE CABINETS TO PROVIDE 30" CLEAR MIN. FLOORING & WALL FINISH TO BE CONTINUOUS UNDER CABINET.
6.	ALL APARTMENT LAUNDRY AREAS: HOOK-UPS TO BE PROVIDED. WASHING MACHINES AND DRYER EQUIPMENT ARE NOT PART OF THIS CONTRACT.

BATH KEYNOTES:	LEGEND
1. VERIFY ROUGH OPENING SIZE w/ SHOWER UNIT REF. MECH DWGS	M MIRROR
2. PLASTIC COATED WIRE SHELF & ROD @ 69" O.C. AFF	TP TOILET PAPER DISPENSER
3. PLASTIC COATED WIRE SHELF & ROD @ 47" O.C. AFF (ACCESSIBLE UNITS)	TB TOWEL BAR
4. WATER HEATER & FURNACE - REF. MECH. DRAWINGS	SR SHOWER ROD
5. 12" DEEP PLASTIC COATED WIRE SHELVES WITH ADJUSTABLE BRACKETS (5 TOTAL)	CL CORNER LEDGE
6. REMOVABLE CABINET	SH SHOWER HEAD
7. ELECTRICAL, WATER, ETC. HOOK-UPS FOR SIDE-BY-SIDE WASHER AND DRYER (ACCESSIBLE). (WASHER & DRYER EQUIPMENT NOT PROVIDED)	SS SHOWER SEAT
8. ELECTRICAL, WATER, ETC. HOOK-UPS FOR STACKED WASHER AND DRYER. (WASHER & DRYER EQUIPMENT NOT PROVIDED)	GB GRAB BAR

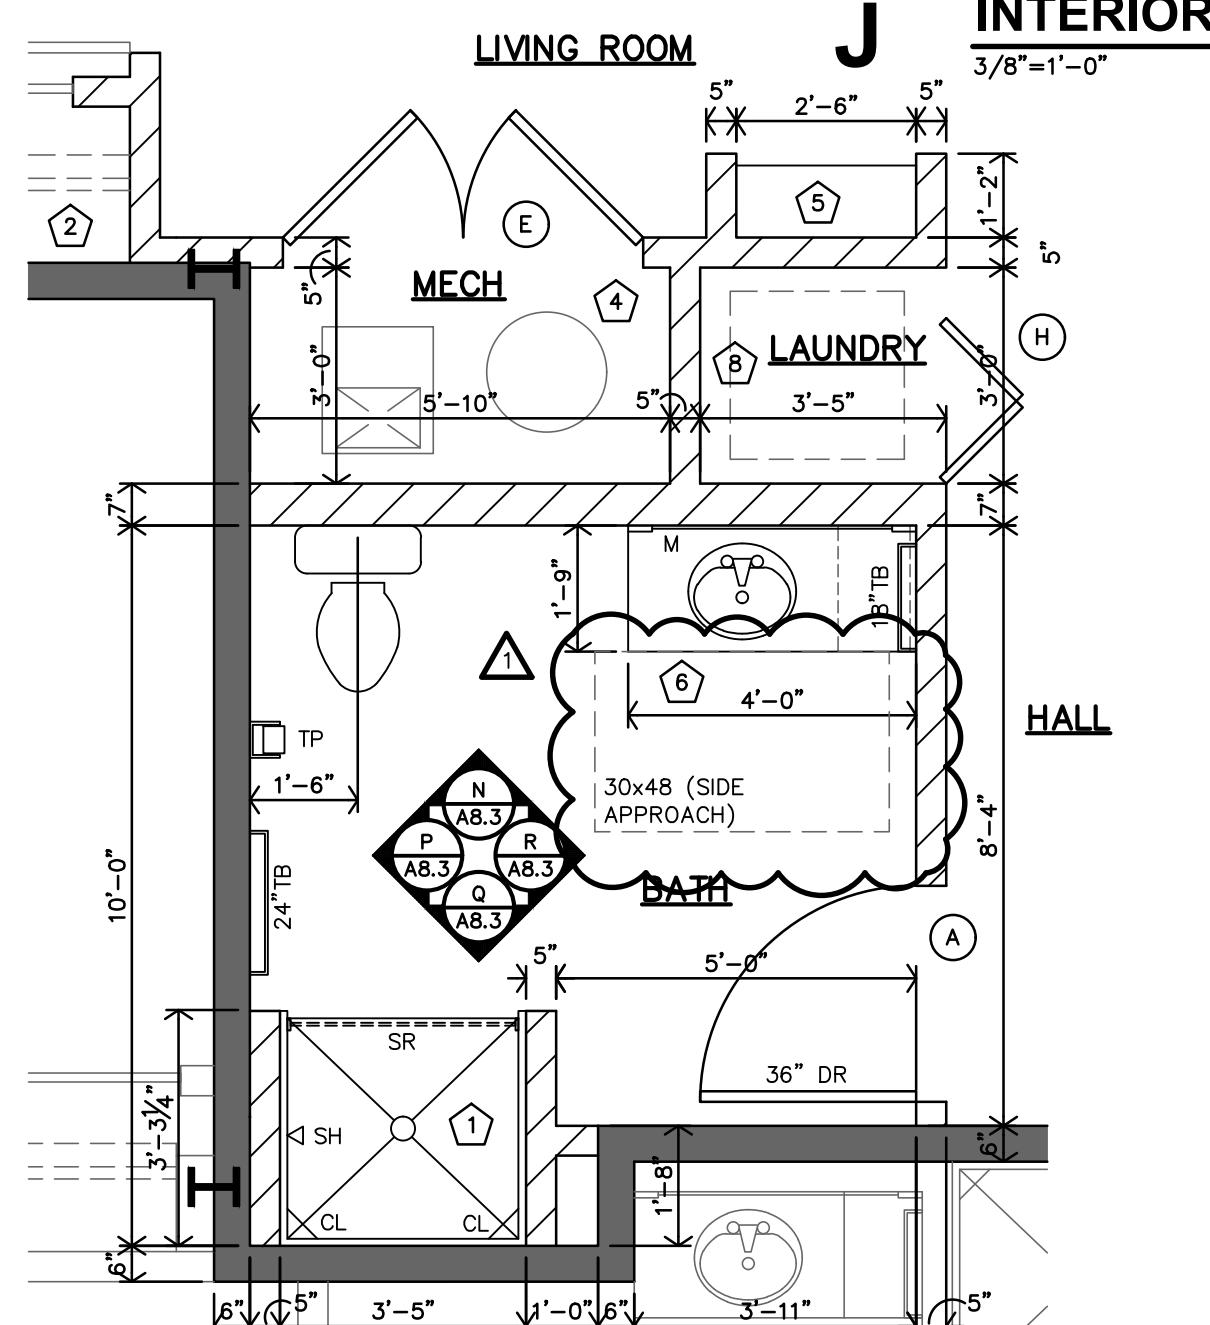
C
TYPE 3 - ADAPTABLE (TYPE B UNIT)
ENLARGED BATH PLAN
3/8"=1'-0"
APT 3 (#113)
SIMILAR: APT. 11 (#202), APT. 19 (#302)

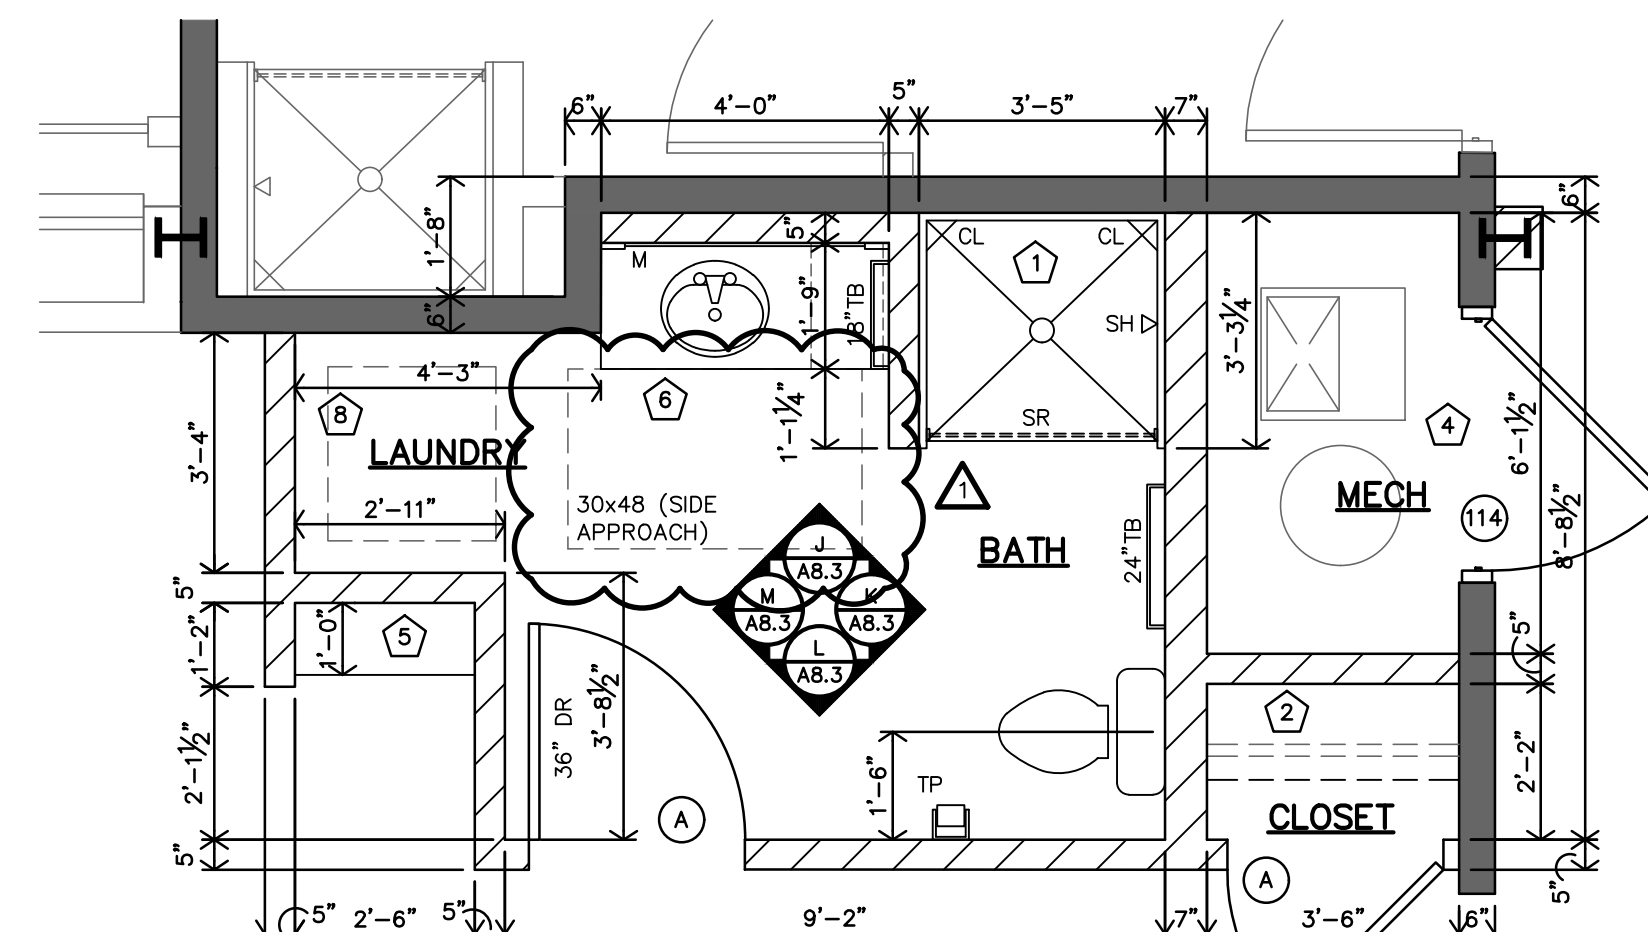
B
TYPE 2 - ADAPTABLE (TYPE B UNIT)
ENLARGED BATH PLAN
3/8"=1'-0"
APT 2 (#112)

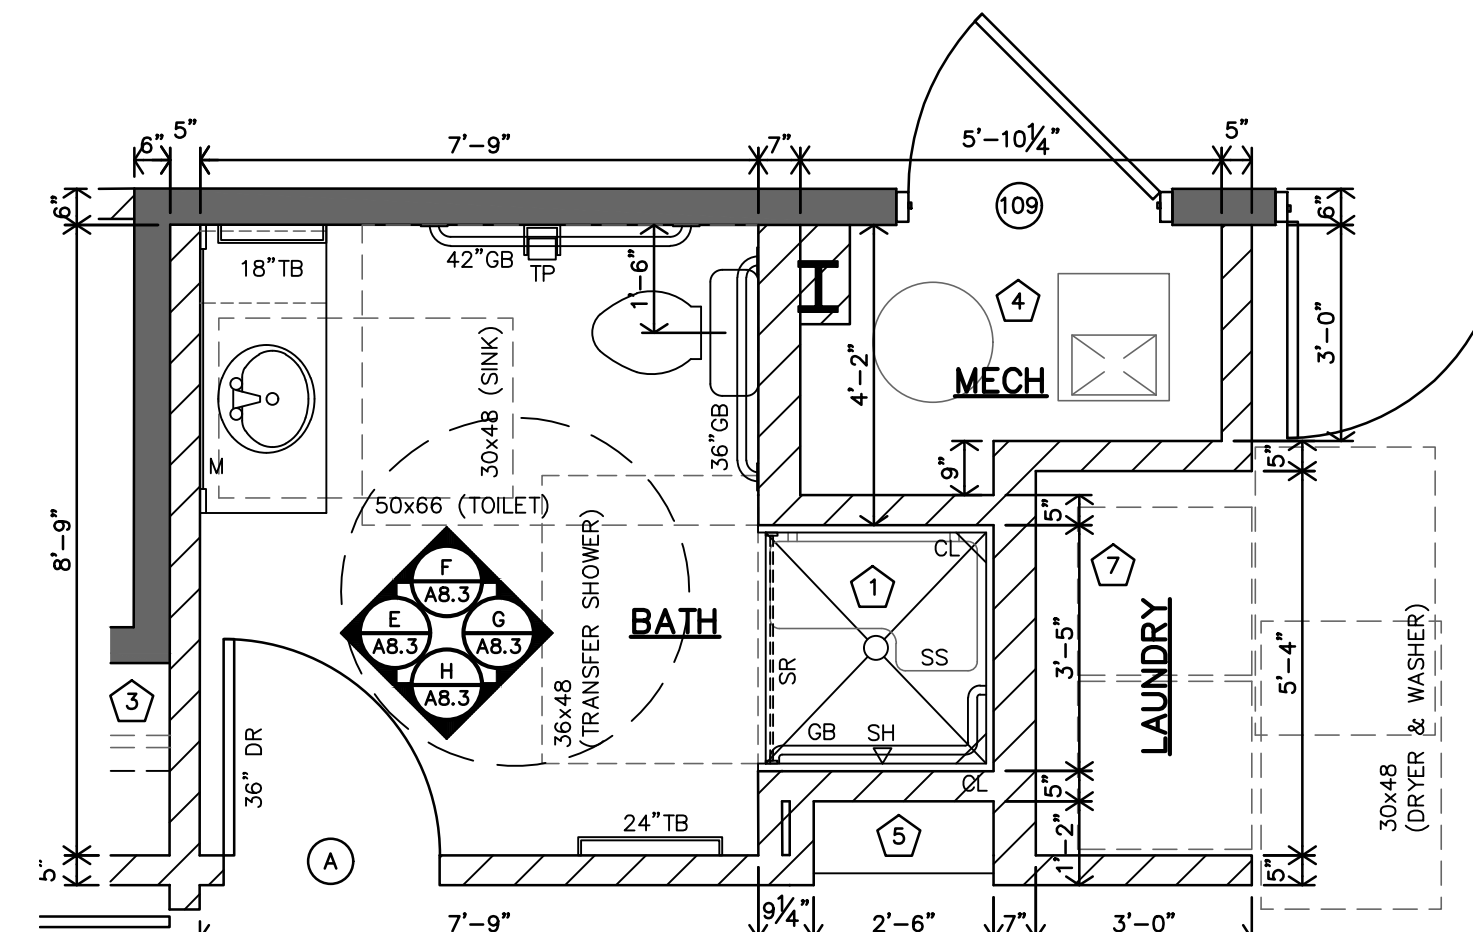
A
TYPE 1 (ACCESSIBLE)
ENLARGED BATH PLAN
3/8"=1'-0"
APT 1 (#109)
