Jones Gillam Renz Architects

Roosevelt Lofts – Historic Rehabilitation & New Apartments – 22-3281

ADDENDUM NO. 1

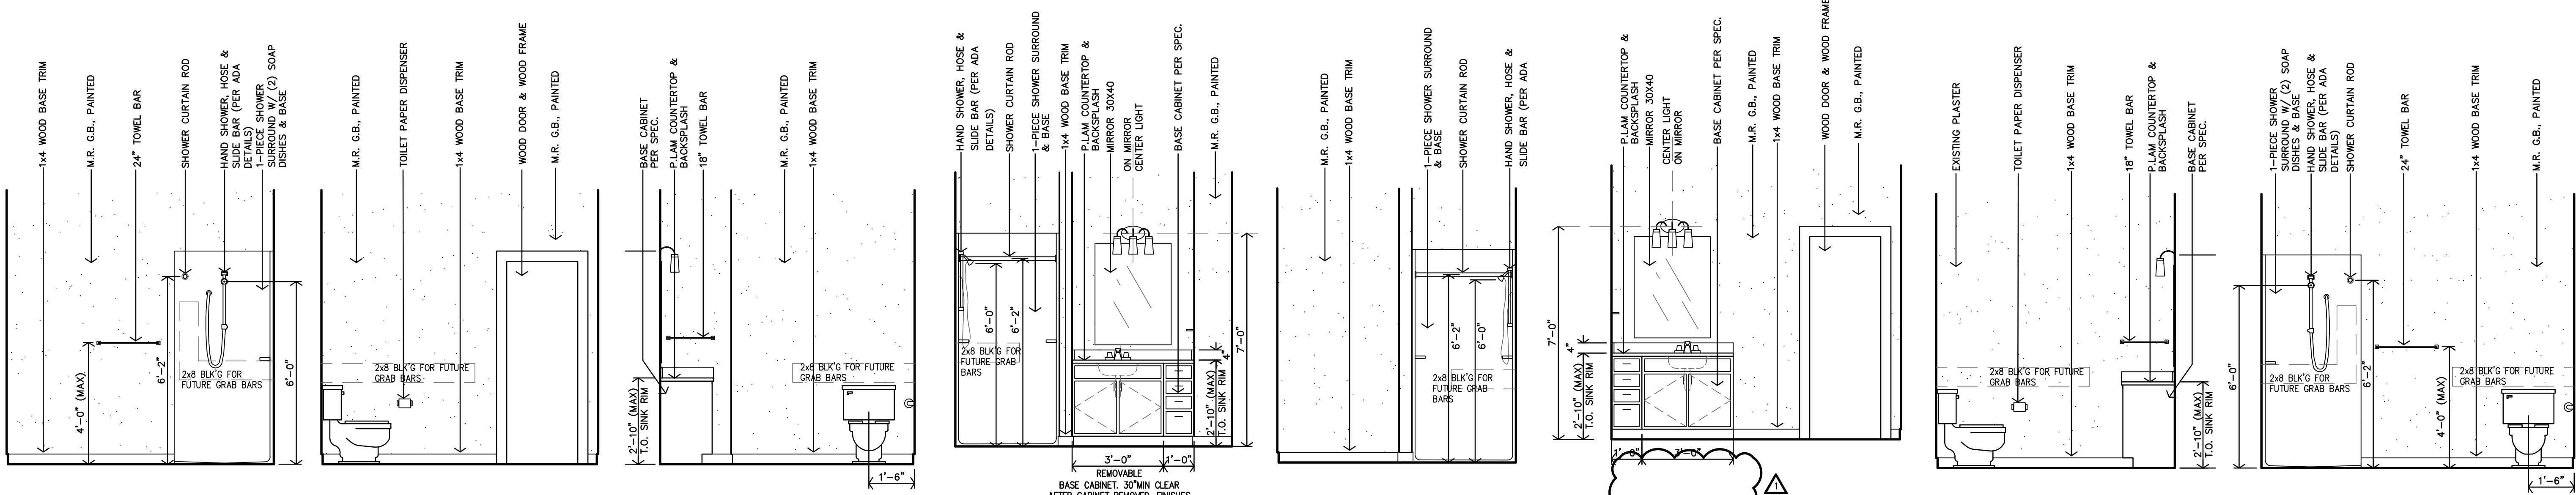
V ADAPTABLE BATH - TYPE #7 INTERIOR ELEVATION
3/8"=1'-0"

U ADAPTABLE BATH - TYPE #7 INTERIOR ELEVATION
3/8"=1'-0"

P ADAPTABLE BATH - TYPE #6 INTERIOR ELEVATION
3/8"=1'-0"

N ADAPTABLE BATH - TYPE #6 INTERIOR ELEVATION
3/8"=1'-0"

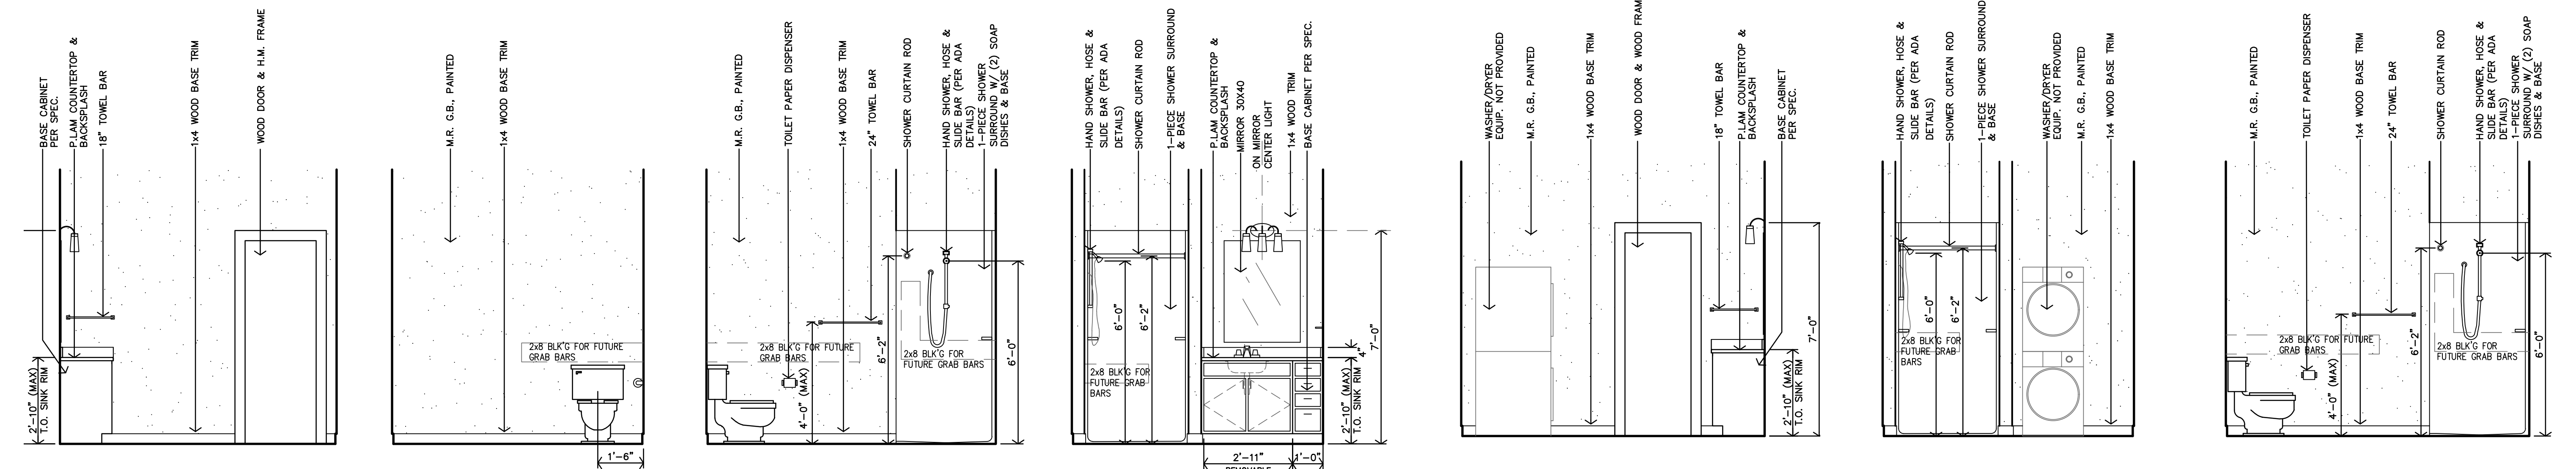
M ADAPTABLE BATH - TYPE #5 INTERIOR ELEVATION
3/8"=1'-0"

L ADAPTABLE BATH - TYPE #5 INTERIOR ELEVATION
3/8"=1'-0"

G ADAPTABLE BATH - TYPE #4 INTERIOR ELEVATION
3/8"=1'-0"

F ADAPTABLE BATH - TYPE #4 INTERIOR ELEVATION
3/8"=1'-0"

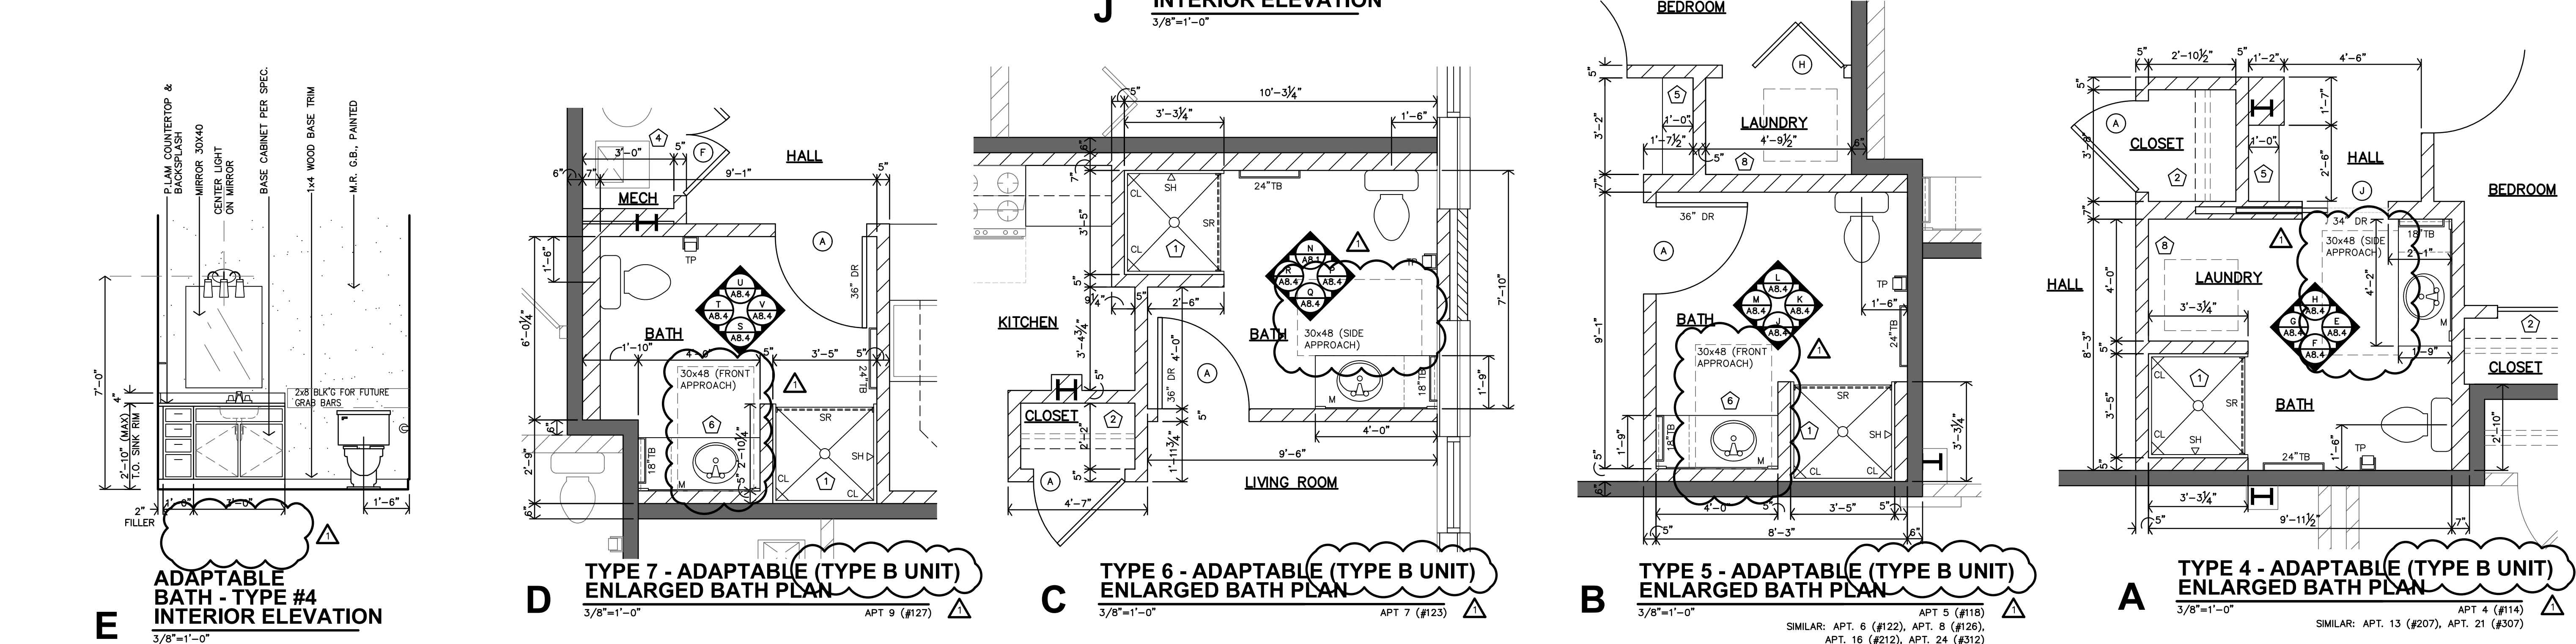
E ADAPTABLE BATH - TYPE #4 INTERIOR ELEVATION
3/8"=1'-0"

D TYPE 7 - ADAPTABLE (TYPE B UNIT) ENLARGED BATH PLAN
3/8"=1'-0"
APT 9 (#127)

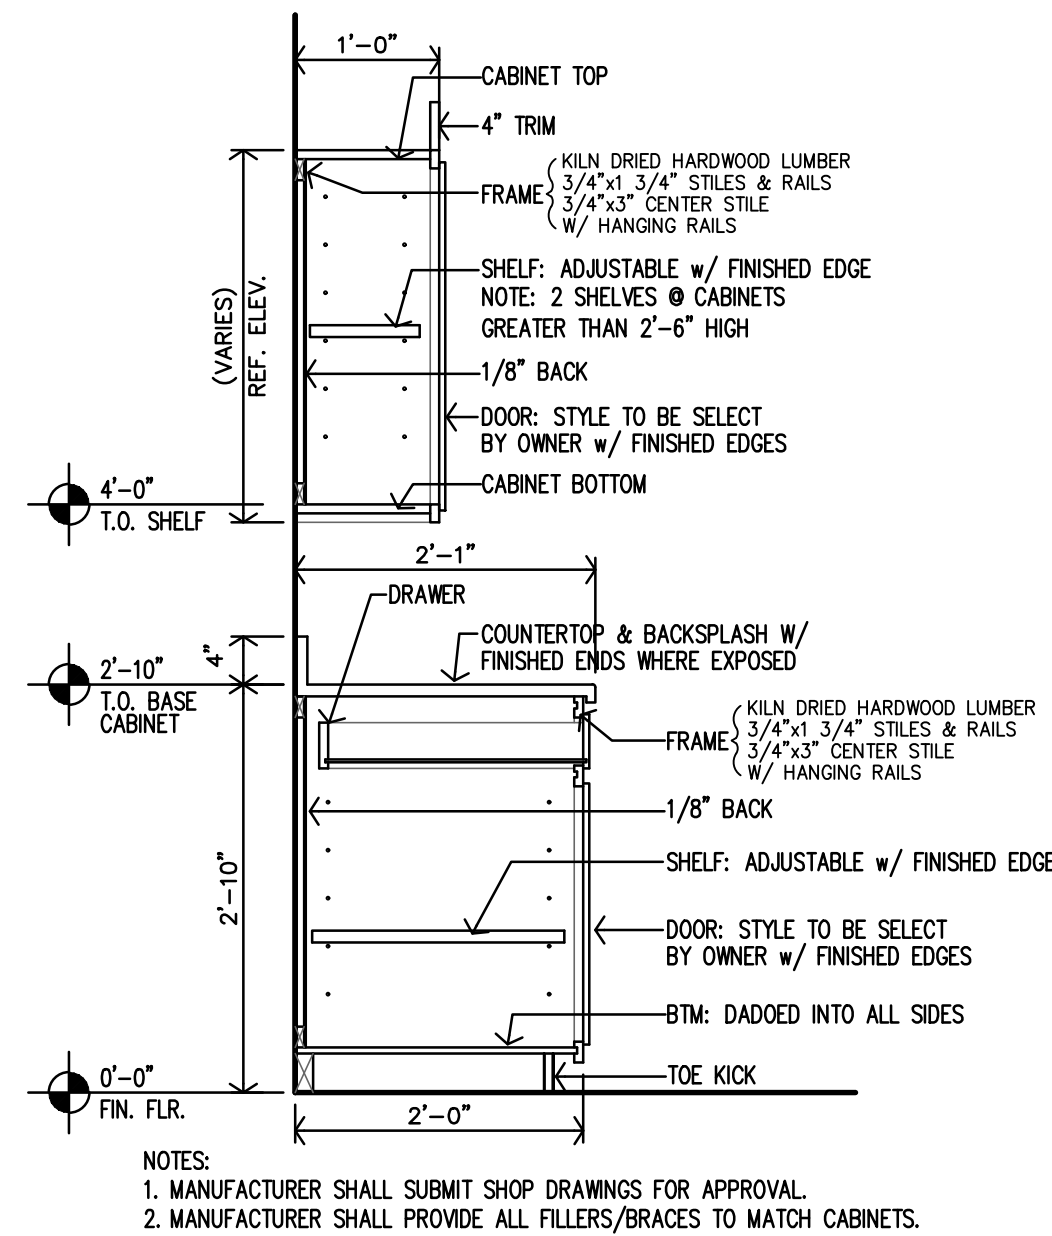
K ACCESSIBLE KITCHEN CASEWORK SECTION
3/4"=1'-0"

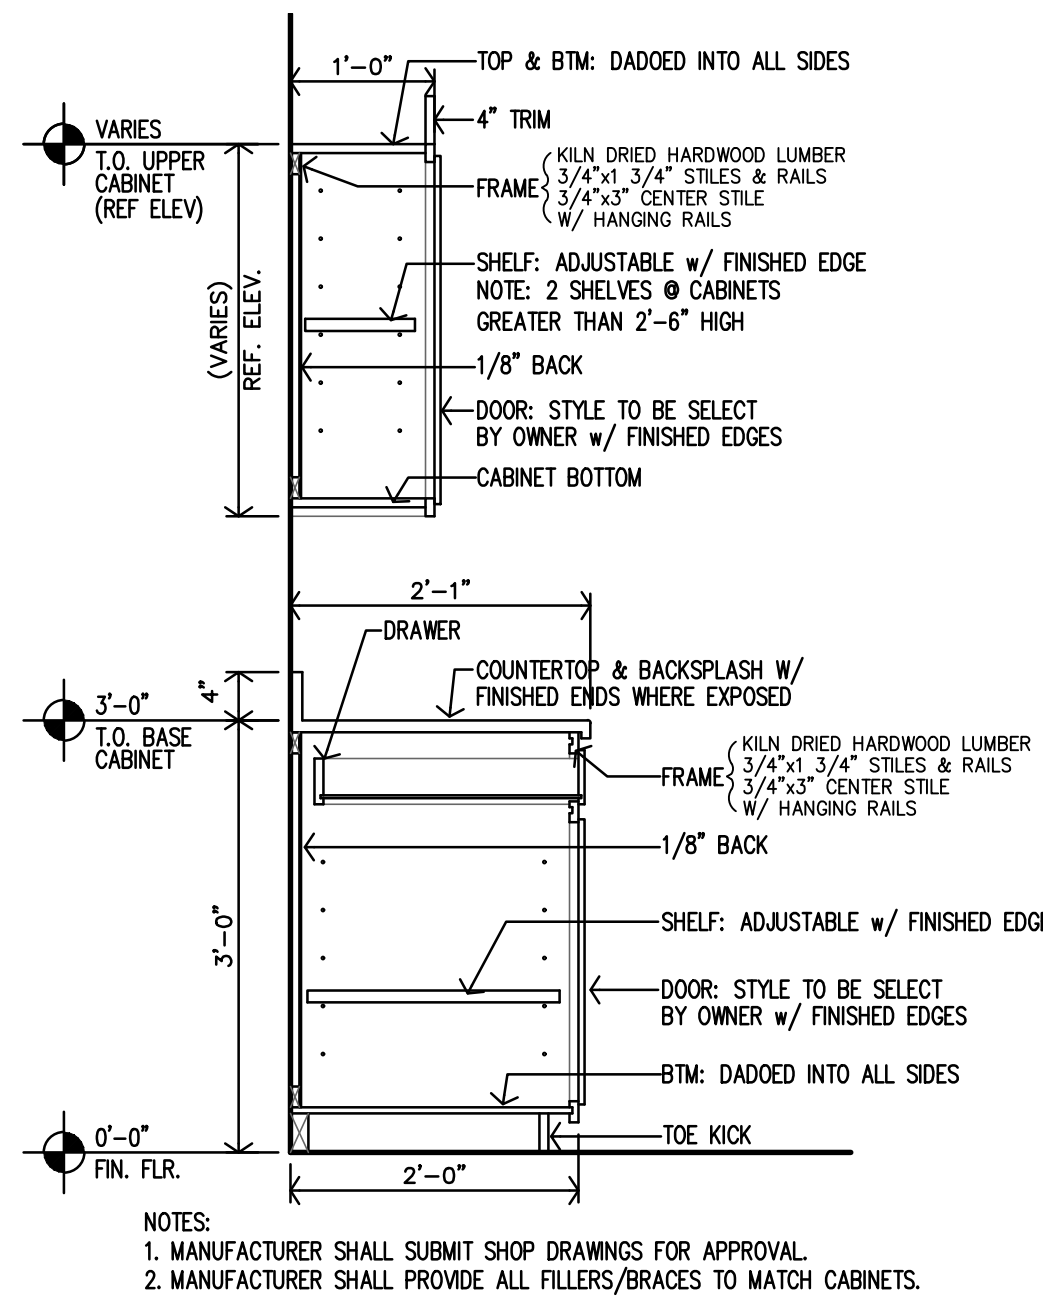
H ADAPTABLE KITCHEN CASEWORK SECTION
3/4"=1'-0"

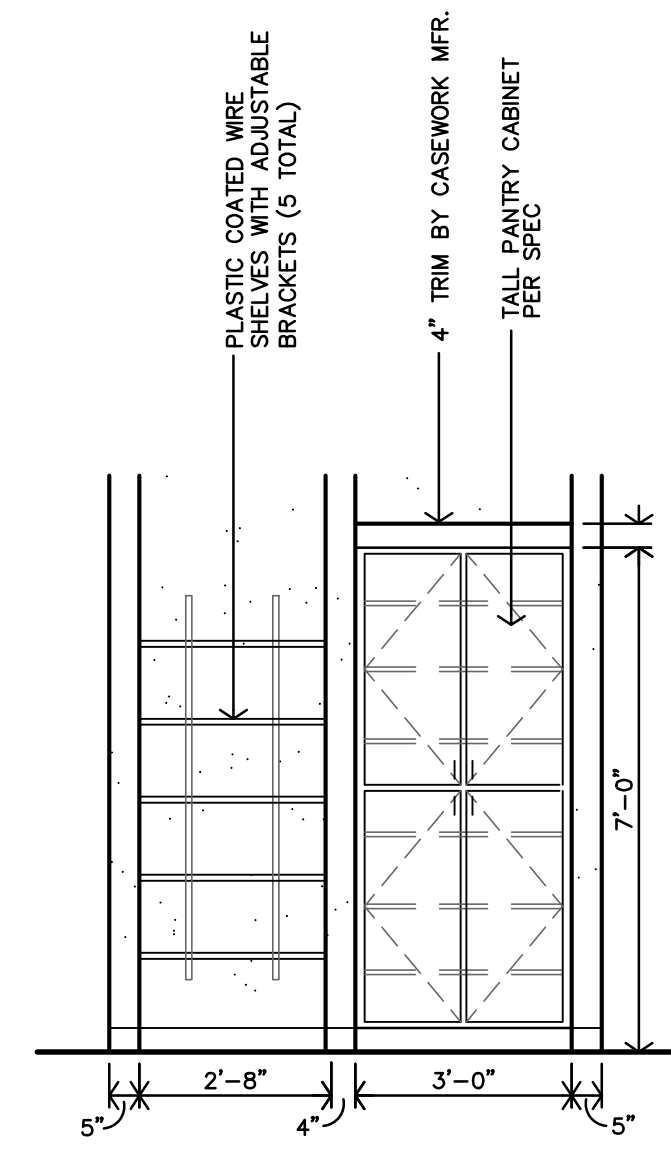
G ADAPTABLE KITCHEN - TYPE #10 INTERIOR ELEVATION
3/8"=1'-0" UNITS: APT. 20 (#303)

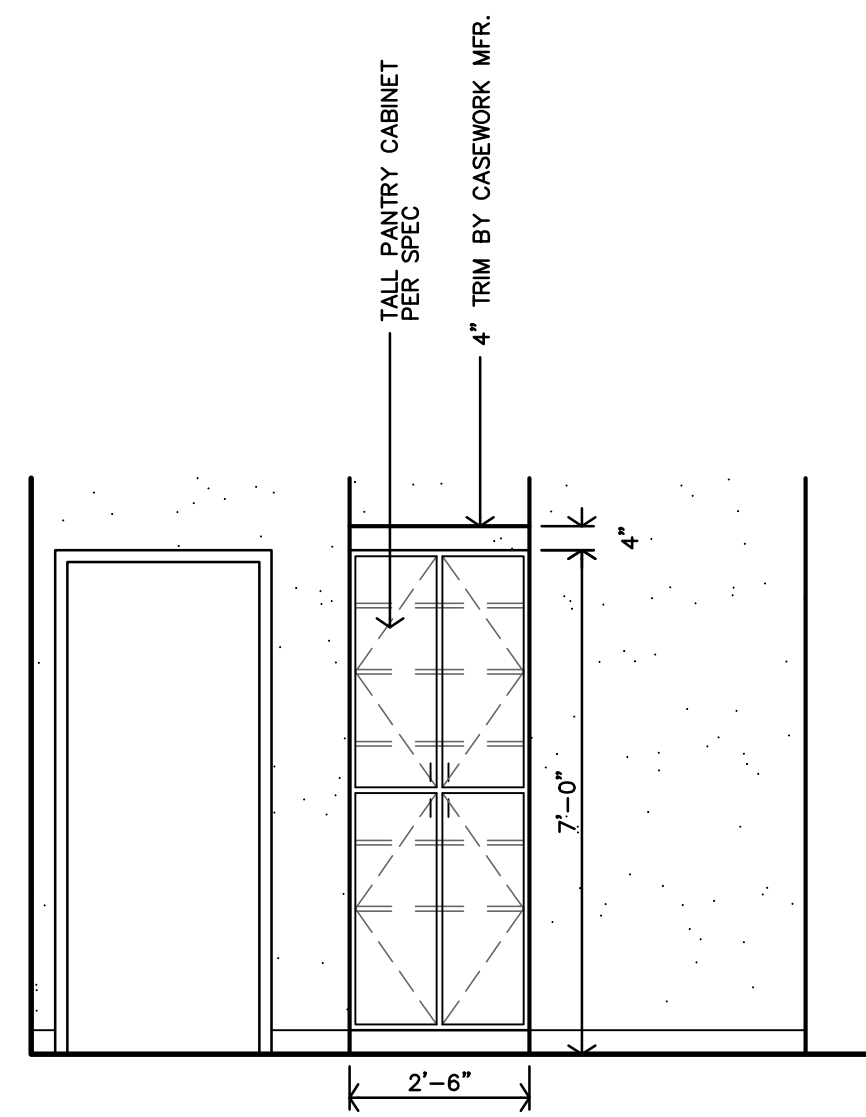
F ADAPTABLE KITCHEN - TYPE #10 INTERIOR ELEVATION
3/8"=1'-0" UNITS: APT. 20 (#303)

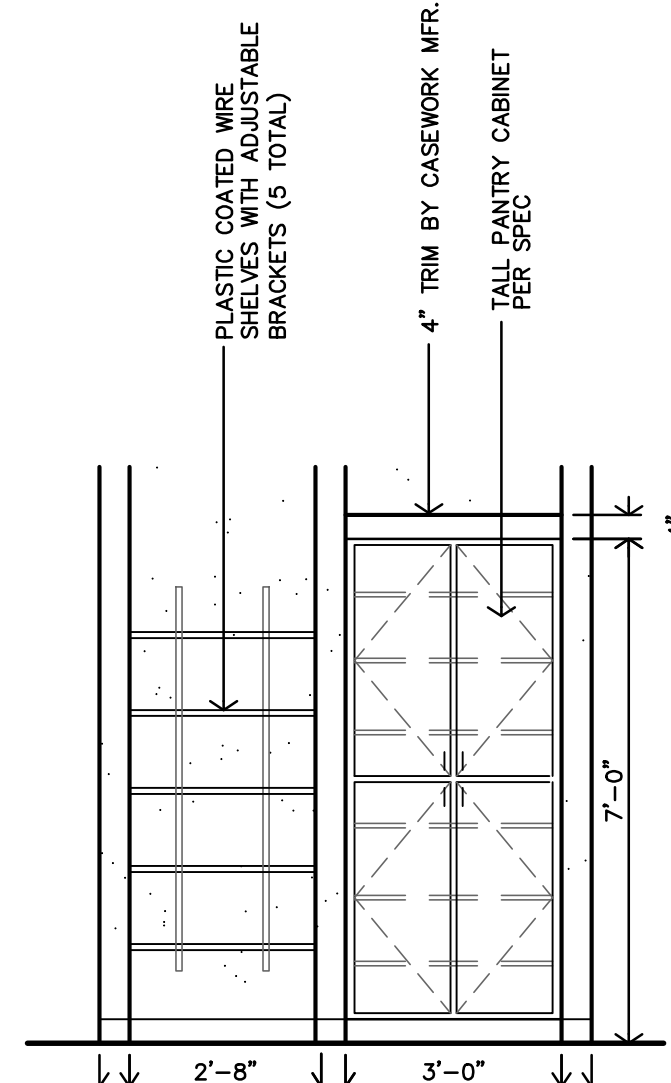
D ADAPTABLE KITCHEN - TYPE #10 INTERIOR ELEVATION
3/8"=1'-0" UNITS: APT. 15 (#211) APT. 23 (#311)
